## 5. THE EXCAVATION

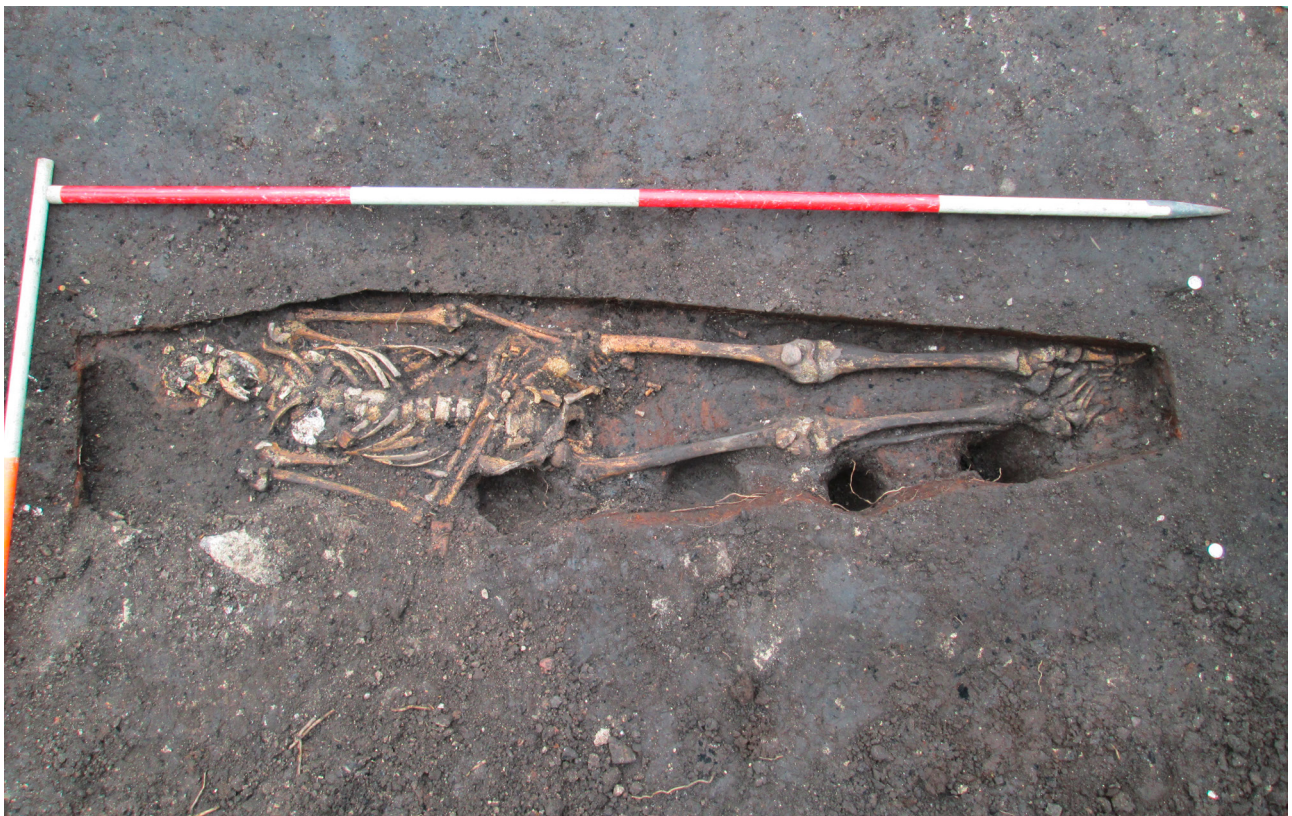
**Illus 10** Burial (SK 018) showing truncation by pinion holes

Coffins [017], [061], [066], [069], [080] and [087] respectively. The skeletons associated with these were SK 018, SK 062, SK 067, SK 070, SK 081 and SK 088. An additional truncated burial (SK 013) was recorded during a watching brief undertaken in 2014 as part of the present project. The majority of the burials had been truncated by the pinion holes relating to the construction of the Poorhouse in Phase 7 (Illus 10 & 11), and by the concrete foundations of more recent development.

At the northern end of the building, the substantial gable end was the best surviving of the walls, with a height of 1.64m and a width of 1.25m; the southern gable end, Context [006], had been severely truncated by a modern brick structure and survived largely as a series of post-holes for timber foundation pinions. These features were observed during the excavation of the later garden soil/midden deposit, with many cutting Graves [033], [063], [068], [082] and [089].

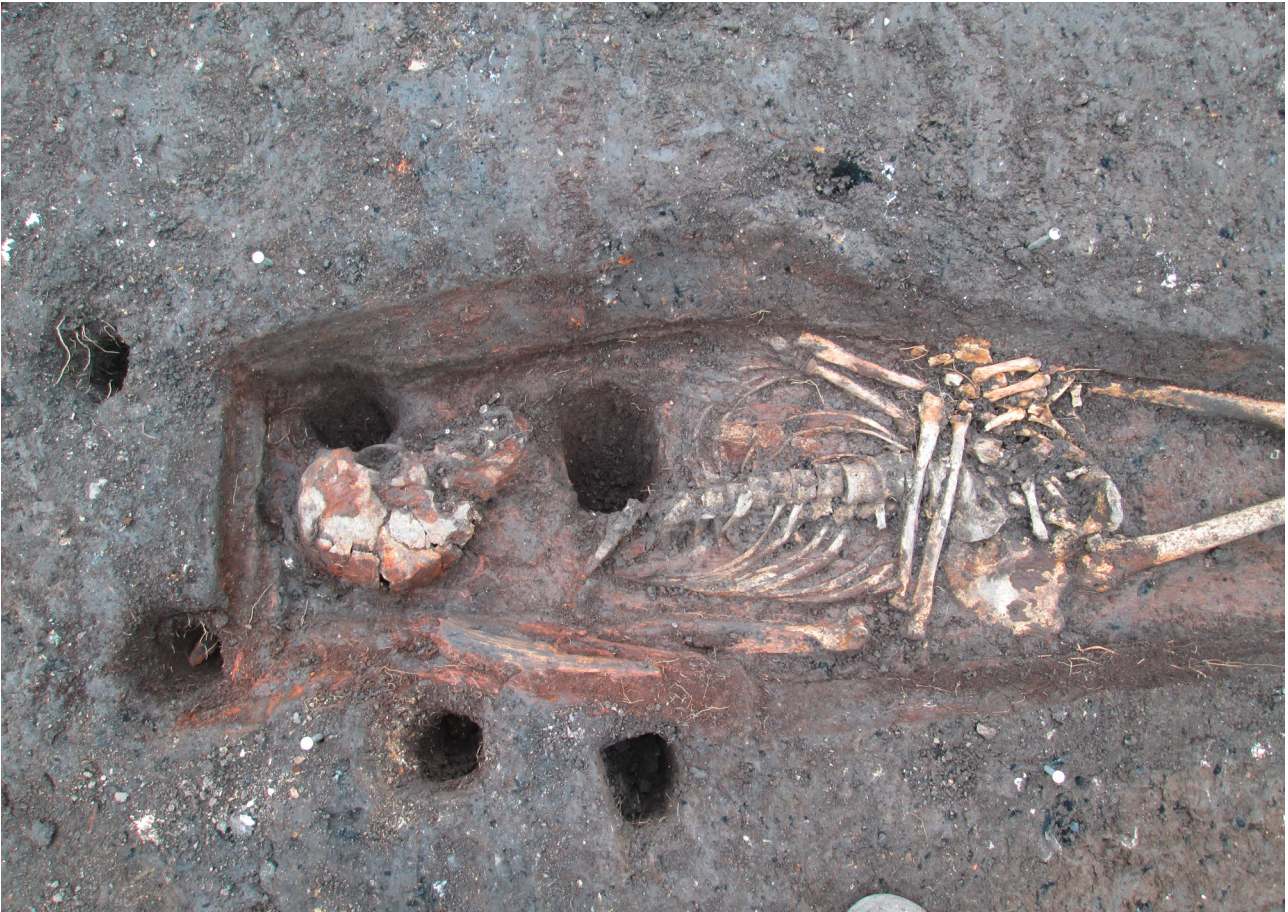
**Illus 11** Detail of burial (SK 062) truncated by pinion holes

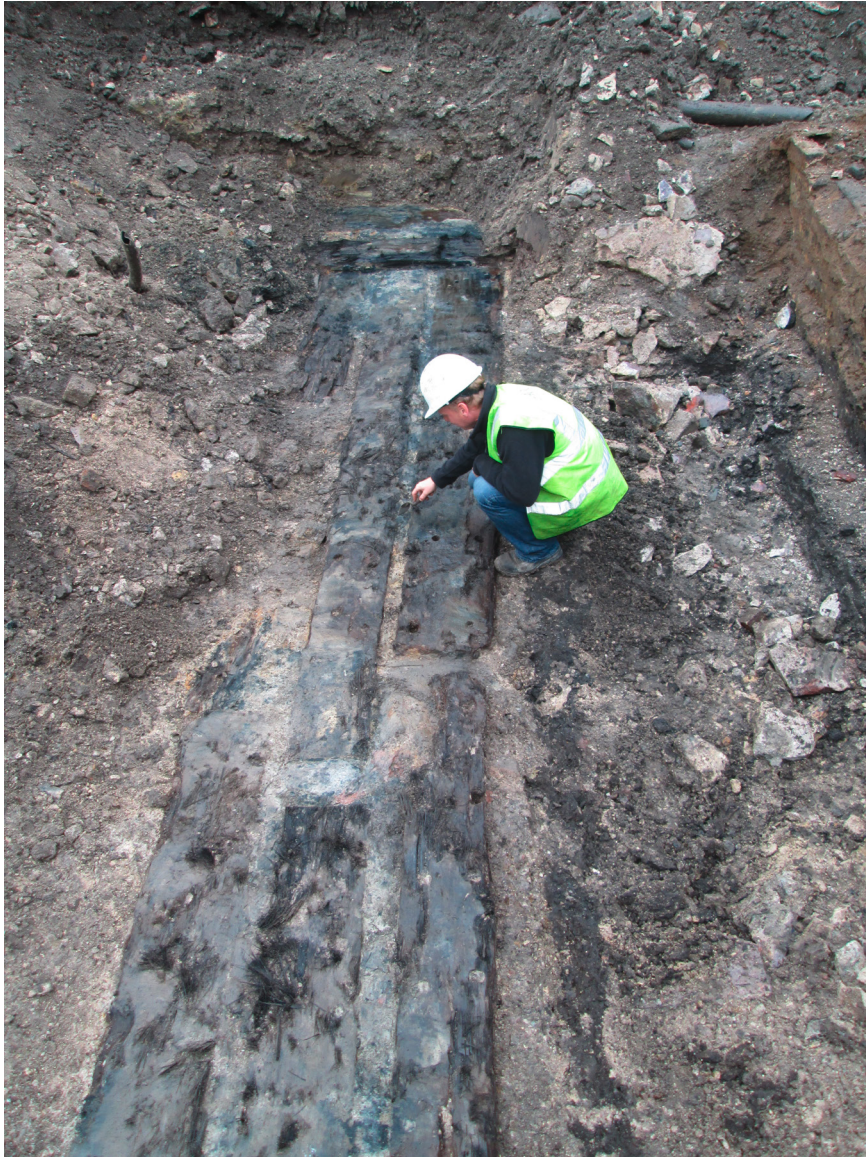
**Illus 12** Oak plank and pinion foundations under excavation

No foundation cuts for the Poorhouse walls were revealed during the excavation. Instead, the walls were constructed on rafts of squared oak planking, visible in a degraded form in section (Context [111]) associated with construction deposits [110] and [122]. These rafts were placed on a substantial bedding deposit of clay silt, degraded lime mortar and cinder [097]. The planks varied in size from 0.60m to 3.84m in length and were between 0.17m and 0.44m in width and c 0.08m thick. Four parallel rows of circular holes spaced between 0.20m and 0.40m apart had been drilled through the planks in order to accept timber pinions, eg [123], [124] and [125]. The partial removal of the northern gable end and the western wall during excavation revealed a large number of these pinions in situ within the planking (Illus 12 & 13).

The pinions themselves were up to 1.10m in length and made of roughly squared oak

roundwood with tapered ends. These timber pinions effectively fixed the foundations into the bedding deposits and the underlying 17th-century garden soils/midden.

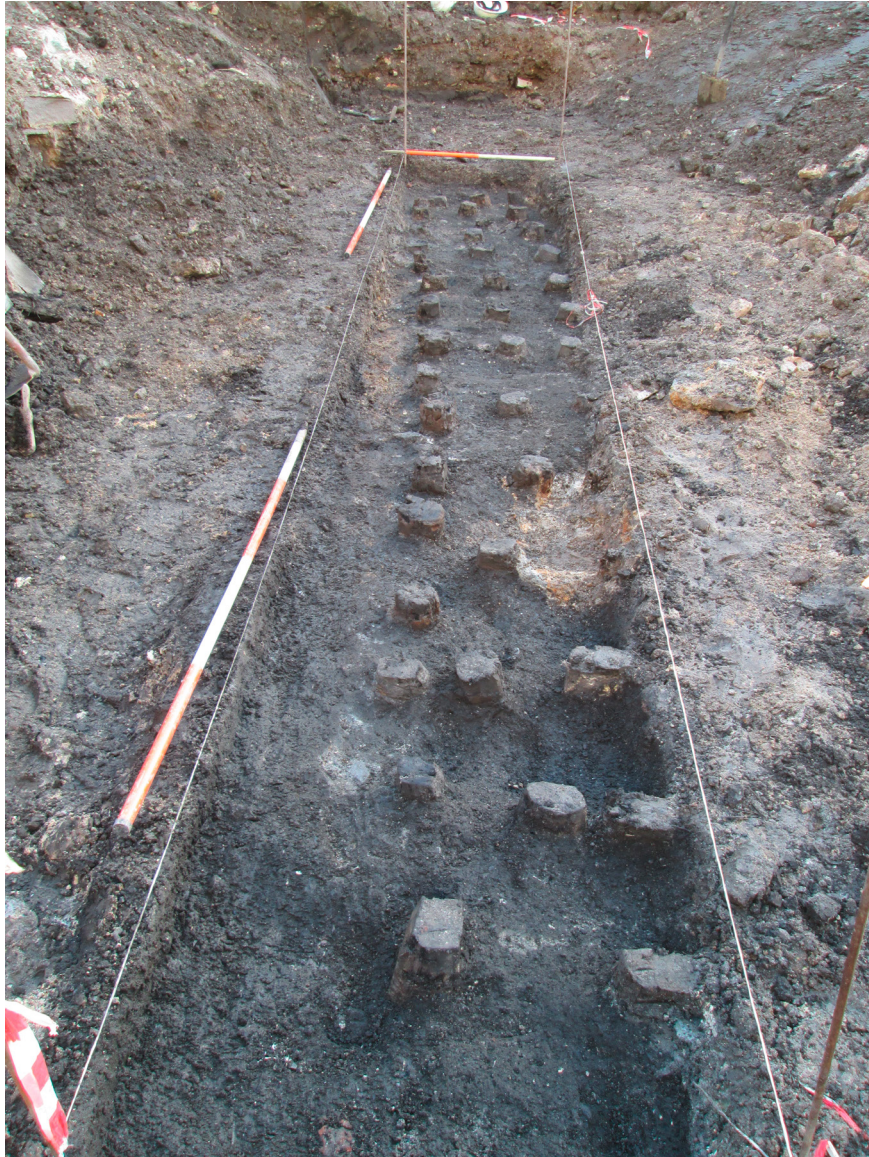
**Illus 13** Detail of pinions of the Poorhouse foundations
