5. EXCAVATION RESULTS

Initially Scheduled Monument Consent (SMC) was granted for the excavation within 8 trenches (Trenches 1–8, Case ID: 300026684 and Case ID: 300033153). Trenches 1–3 were located within the Castle scheduled area (SM 276) and Trenches 5–8 were within the Burgh scheduled area (SM 3410) while Trench 4 fell within both scheduled areas (Figure 4). Consent was also given by Historic Environment Scotland under the granted SMC to examine wall relationships in three further areas (Areas A–C). In 2020, SMC was sought to explore the possibility of the existence of a gate between the two drum towers along the north wall of the Outer Bailey this area forming Trench 9 (SM276 Case ID: 300043382). The site code used during the excavation work was TAR 19 and the initial results of the excavation appeared in the subsequent Data Structure Reports (Regan 2019; 2020b).

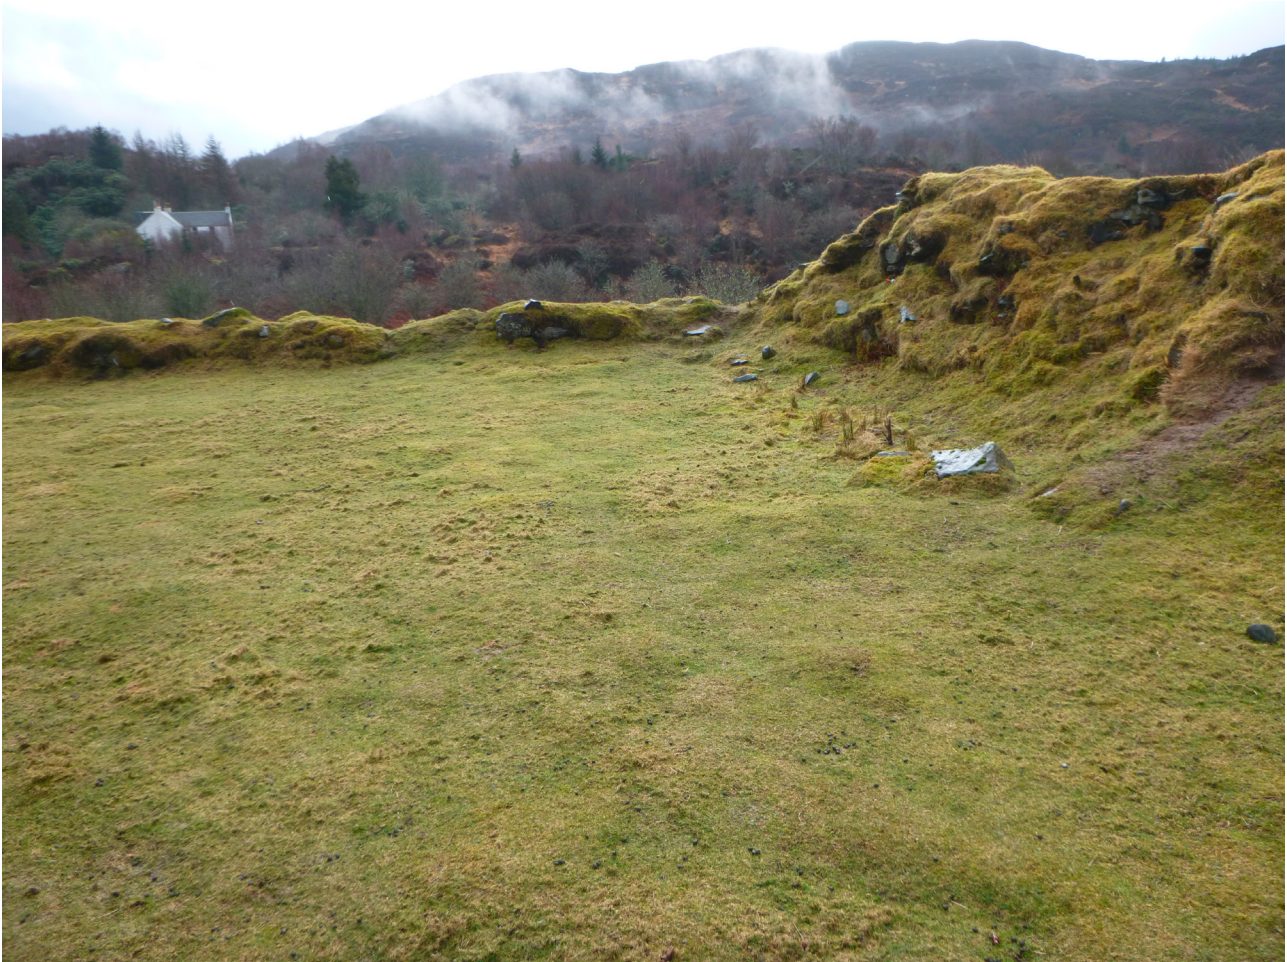
Illus 11 Area of Trench 1 pre-excavation showing junction of Inner and Outer Bailey walls from the north

This trench was located on relatively flat ground at the junction of the Inner and Outer Bailey walls to examine the relationship of the walls and establish a chronology of construction while investigating the area's potential use in the medieval period (Illus 11 and 12).

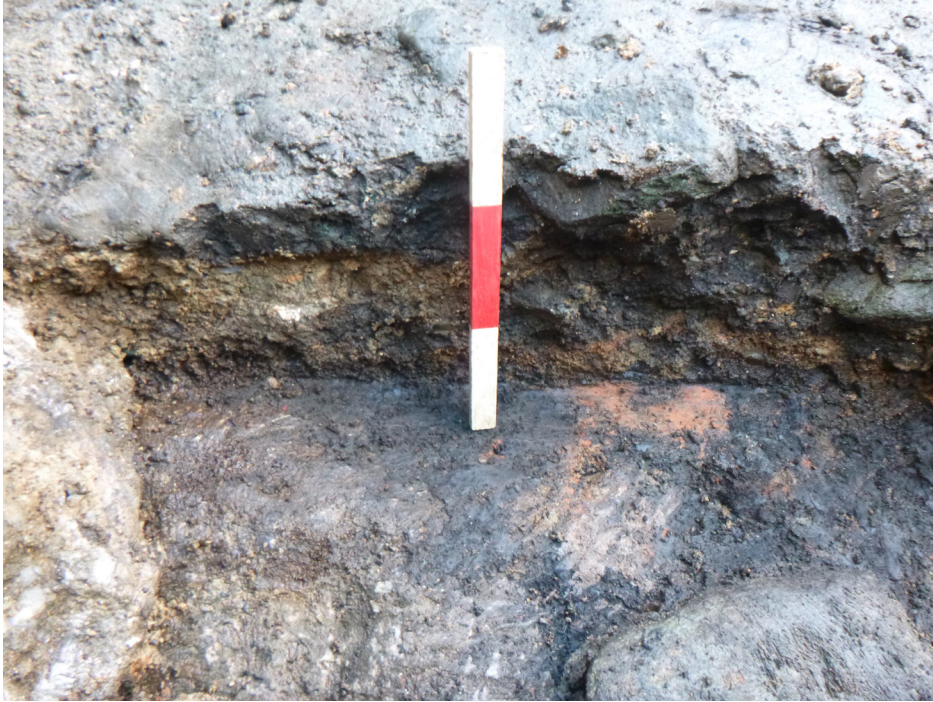
Natural bedrock was encountered within the excavated trench at 33.08m OD or 1.30m below the present ground surface. Above this lay a dark grey peaty soil, C076. This soil was observed to contain organic preservation including recognisable remains of wood and plant material, which likely survived due to the anaerobic nature of the soil and it also contained carbonised hazel (Illus 18 and 19). The upper surface of this deposit was fire reddened in part, indicating burning had taken place on the ground surface although it was impossible to determine if this represented limited burning, as in a hearth area, or is representative of more widescale burning.

Illus 19 Trench 1 deposit C076 with burning, below deposits C075, C074, C073, and C065

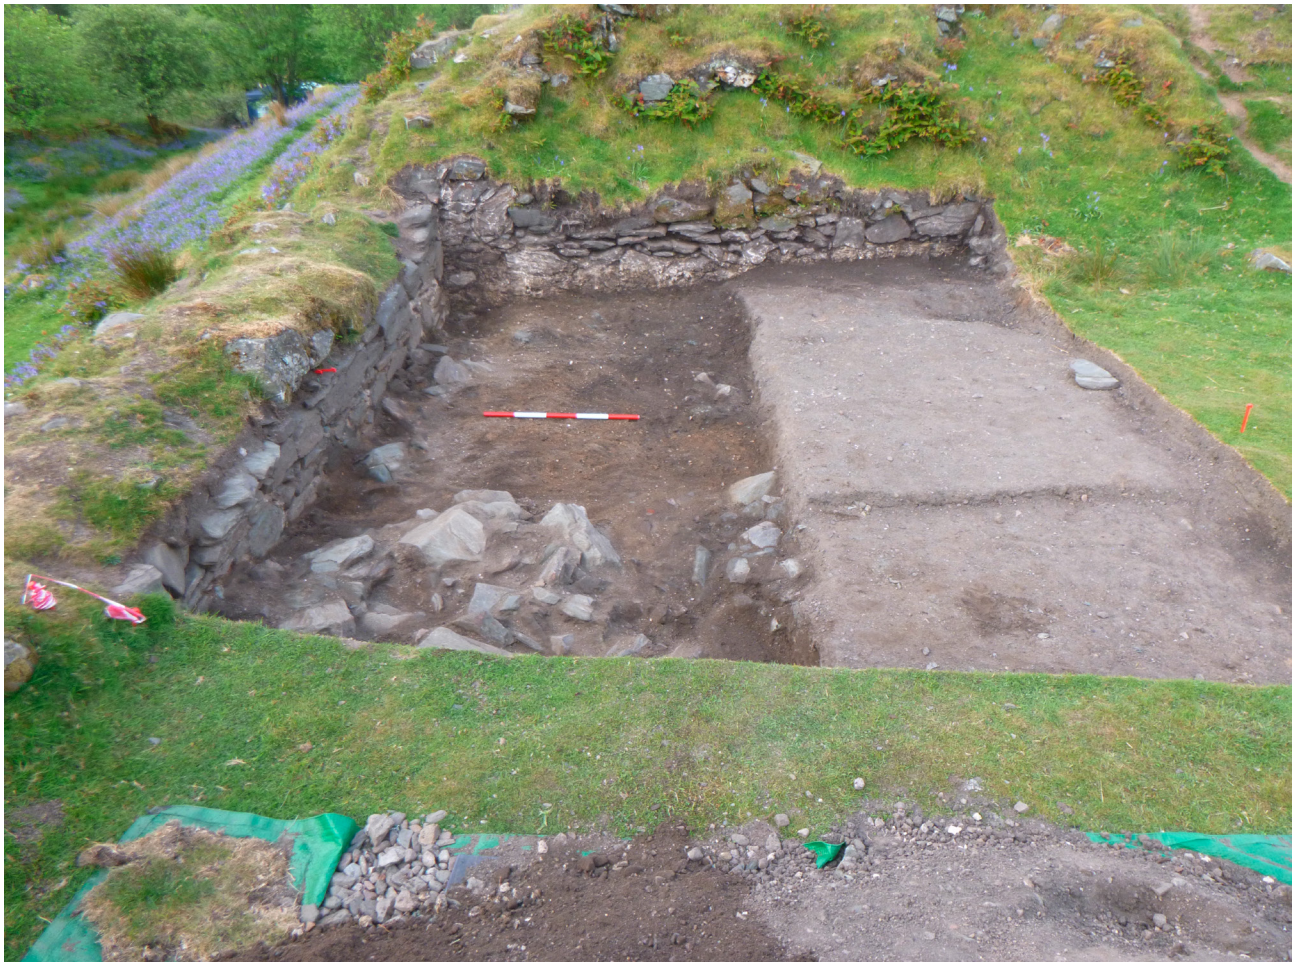
Above this was an extensive deposit of wall collapse/demolition, C014. This rubble deposit was up to 0.50m deep across the trench and contained some substantial masonry blocks surrounded by degraded mortar. Numerous voids between the rubble blocks suggested that this deposit formed relatively rapidly. Apart from the rubble and mortar content this deposit was relatively sterile of finds, the exception being a large fragment of slag.

Illus 21 Trench 1 top of rubble deposit C014 exposed in eastern side of area from the southwest

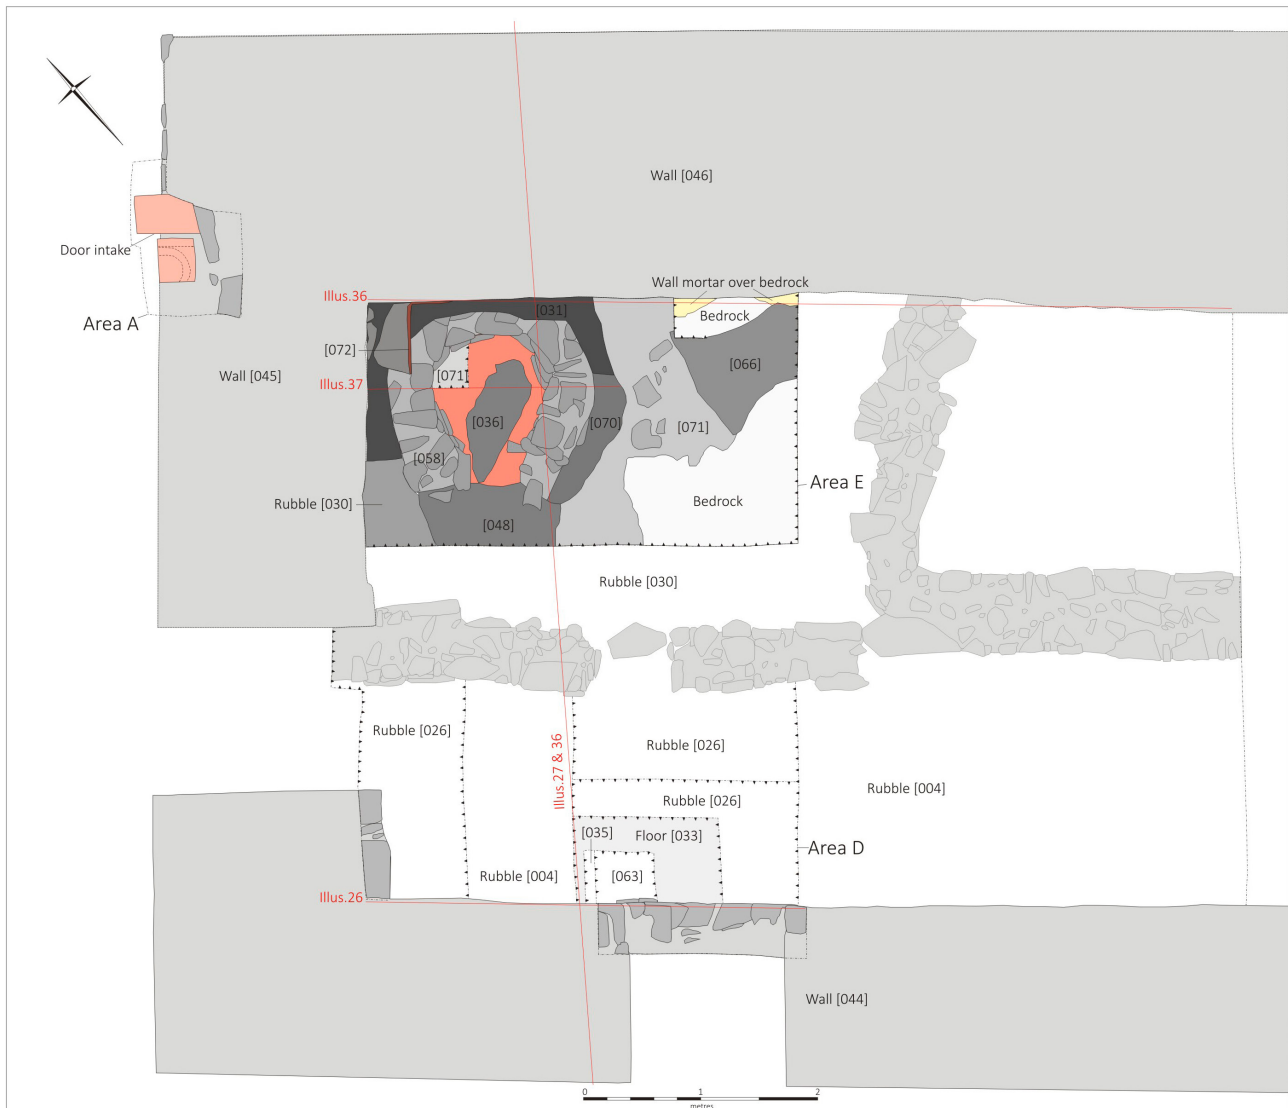
Illus 25 Trench 2 plan of medieval deposits

In both Area D and Area E natural bedrock was exposed and above this were medieval occupation sequences (Illus 25).

At the junction of walls C046 and C045 at the northwest of the area it was noted that two stones had been discoloured by burning, suggesting the presence of a fireplace or fire installation, C072, in this corner of the range. Possibly associated with this feature were two thin deposits of charcoal, C069 and C067 (containing alder, birch, hazel and oak), separated by an equally thin deposit of mortar, C068. The lower charcoal deposit lay over a sandy gravel deposit similar and possibly the same as C033 in Area D, although this was not proven. Built over the upper charcoal deposit and possibly a replacement for the burnt feature was a small 'keyhole-shaped' hearth or boiler, C058 (Illus 25, 32, 35 and 37).

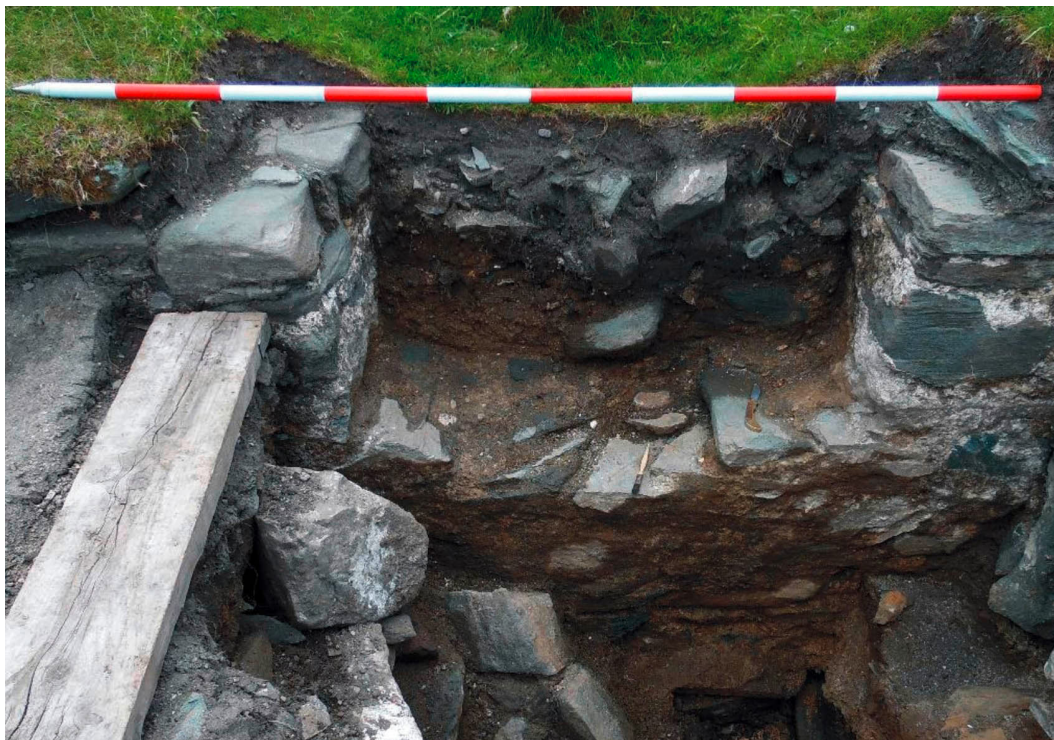
As with wall C046 in Trench 1, where the builders did not make contact with bedrock, the wall footings were wider or were offset at the basal course to the rest of the wall above. The wall in the trench stood up to 1.70m high and was bonded and coated with a firm cream/off-white coloured mortar. The wall also contained an opening, most likely a door, being 1.35m (4ft) wide. The base or threshold of this opening was 0.95m above the base of the wall below, however only 0.32m above the basal internal floor C035, indicating the opening function as a door rather than window opening.

Illus 30 Trench 2 Area D doorway within wall C044 from north (photograph by Mark Thacker)

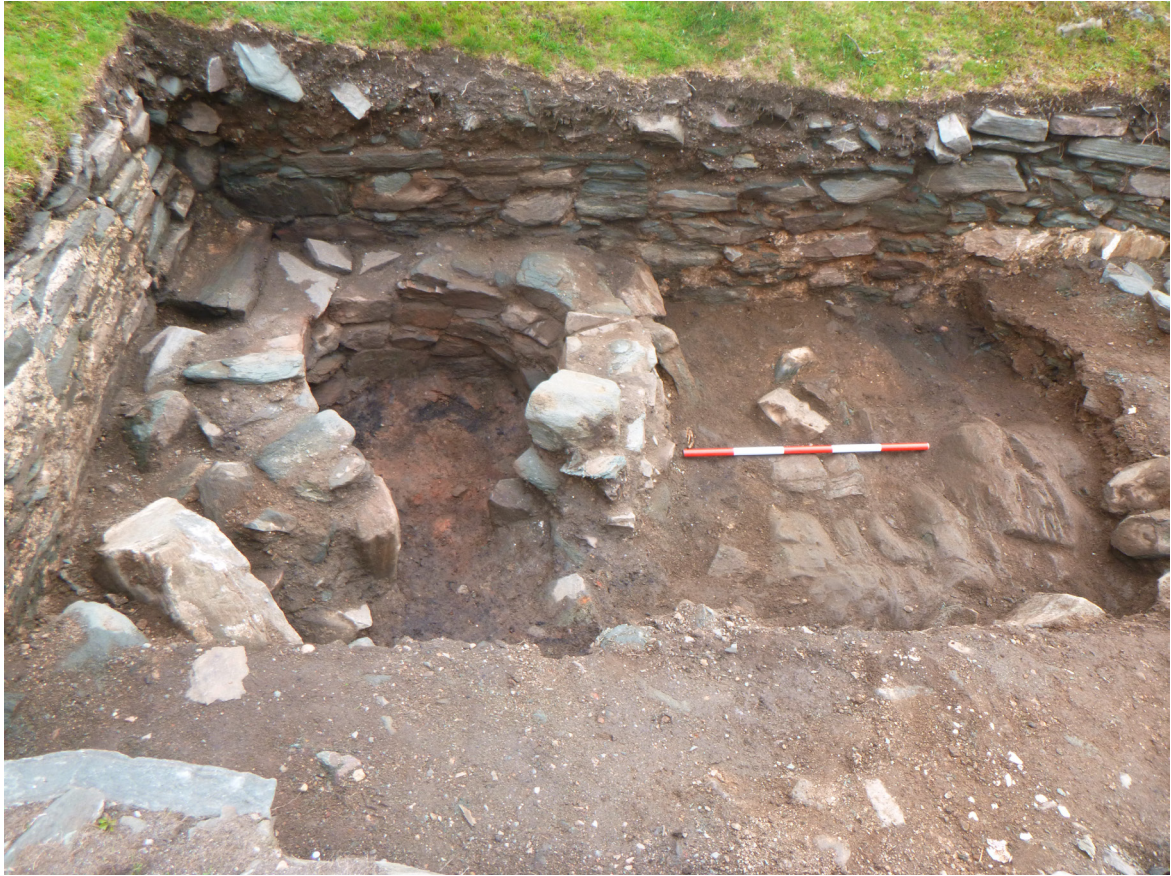
This feature was constructed from rubble and clay, the walls standing up to 0.63m in height. The internal walls of C058 and the clay floor, C039, were pink/red in colour, the effects of burning.

Illus 32 Trench 2 Area E from southwest with hearth area C058

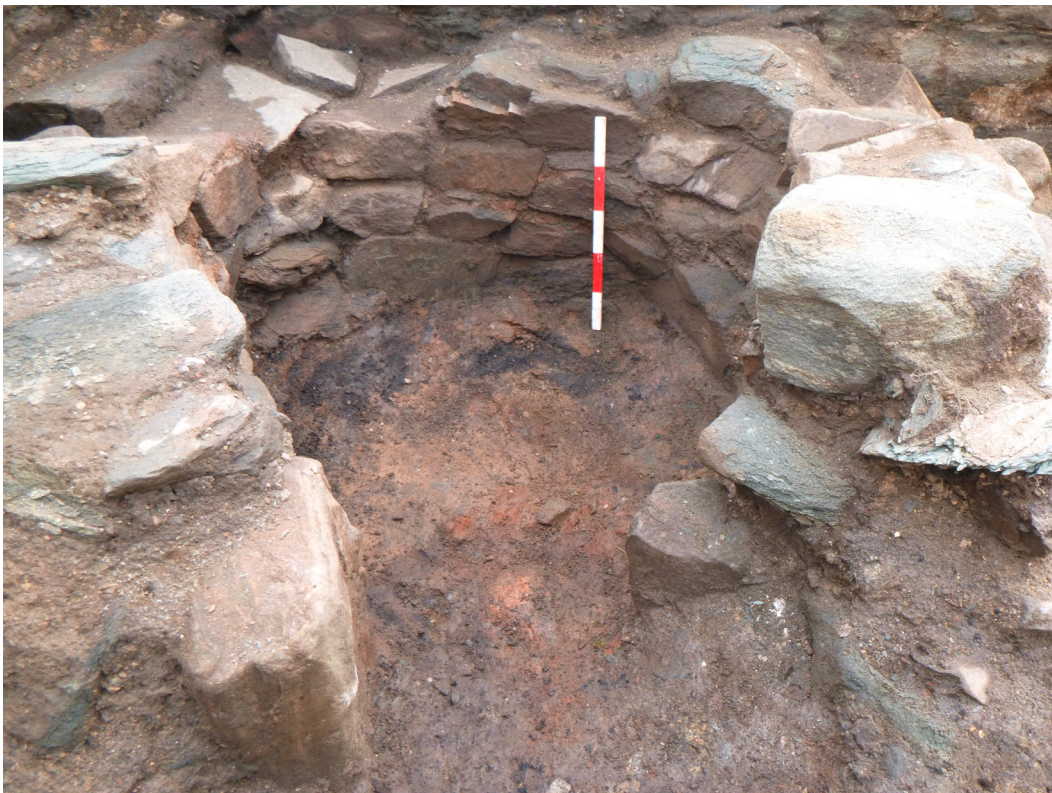
Illus 35 Trench 2 Area E hearth feature C058 from southeast

It is hard to see how this feature functioned as an oven as the internal floor was lower than the floor level around its mouth or entrance and there was no evidence of any collapsed roof within its internal space. While this might be explained by later robbing, it seems more likely this feature did not have a roof and if this feature was indeed open then it is possible this was used in the heating of a cauldron or vat, although this must remain speculation. Little evidence of any fuel was left in this feature as it appears to have been cleaned out after its last use.

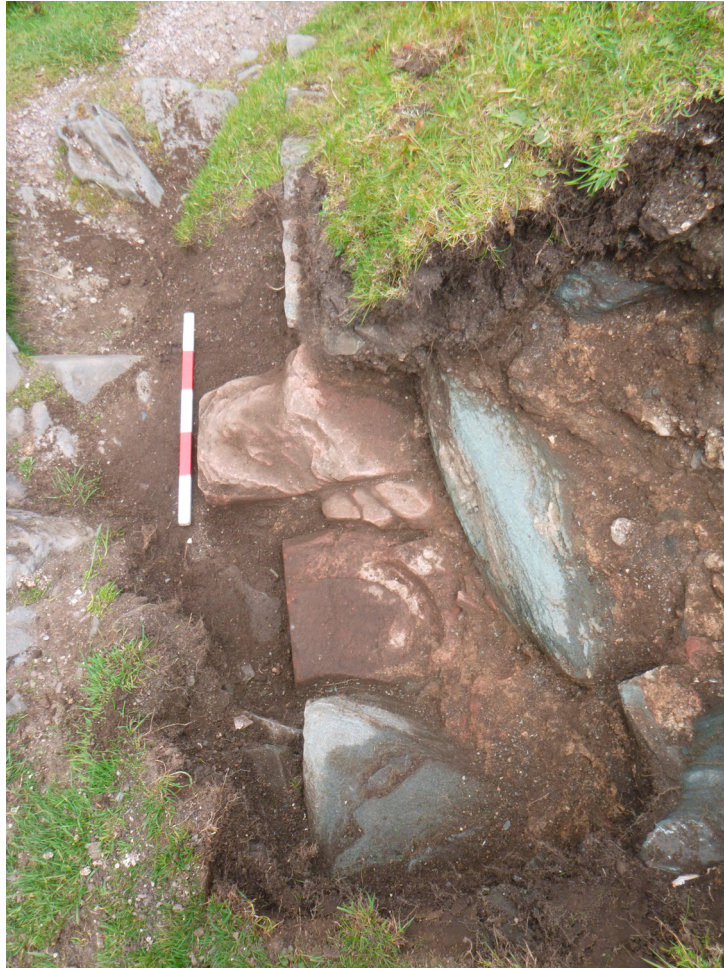
relationship of these walls more fully, vegetation cover was removed within Area A. Unfortunately, if anything the relationship of the walls on this side was less clear than on the inner junction. However, this small, exposed area did reveal the eastern side of the gate into the Inner Bailey (Illus 25 and 46).

This consisted of a door intake in red sandstone masonry. The red sandstone block within the internal door rebate had a curvilinear groove either carved or worn in its upper surface. If carved, then it is possible that this block was reused from an earlier building. However, it is possible that the groove comes from wear, or has been deliberately fashioned to receive a door mechanism, although what type remains unclear.

Illus 46 Area A eastern side of entrance into Inner Bailey with door intake from the southwest

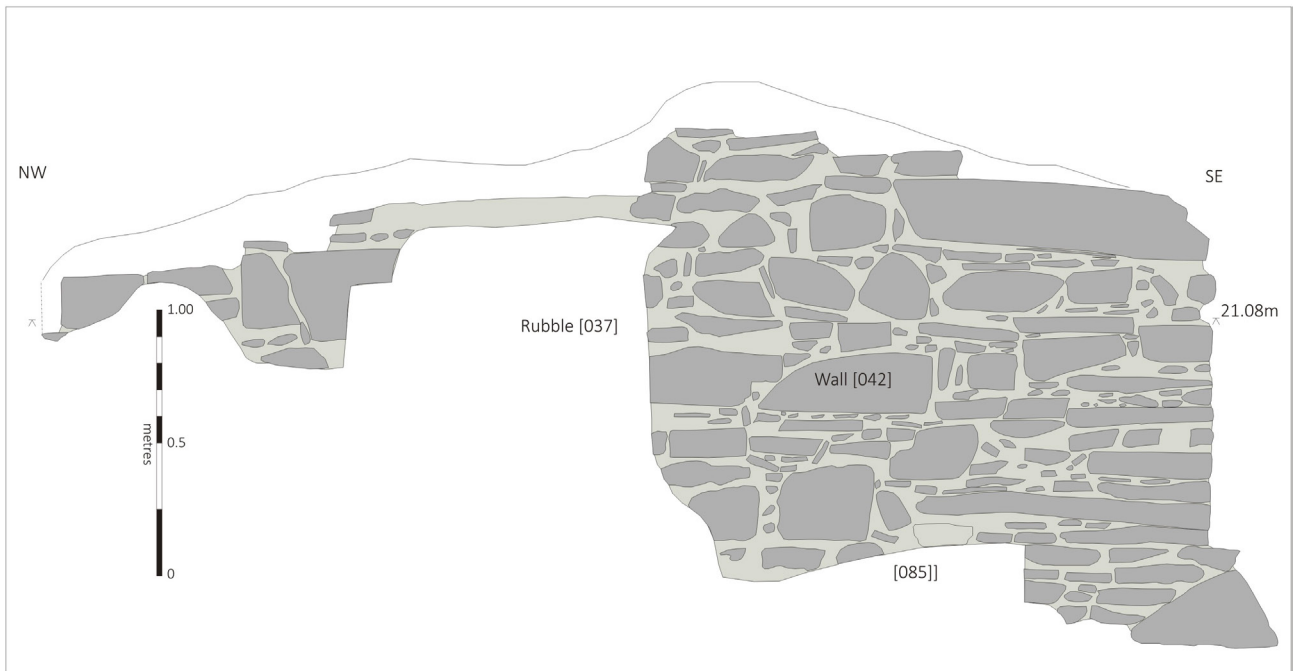
Illus 63 Trench 4 Area F elevation of external face of tower wall C042

In Area F the external face of the southeast corner of the tower C042 was exposed. The area was excavated down to the basal course of the foundation of the wall (Illus 63–65). The wall survived to 1.9m in height, with the core of the wall to the north standing 0.9m higher, and was constructed to a batter of approximately 1:10, the wall face was tightly built in well-bonded rough courses of large narrow schistose slabs up to 1.15 x 0.21m. No protruding foundation plinth is apparent at the base of this wall, although the adjacent external face of wall does display a low battered plinth. The wall face was traced for a length of 4.3m from the southeast corner of the tower. No foundation trench was apparent, and the wall appears to have been founded on natural glacial till, although some extra support was added on the corner of the wall where the wall stepped out to the east. The wall face had some traces of a sandy mortar render although for the most part this appeared to have degraded from the surface.

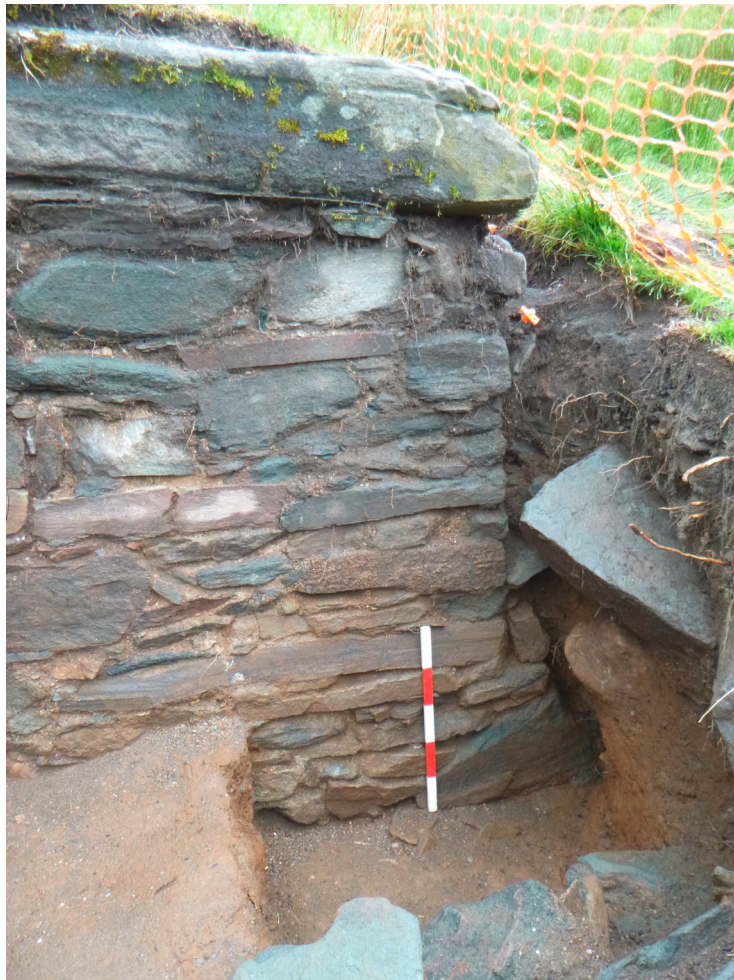
Illus 64 Trench 4 Area F southeast corner of tower wall C042 from southwest

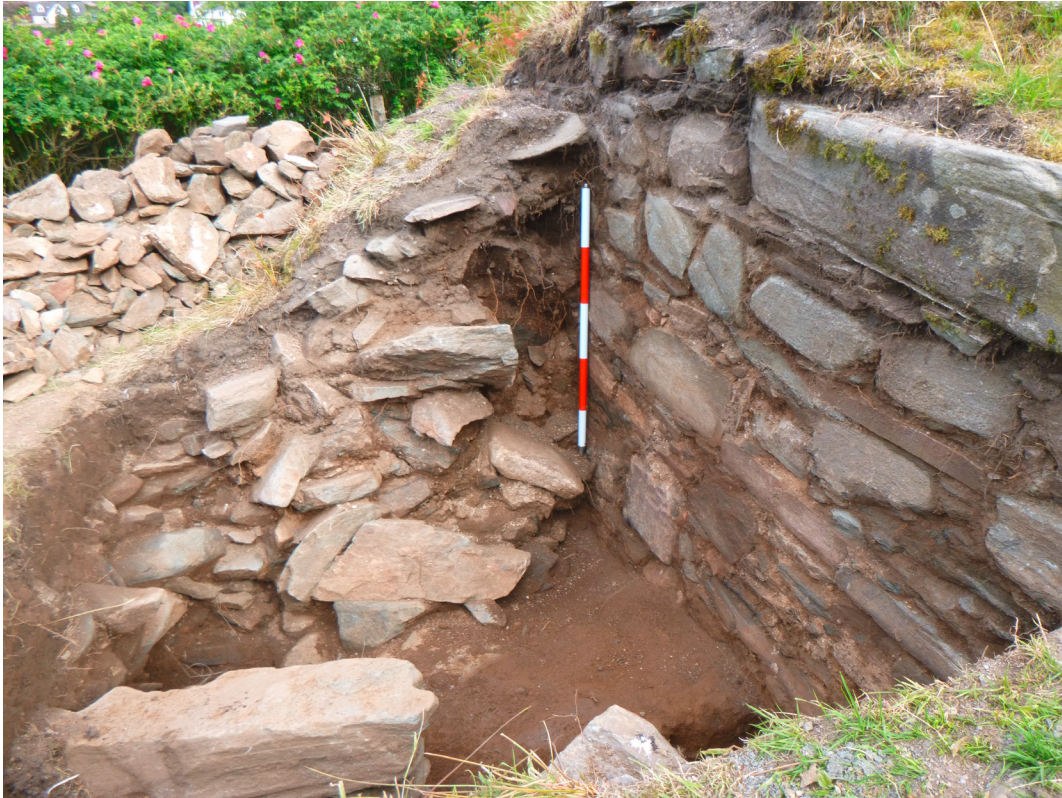
the glacial till below the wall foundation and possibly represents redeposited soil protecting the foot of the wall after its construction. This deposit sloped away from the wall to the south and may have formed a bank along the outer face of the wall. Sealing this was an extensive deposit of rubble, C037, the upper extent producing a quantity of post medieval artefacts.

Illus 65 Trench 4 Area F deposit 085 and rubble C037 against wall C042 from east
