## 6. ARCHITECTURE

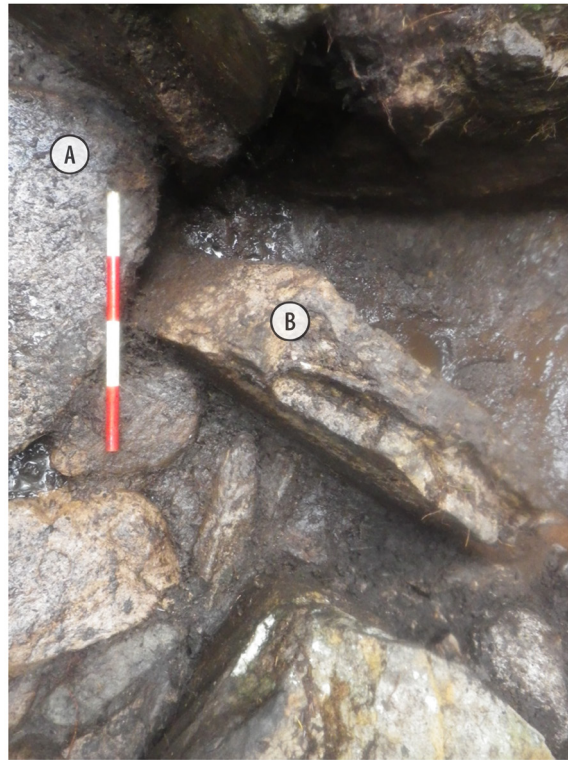
(A) (005)      (B) (009)

**Illus 9** The upper passage-stone (009) which had fallen to the 'floor' of the passage with its east end under the largest flagstone of the chamber (005). (image: Forestry and Land Scotland)

The passage was *c* 1.08m long and narrowed from a 0.84m wide entrance to 0.68m at the entrance into the chamber. A single sandstone orthostat (009) formed the southern side of the passage (Illus 8). The orthostat (009) on the northern side of the passage was broken in two; the lower portion of the stone was discovered in situ while the upper portion was discovered collapsed within the passage (Illus 8, 9, and 10). The eastern end of the collapsed upper passage stone lay under the largest flagstone (005). Smaller stones had been packed in the space between the lower passage stone and the outer entrance kerbstone.

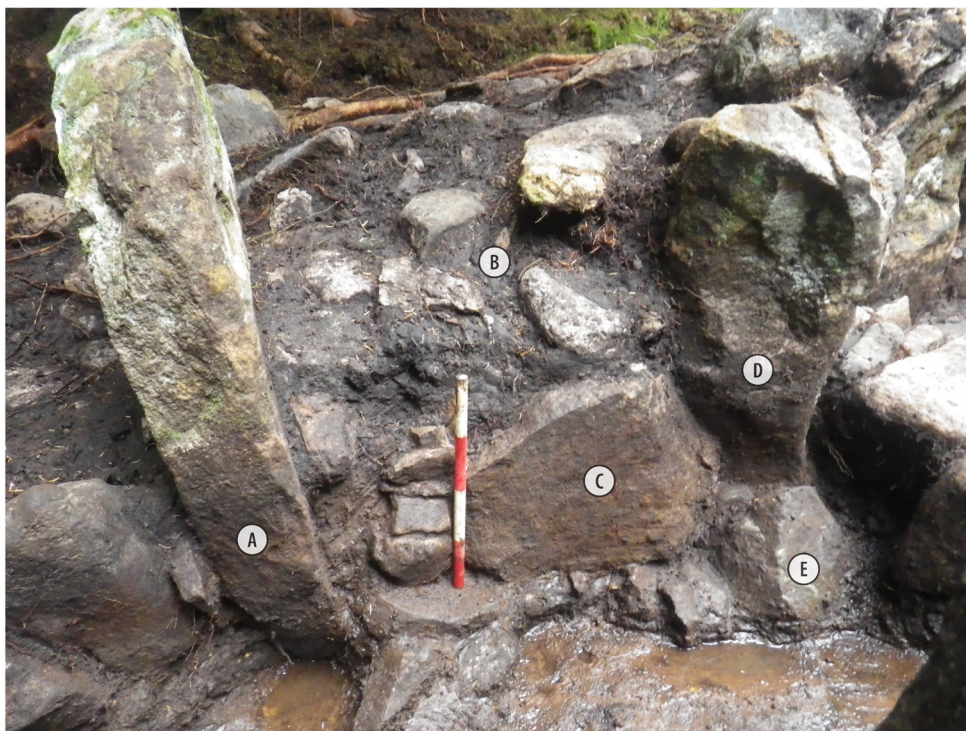
(A) (006)      (B) (019)      (C) (009)      (D) (004)      (E) (015)

**Illus 10** Detail from section 8B. (image: Forestry and Land Scotland)
