## PART II: THE SURVEYS

## 6 STAC DOMHNUILL CHAIM

### 6.1 Physical description and location

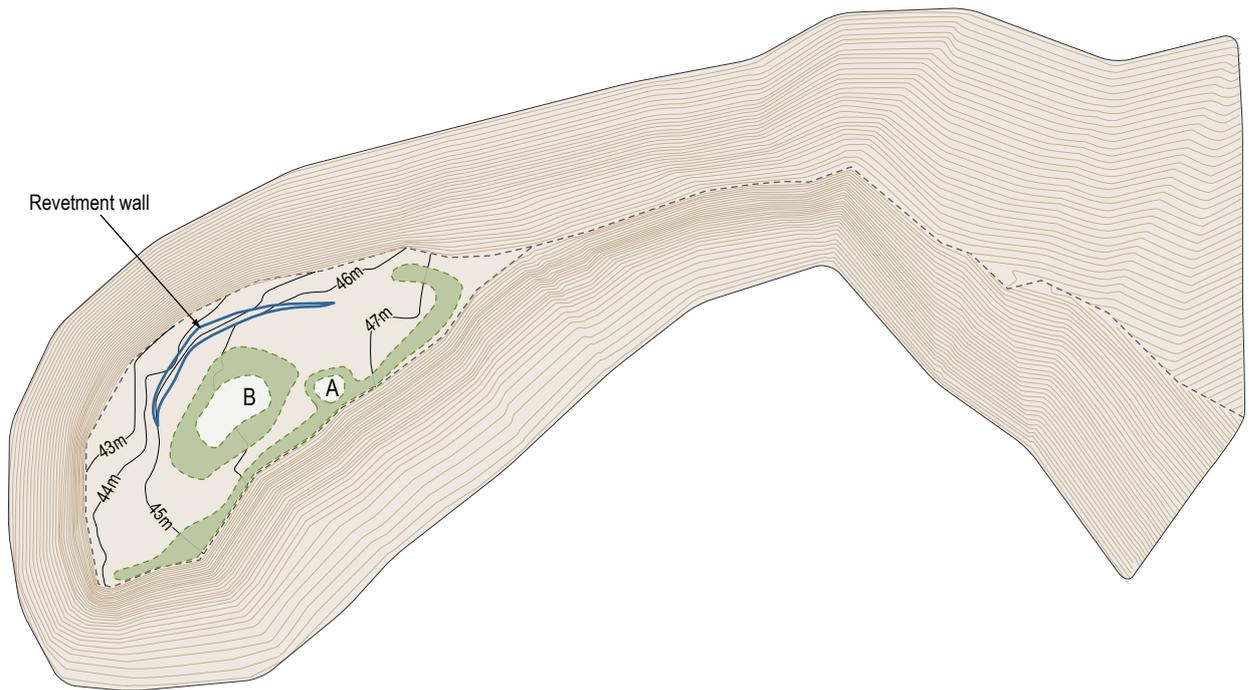
*Illus 2 (opposite) Location map and topographic survey of Stac Domhnuill Chaim*

The archaeology on the summit was well described by Thomas (above), and little change was seen when visited by STAC. There were two buildings on the summit of the stack, Structures A and B. They were partly enclosed by a perimeter wall (Structure C), which also formed a small, enclosed courtyard at the

north end of the site. A possible path led to the lower reaches of the stack on the west side, running from the courtyard, and parallel to Structure B (illus 4).

Structure A was a small, *c* 2m internal diameter, circular turf and stone building adjoining the perimeter wall (Structure C) on the north-eastern edge of the stack. It had no apparent entrance, although a small break was shown in the middle of the west wall by MacPhail (Thomas 1890).

Structure B was the remains of a sub-rectangular building, of stone and turf, 2 × 6m internally, *c* 5 × 10m externally. There was no visible entrance, although one was shown to the south of the east wall by MacPhail (Thomas 1890). It occupied the centre of the stack, and was separated from Structure A by a narrow gap, which was likely to have been a wider passage in the past, before the walls of both structures slumped and broadened. The walls survived to a height of between 0.5m and 1m.

Structure C was the perimeter wall. It was constructed of stone and turf, and extended from the northern end of the stack, down the eastern side, to its southern end. At this end the wall became harder to define, but it possibly enclosed two terraces, which occupied the southern end of the stack. Beyond and enclosing these lower terraces, a line of stones may have represented another wall.

A revetment wall, which may have been contemporary with the perimeter wall, appeared to support Structure B around the western edge of the stack. This formed part of a possible path which could be traced to the north-west corner of the site, leading to a small, enclosed area formed by the perimeter wall and the natural rock outcrops at the north end of the site.

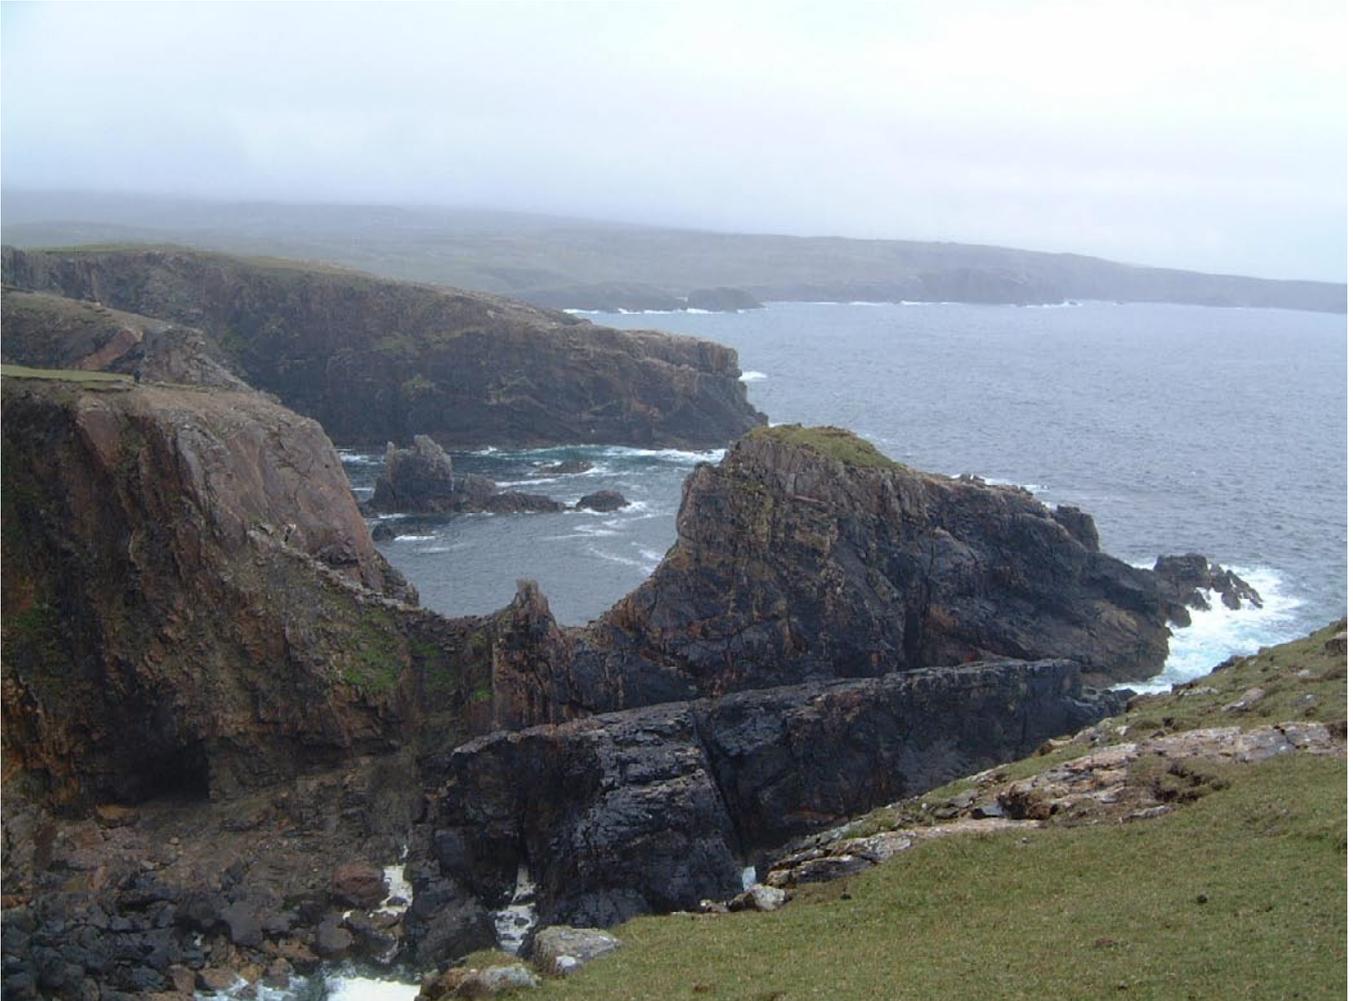
*Illus 3 Stac Domhnuill Chaim, looking south*

Access to the stack was probably the most difficult of all attempted. A vertical cliff of *c* 20m was the first obstacle, leading to a thin spine covered in loose,

fallen blocks. The spine dropped and then rose to the foot of the stack proper over a distance of *c* 60m. Finally, a 30m vertical ascent led to the summit (*illus 3*).

Two stakes were used to anchor a set of static ropes for the initial descent. Two rock bolts anchored further static ropes along the length of the spine. These ropes were used as protection to traverse the spine, with rock anchors fixed every 5m. It was necessary to knock off substantial amounts of loose stone blocks during the initial traverse. The final ascent was made using climbing techniques, with a combination of temporary rock anchors, pitons and rock bolts providing protection. One stake was fixed on the summit, which was positioned as far from the visible archaeology as possible. This stake and two rock bolts had to be left in the stack to provide protection for egress.

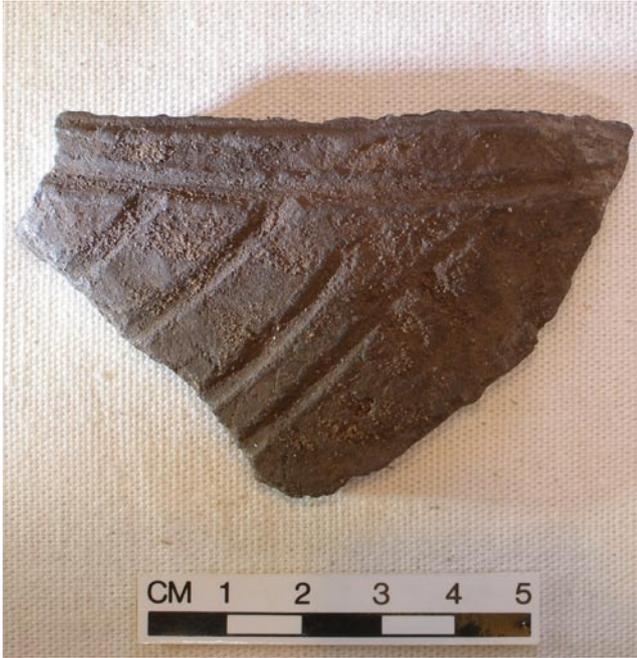
*Illus 5 Neolithic pottery from Stac Domhnuill Chaim*

Two base sherds of undecorated pottery were discovered outside the western end of the structure

eroding from one of two open erosion scars. They are considered to be later prehistoric or medieval in date (see [Appendix 3](#)).

from, and 2–3m down slope, of the structures. It measured *c* 4m long by 1.5m high, and had two main deposits, one sealing the other. A pit containing a charcoal-rich soily fill was noticed cut into the lower deposit. The pit was V-shaped in profile, *c* 0.3m deep and the same in diameter. Some 0.5m to the right and 0.2–0.3m lower down from this pit a large body sherd of decorated pottery was discovered, which has since been assigned to the early prehistoric, possibly Neolithic period by Trevor Cowie at the National Museum of Scotland ([illus 5](#)).
