7 STAC A' CHAISTEAL

7.1 Physical description and location

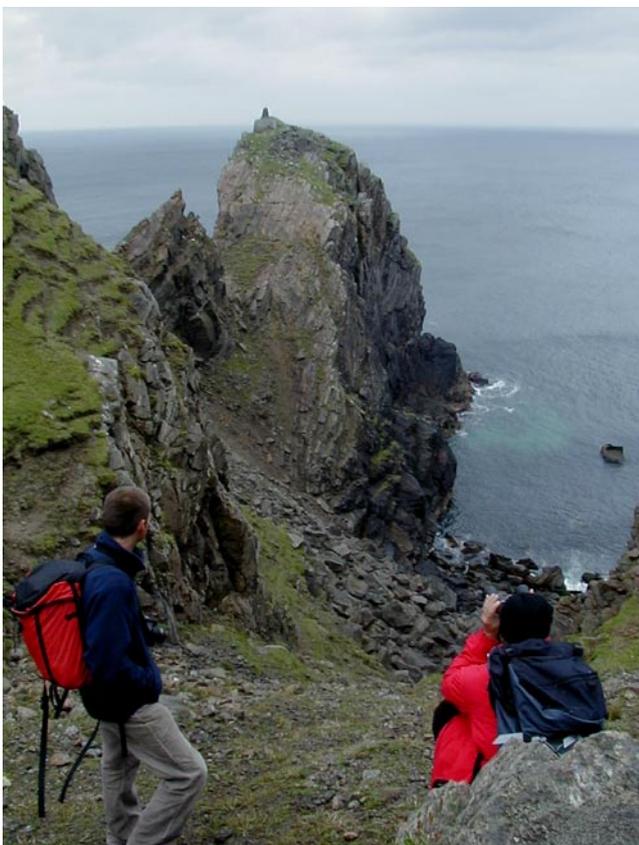
Illus 7 Stac a' Chaisteal from the south

Stac a' Chaisteal (NMRS no. NB24NW 5) is located at NGR: NB 2024 4540, almost exactly halfway between the glens of Garenin and Dalmore in the parish of Uig, in the common grazing lands, *c* 4km from the nearest road end (illus 6). It is a pinnacle shaped stack, over 50m high, and joined to the adjacent cliffs by a thin, 35m long spine of rock (illus 7).

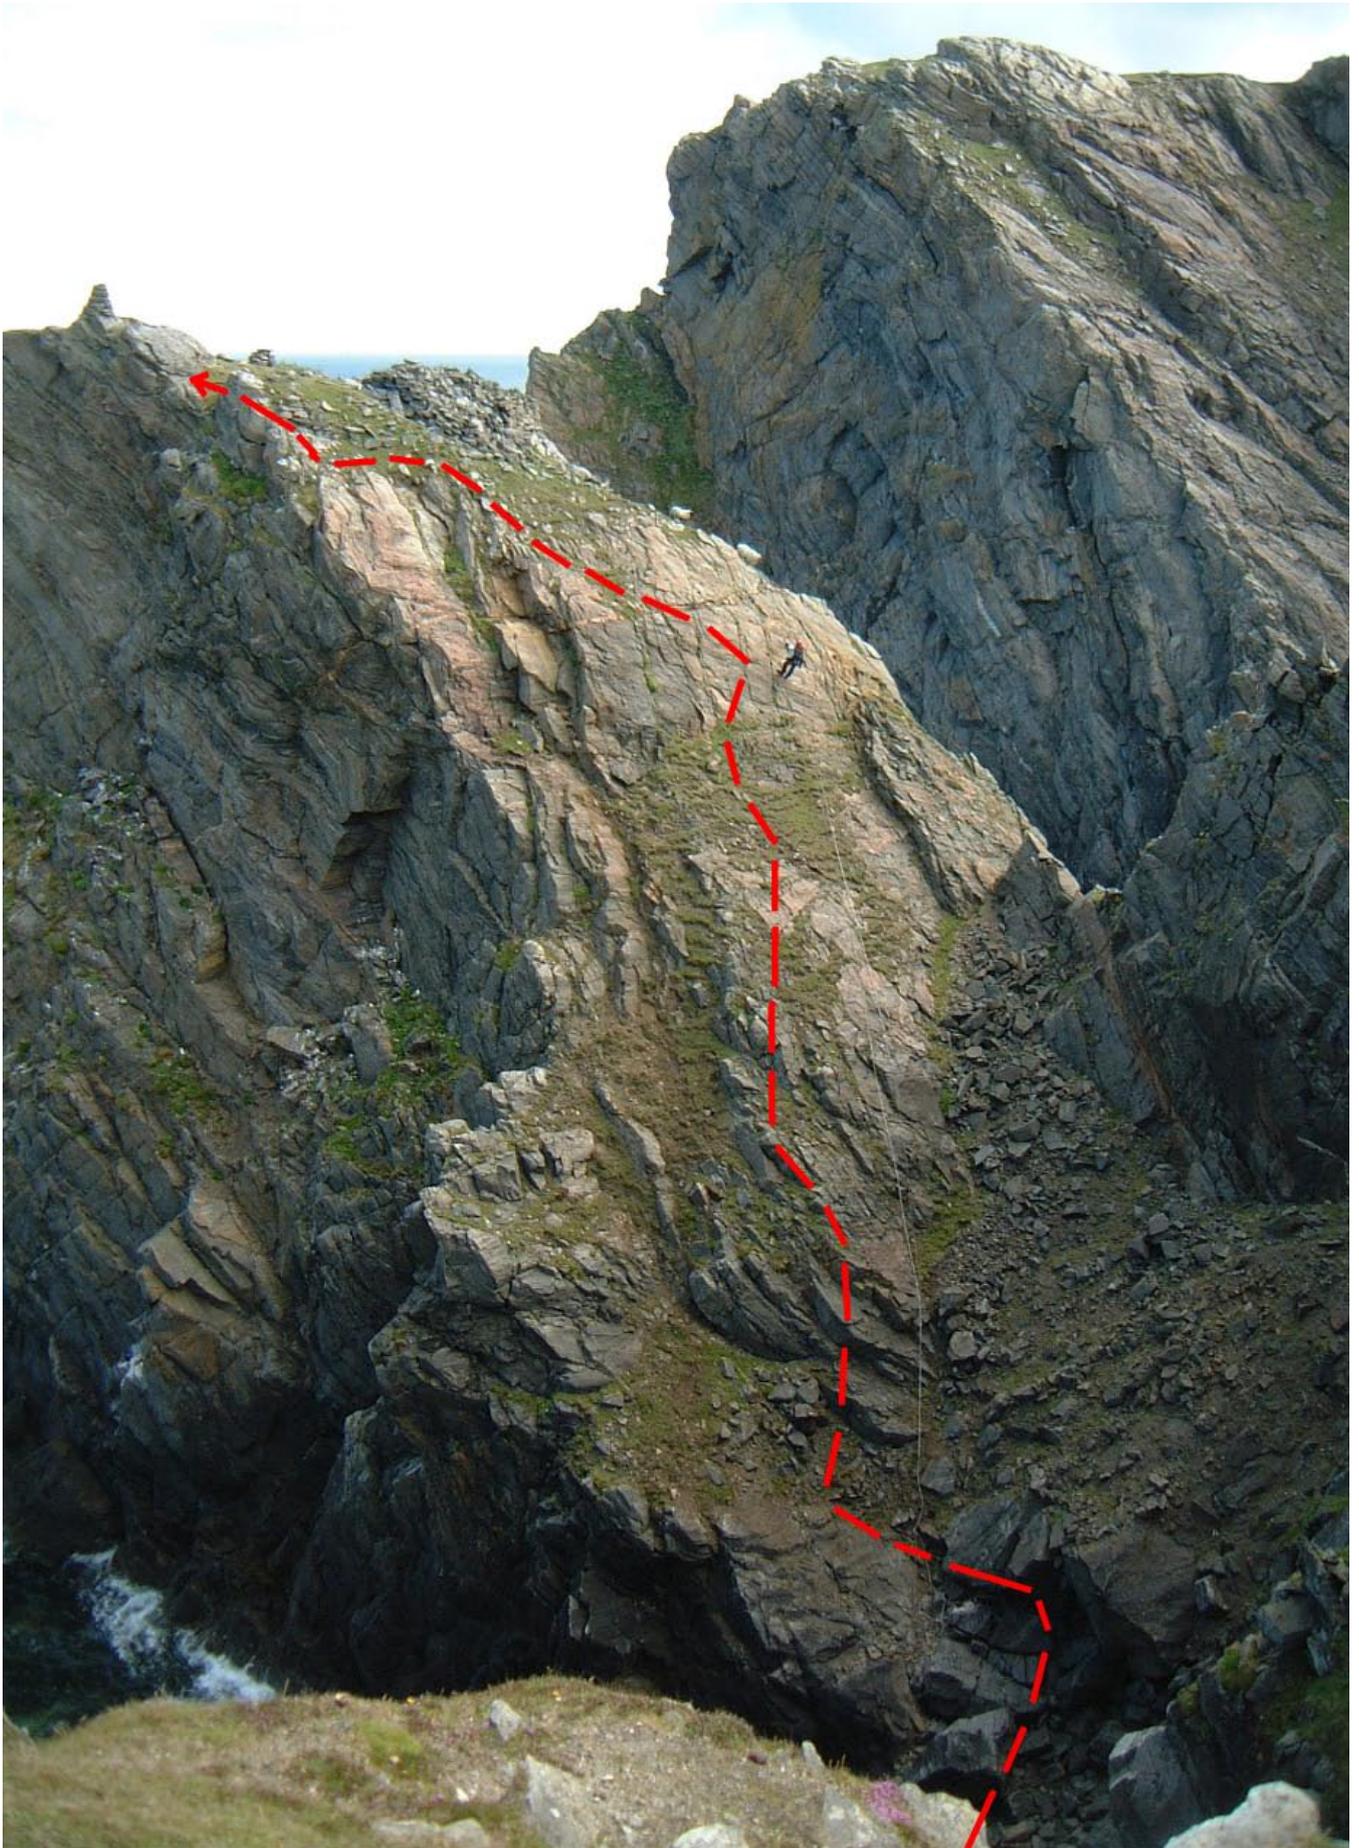
Illus 8 Access onto Stac a' Chaisteal from the south

The access route was therefore chosen to avoid these loose areas as far as possible. It commenced with a 30m abseil down a steep grassy ramp on the stable, southern headland to gain the shoreline. Two stake anchors driven into the top of the landward cliff secured the ropes for this end. From the small and boulder-strewn beach, the stack was scaled directly up its landward face. A fixed rope was then secured up the route for the rest of the fieldwork. The route was protected using climbing techniques to fix rock

anchors and pitons into appropriate cracks in the rock (illus 8 and 9).

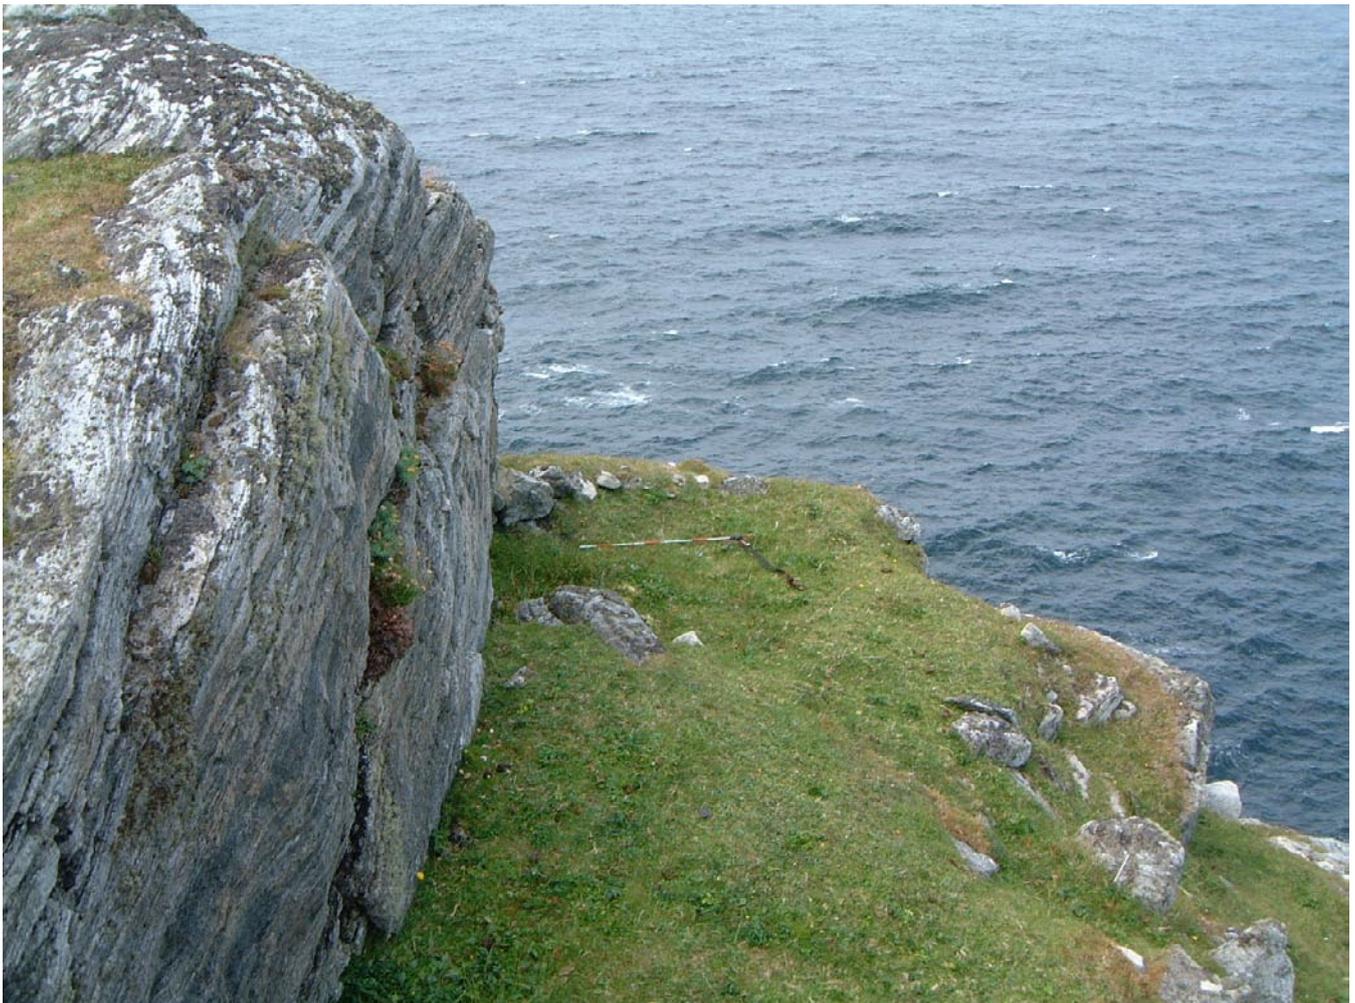
Illus 10 Stac a' Chaisteal Structure A from the east. Scale 1.2 m long.

On the seaward or northern face of the stack, the turf and stone footings of a curved, double-skinned, drystone wall abutted an outcrop of rock and then ran along the top of a north-facing cliff for $c 3\text{m}$ before terminating at the easy angled grassy slope of a natural terrace (*illus 10*). The wall was $c 0.4\text{m}$ thick and is constructed of blocks of Lewisian gneiss, which measure on average $c 200\text{mm}$ long \times 200mm wide.

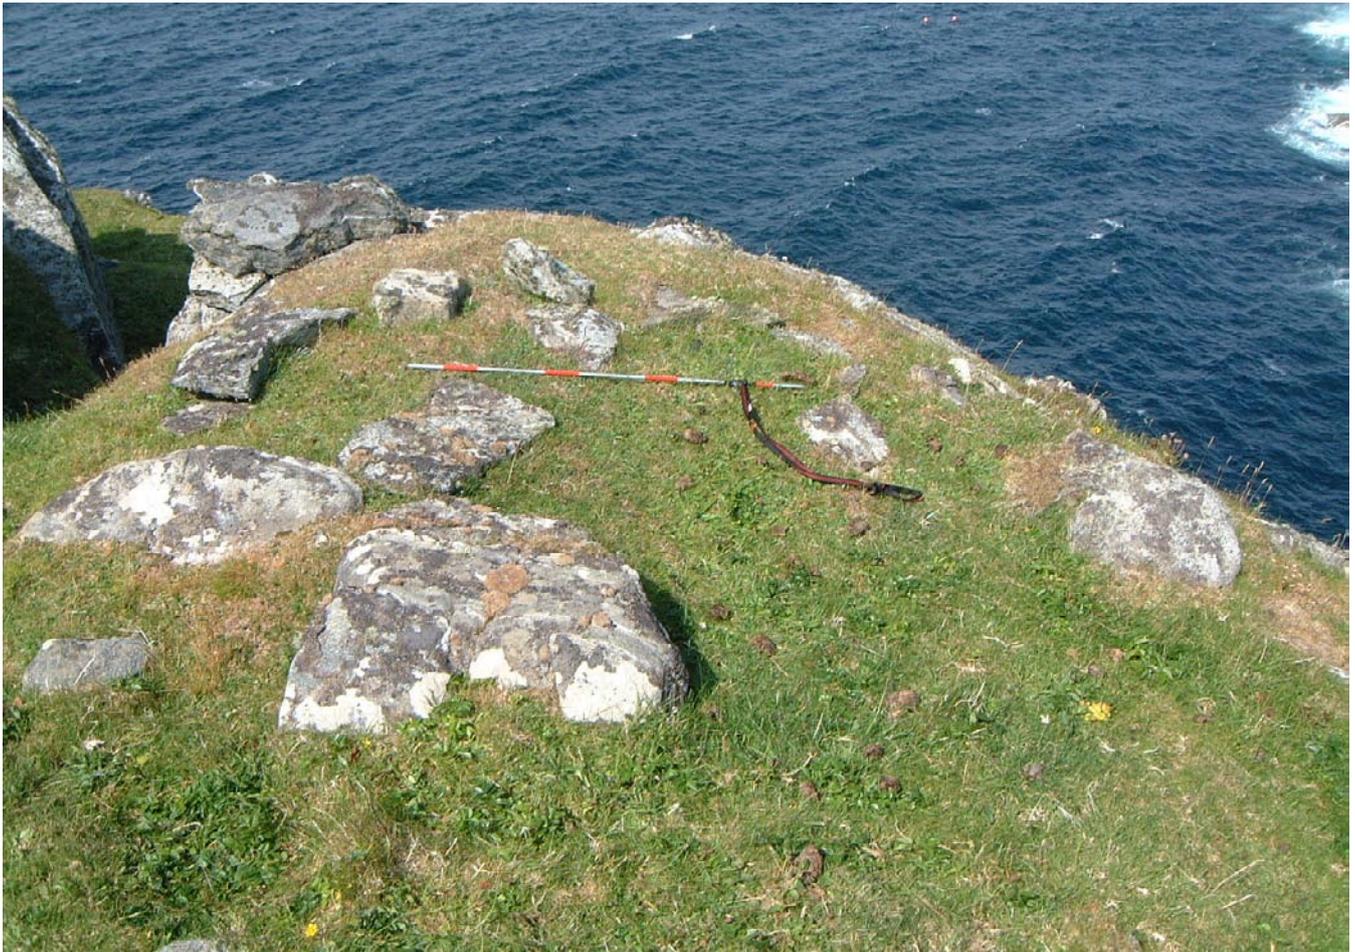
Illus 11 Stac a' Chaisteal Structure B from the south. Scale 1.2 m long.

Approximately 8m upslope and to the south-west of Structure A, resting upon another outcrop of rock, were the horseshoe-shaped foundations of another double-skinned, drystone-walled enclosure (Structure B), which opened to the south. This was slightly more substantial than Structure A. It measured roughly 4 × 4m in plan, with walls 0.5m thick (*illus 11*).

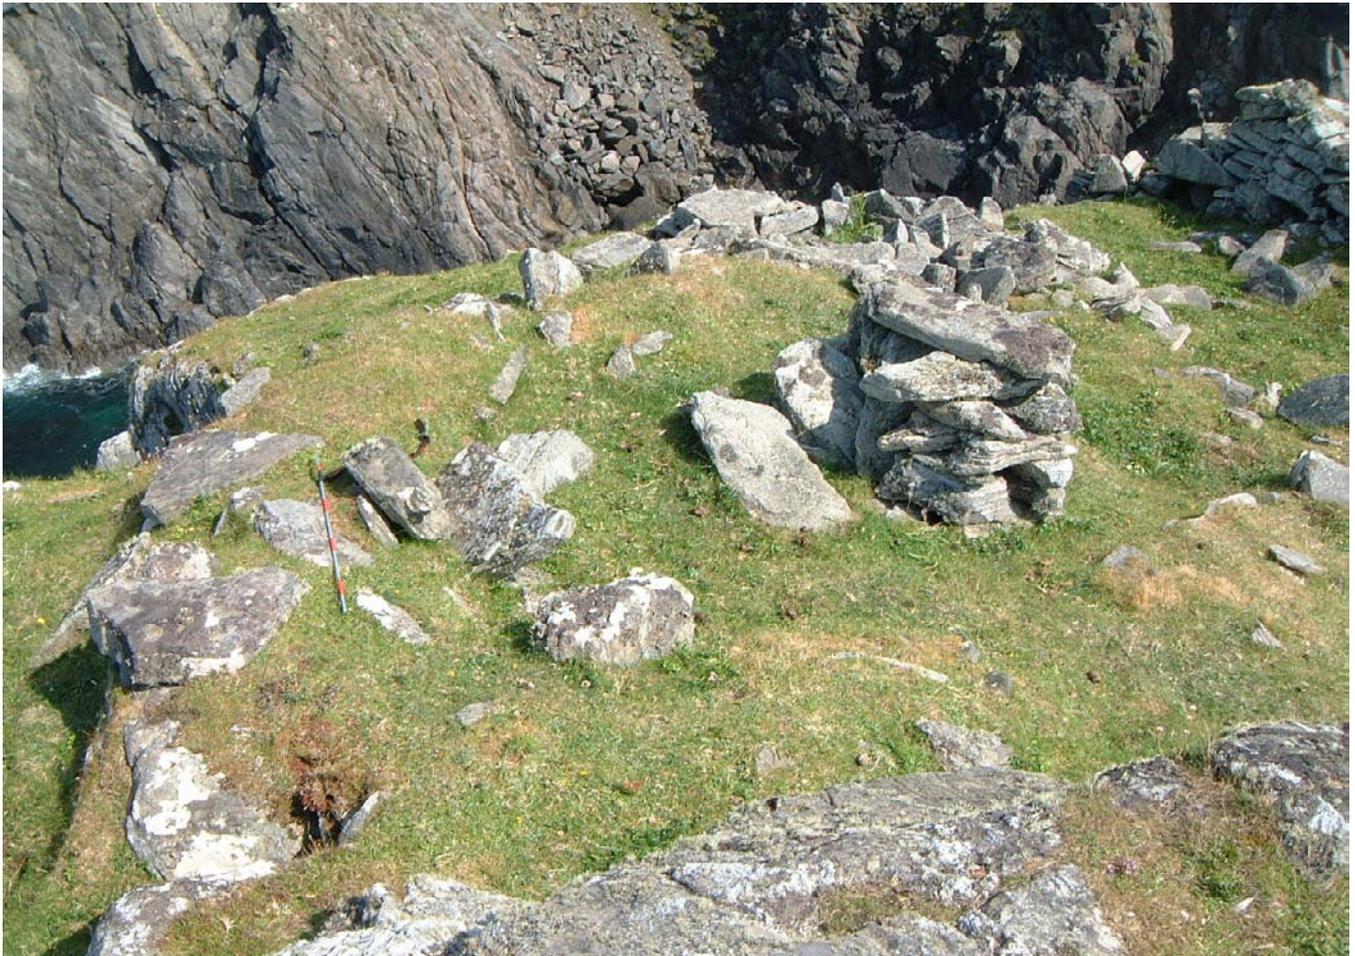
Illus 12 Stac a' Chaisteal Structure C from the west. Scale 1.2 m long.

Structure C was also horseshoe-shaped and opened to the south. It measured 5m N/S by 4m E/W internally. The wall rested upon and covered the whole of an outcrop of rock (*illus 12*).

The foundations of the structure were constructed of large slabs of gneiss measuring up to 1 × 0.2–0.7m, with a wall thickness of *c* 1m. The walls were more heavily built than the two structures previously described, and belonged to a more substantial building. Only one course of walling was visible along its length, but the south-east wall end to the structure revealed at least three courses of stonework, which showed signs of corbelling.

In the middle of Structure C was a stone construction c 1.5m high by 1m long and 0.5 m. wide. It consisted of two rough piles of stone slabs with a larger, flat slab on top (to the right in [illus 12](#) above). The construction was so poor that it gave the impression of being very recent in origin, and did not seem to relate to the other structures. It is known that within living memory young men would challenge each other to ascend this and other stacks (D R MacLeod, Gearrannan, pers comm) and would build something to prove their exploit. This may be one such construction.

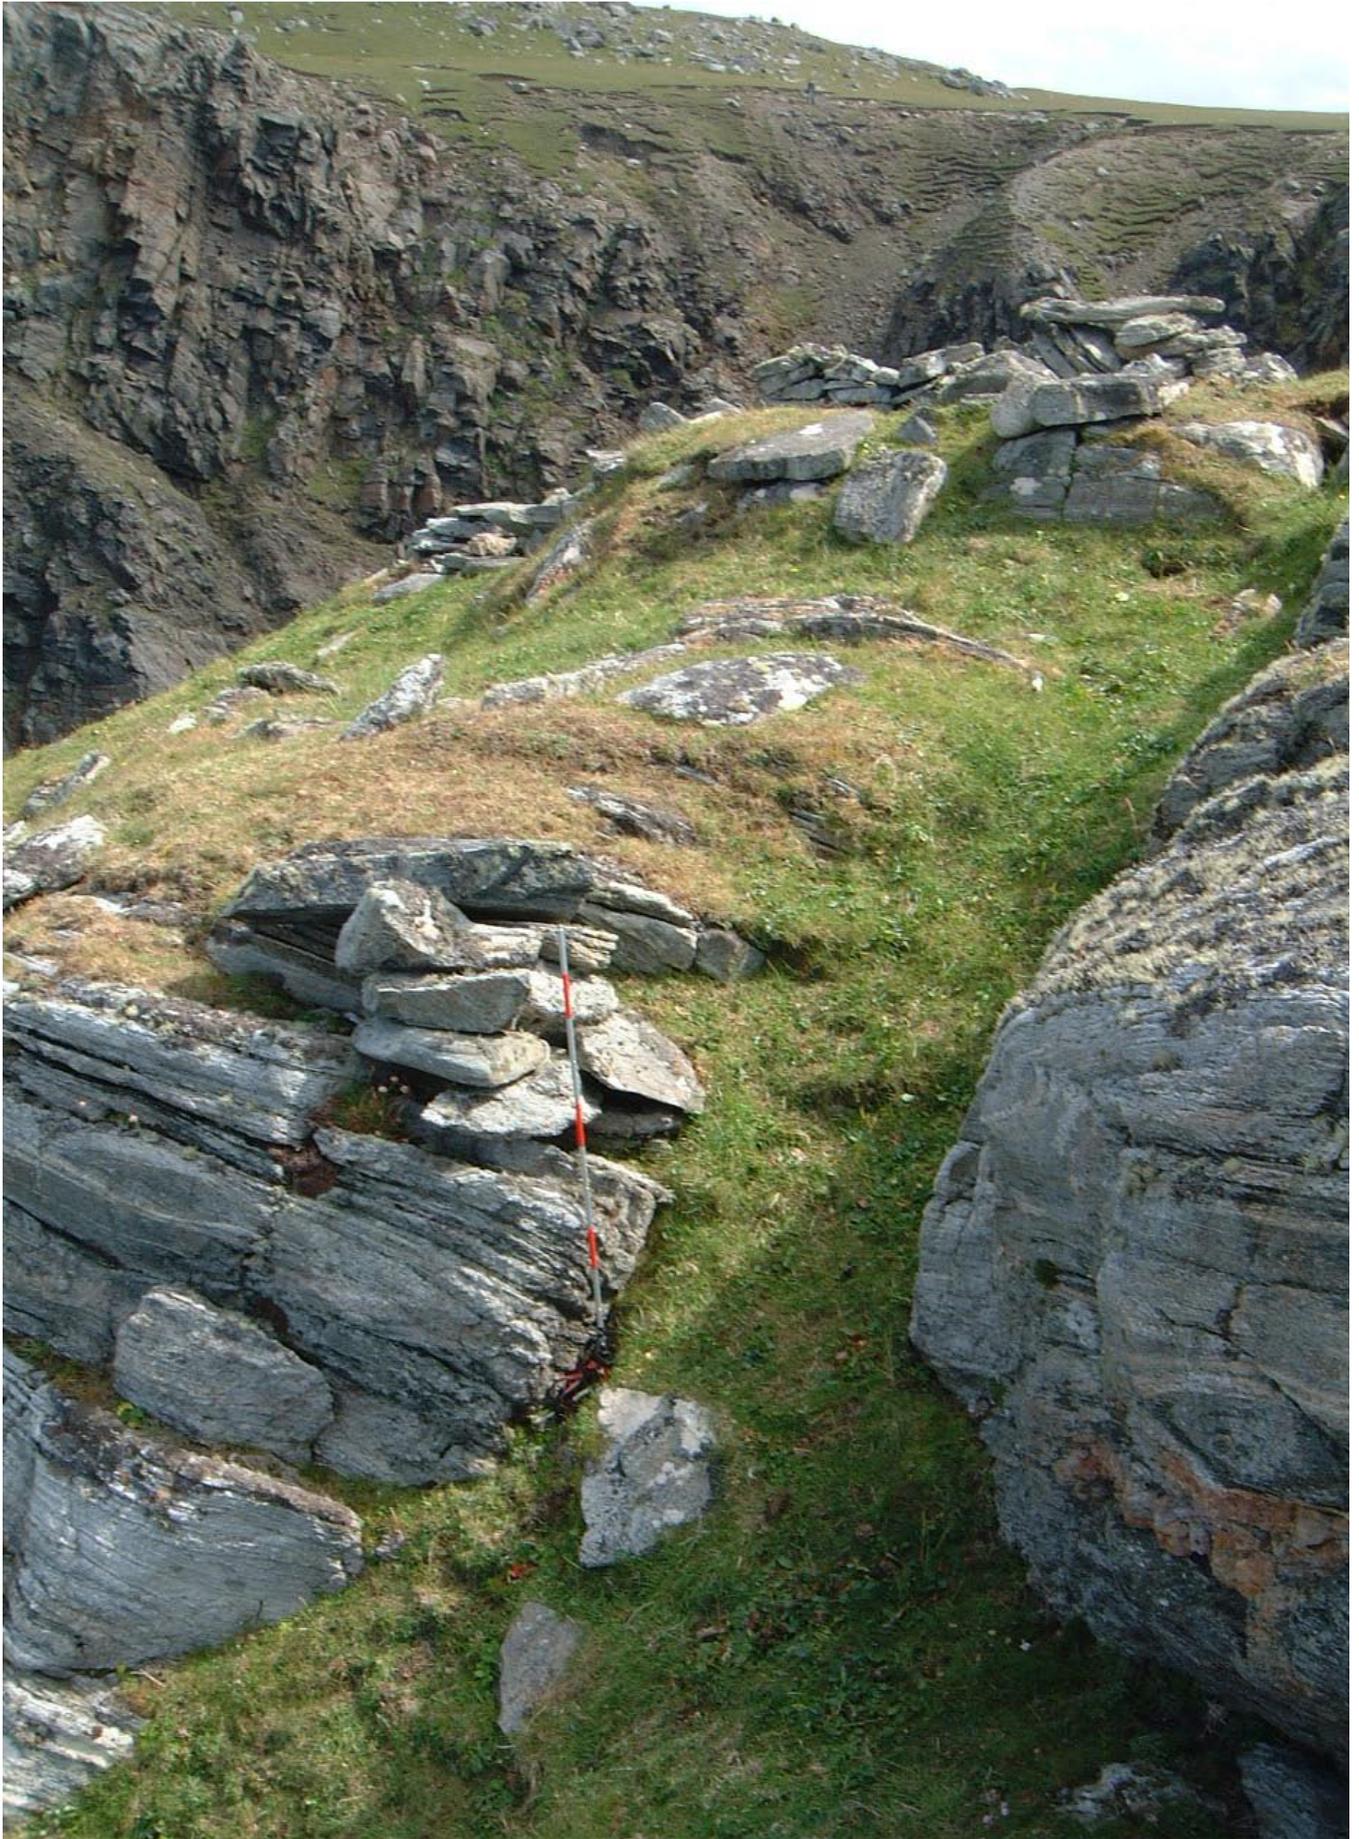
Illus 13 Stac a' Chaisteal Structure D from the north-west. Scale 1.2 m long.

To the north of Structure C and running along the west side of Structure B was a short pathway set into a natural fissure between two rock outcrops. This measured *c* 1m wide, was orientated N/S, with the outcrop to the west 1.5m high. Although the outcrop to the east was lower, it had been accentuated by the construction of a roughly built section of drystone walling (*illus 13*). This formed a natural passage, and may have been used to gain access to the site from the seaward side of the stack.

The section of walling was perched on the edge of the outcrop and was right-angled, with faces to the north and east. It was constructed of large gneiss slabs, measured *c* 0.5 × 0.5m, and survived to a height of 0.7m. This may have been the east jamb of a doorway, and could have held a lintel, although there were no obvious marks or signs of quarrying of the rock face to the west.

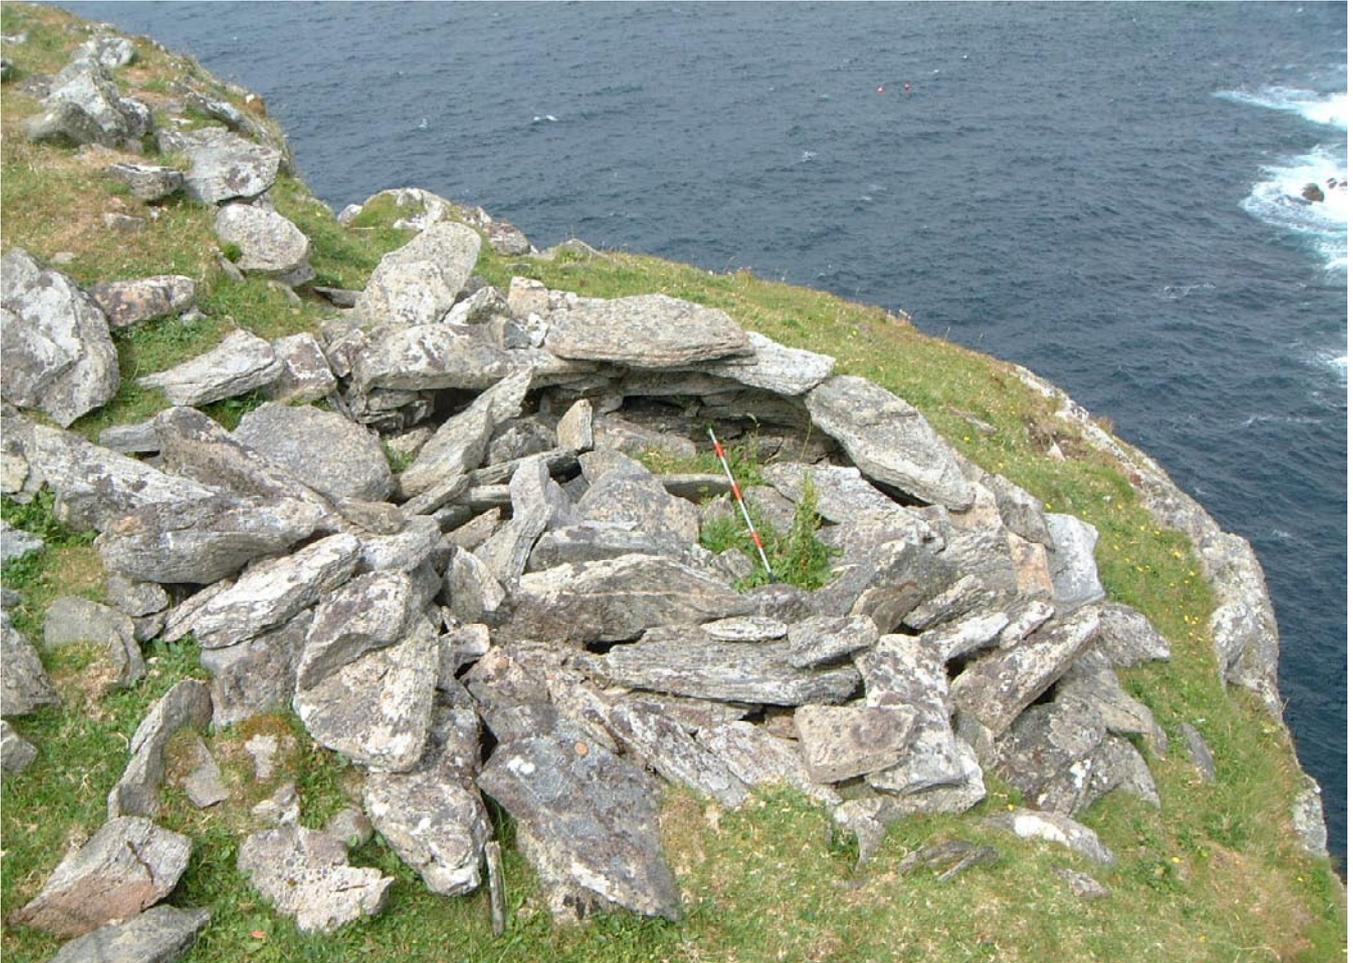
Illus 14 Stac a' Chaisteal Structure E from the south-east. Scale 1.2 m long.

Structure E is a drystone, beehive-shaped, corbelled cell, which measured $c 4 \times 4\text{m}$. It was constructed of a single face of large gneiss slabs attaining over 1m in length and, although the wall had large gaps throughout, it has survived to a height of 0.5m or four courses above present ground level (*illus 14*). The cell vaulted sharply inward over these four courses from an inside diameter of $c 3.6\text{--}1.4\text{m}$ at its full height.

The cell had two openings. One entrance was on the west side and was well-constructed but partially collapsed, including its lintel. It was 0.3m high and 0.6m wide. A passage leading to the entrance was formed by the eastern wall end of Structure C and an opposing wall at right angles to this.

The second entrance was in the north of the cell, where a 0.5m wide by 0.4m high opening led into a 1m long passage flanked by stone orthostats. This passage is in a derelict state but would have been roofed, judging by the amount of masonry tumble present.

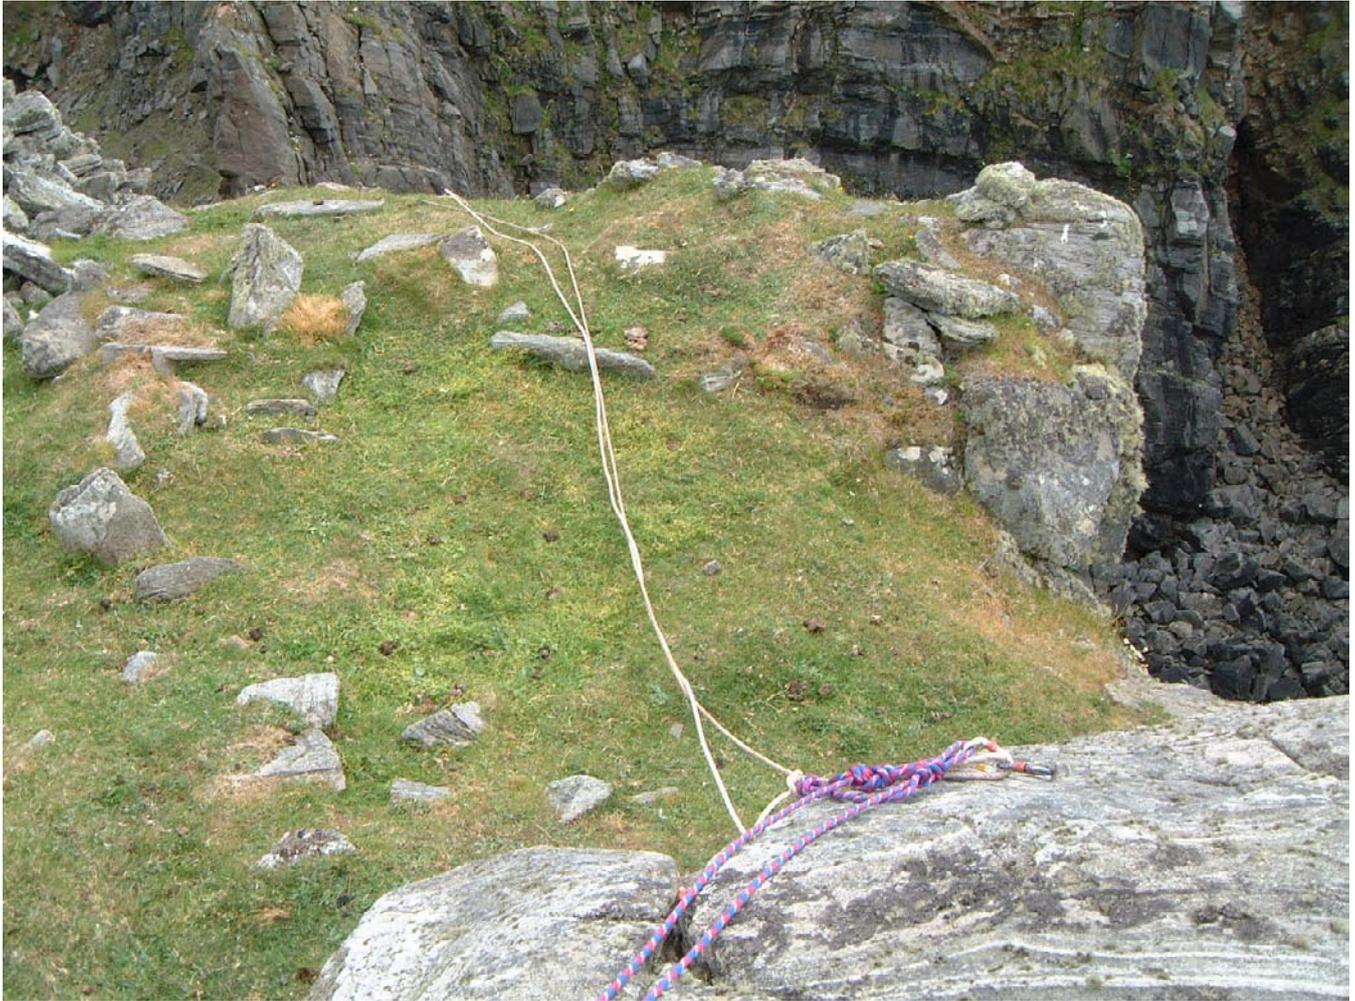
Illus 15 Stac a' Chaisteal Structure F from the east

first, Structure F(a), comprised two courses of a drystone, double-skinned wall, of large $c 0.6 \times 0.3 \times 0.3\text{m}$ rectangular blocks, partially turfed over. It was $c 0.8\text{m}$ wide and stretched 3m E/W on the south-west of the stack (*illus 15*). The western end was partially collapsed and had fallen over the edge of the stack.

Both Structure F and Structure G(a) have jagged western ends where it is clear that they are falling into the sea; some of their courses overhung the cliff face.

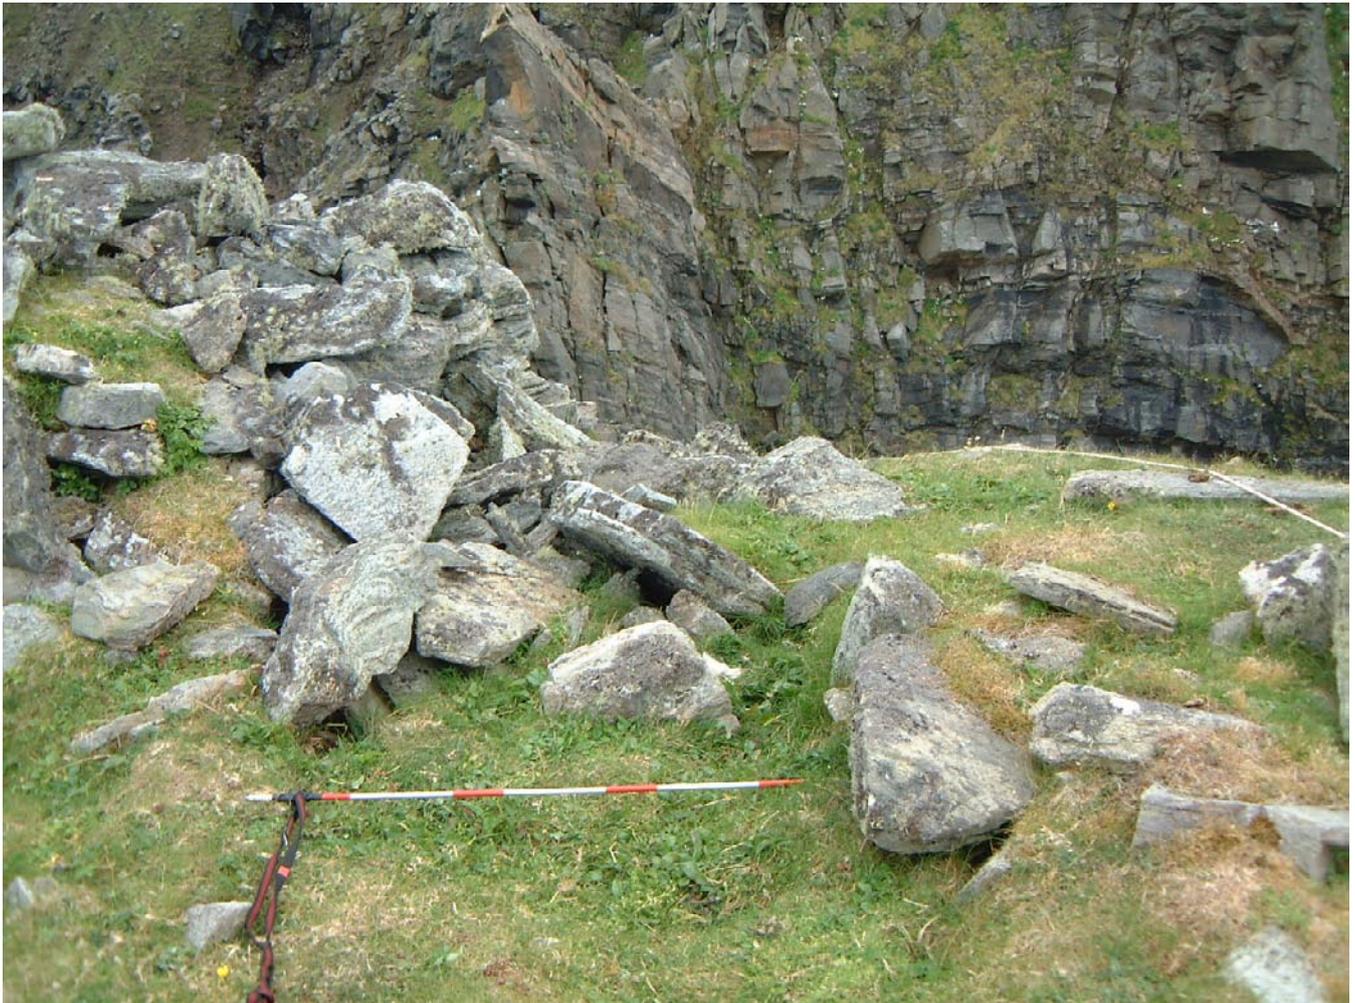
Illus 16 Stac a' Chaisteal Structure G from the north-west. Scale 1.2 m long.

At its eastern end, Structure G(b) may have been the same as the foundations of a wall running N/S, parallel to the west wall of Structure H (illus 16). The structure ran for approximately 5m, and was constructed of blocks of the same size and character as Structure G(a), but other dimensions were unclear due to vegetation cover.

An obvious passage was formed between Structure H to the east, and Structures F and G to the west (illus 16 above). This was described by the Ordnance Survey as the entrance passage to a massive structure spanning the whole width of the stack, an interpretation that was supported by this survey.

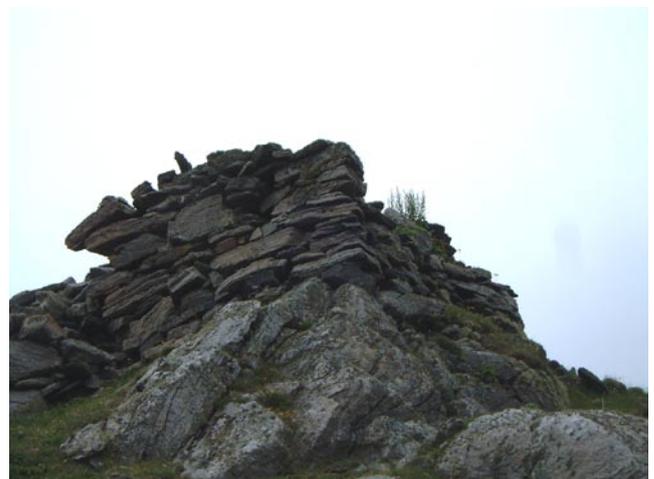
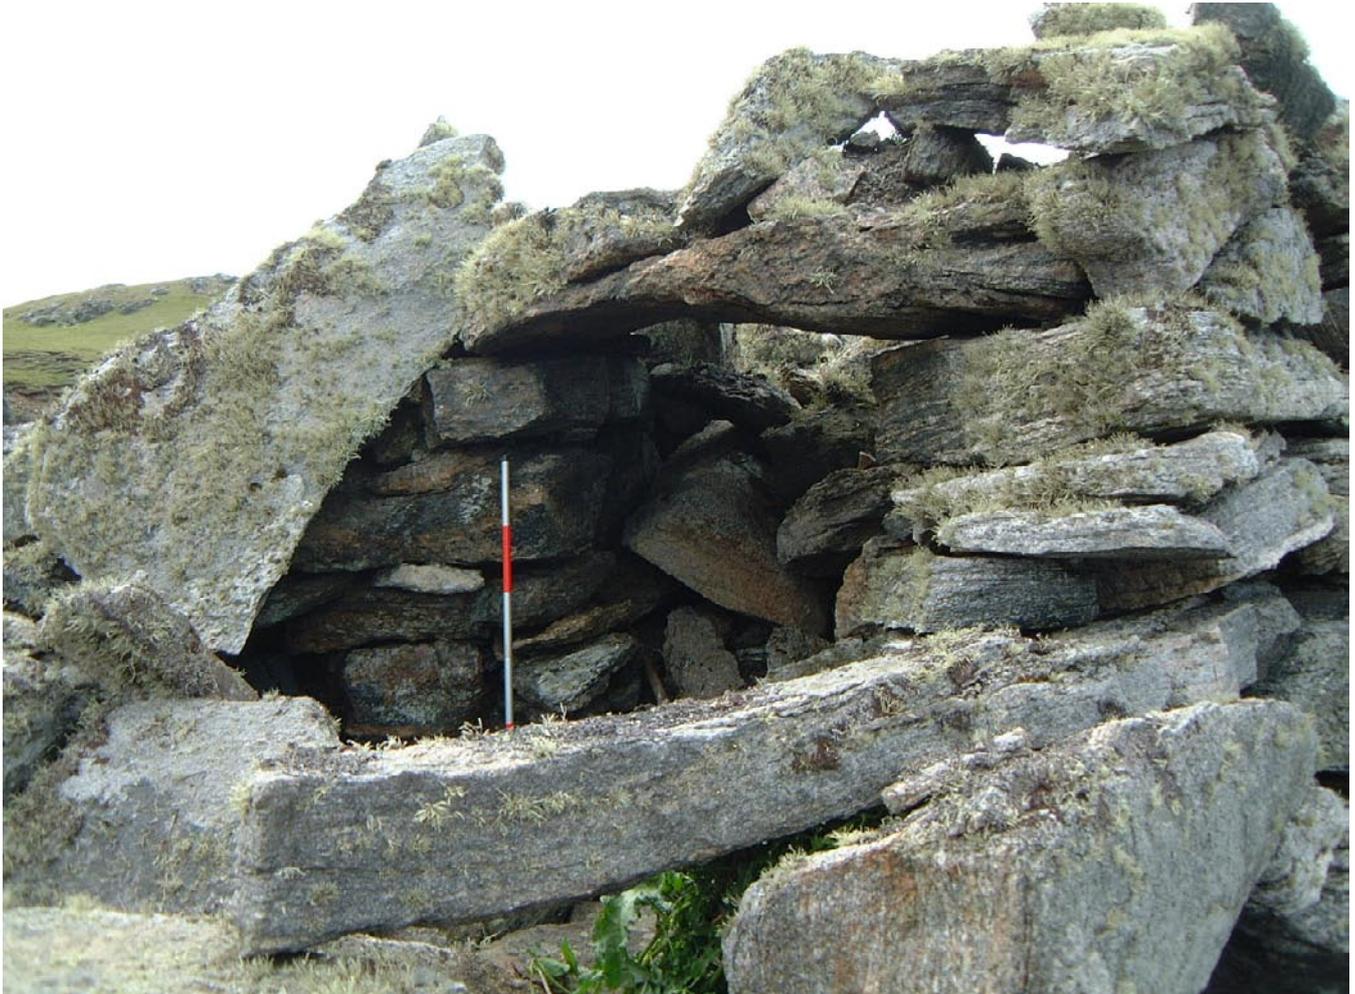
Structure H was the most substantial and best preserved building on the stack, surviving in places up to eight courses or 2m in height. It was sub-rectangular in plan and measured 6 × 4m. A substantial batter was apparent on what remains of the south, landward-facing wall. The building stood across the south-eastern neck of the stack, blocking access to its interior. Most of its southern and western wall sections were collapsing into the sea, but the eastern wall and the south-eastern corner

were well preserved and remained perched on the edge of a 40m-high cliff (illus 17 and 18)

Illus 17 Stac a' Chaisteal SE corner of Structure H from south-east

Illus 18 Stac a' Chaisteal NE corner of Structure H from the north. Scale 0.4 m long.

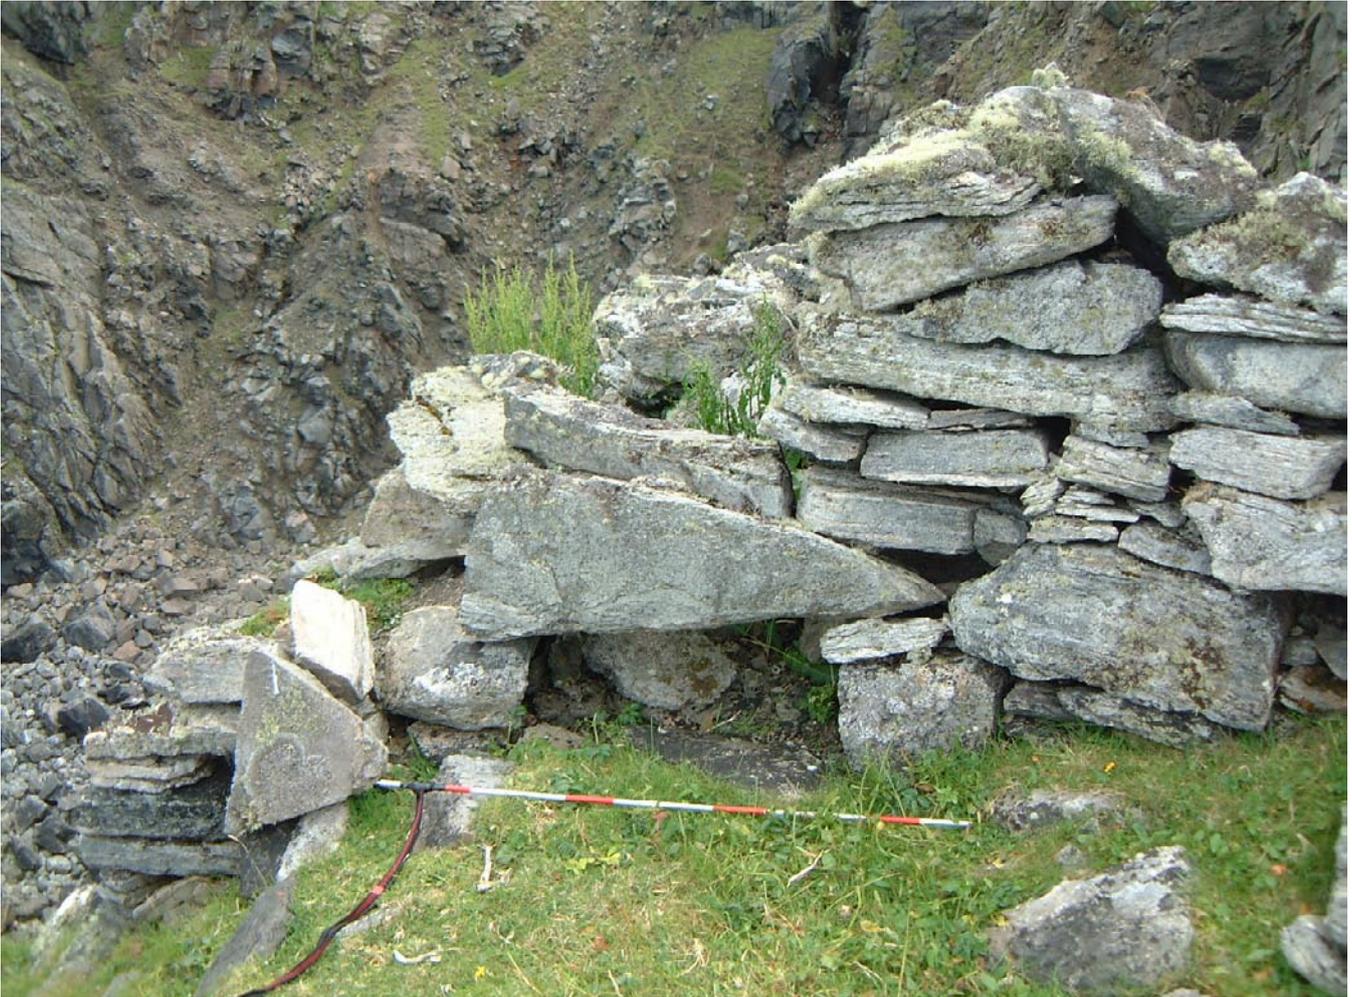
Illus 19 Stac a' Chaisteal triangular lintel Structure H from the north. Scale 1.2 m long.

The north wall survived intact to a height of 1.5m to its roof stones. It formed an internal gallery which possibly turned south to follow the east wall of the structure. An entrance, 0.8m wide with a triangular lintel (illus 19), and a mere 0.3m higher than the present ground surface, was present in its outer wall. It opened directly onto the internal gallery. No other entrance was visible.

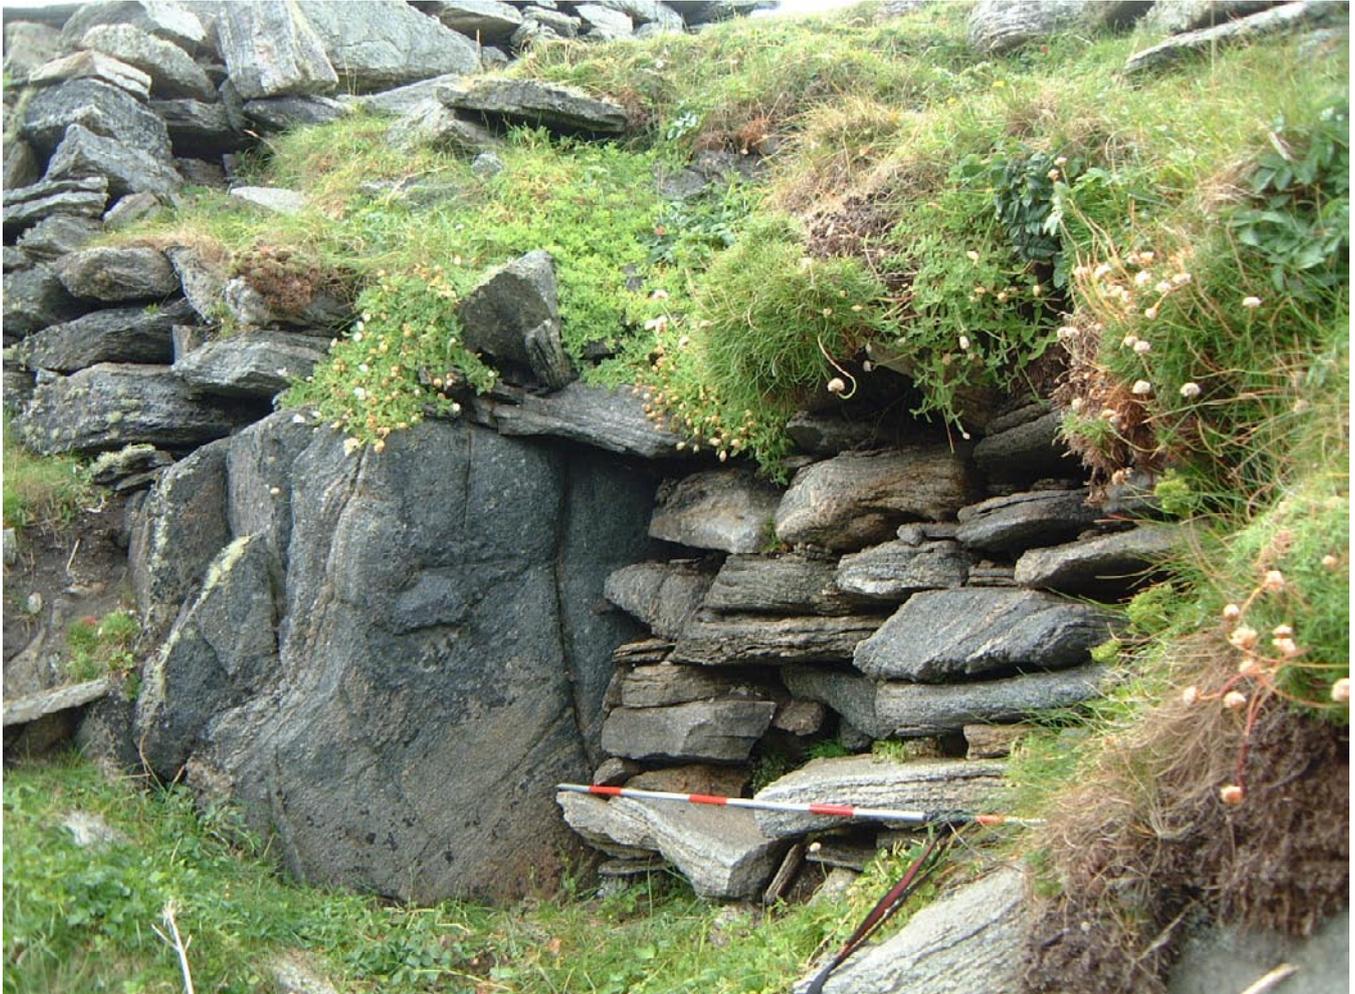
Illus 20 Stac a' Chaisteal revetment M from the north. Scale 1.2 m long.

A substantial revetment wall measuring 2m high and c 6m long underlay and supported structures E, L and H. It was built along the south-eastern flank of the stack (*illus 20*). This may have related to the earliest phase of construction on the stack. It sealed a steep gully draining water away from the summit plateau onto its eastern face. It was well preserved, with no evidence of subsidence or collapse.
