# 11 EILEAN NAN LUCHRUBAN

## 11.1 Physical description and location (*illus 38*)

### 11.5 The survey (*illus 40*)

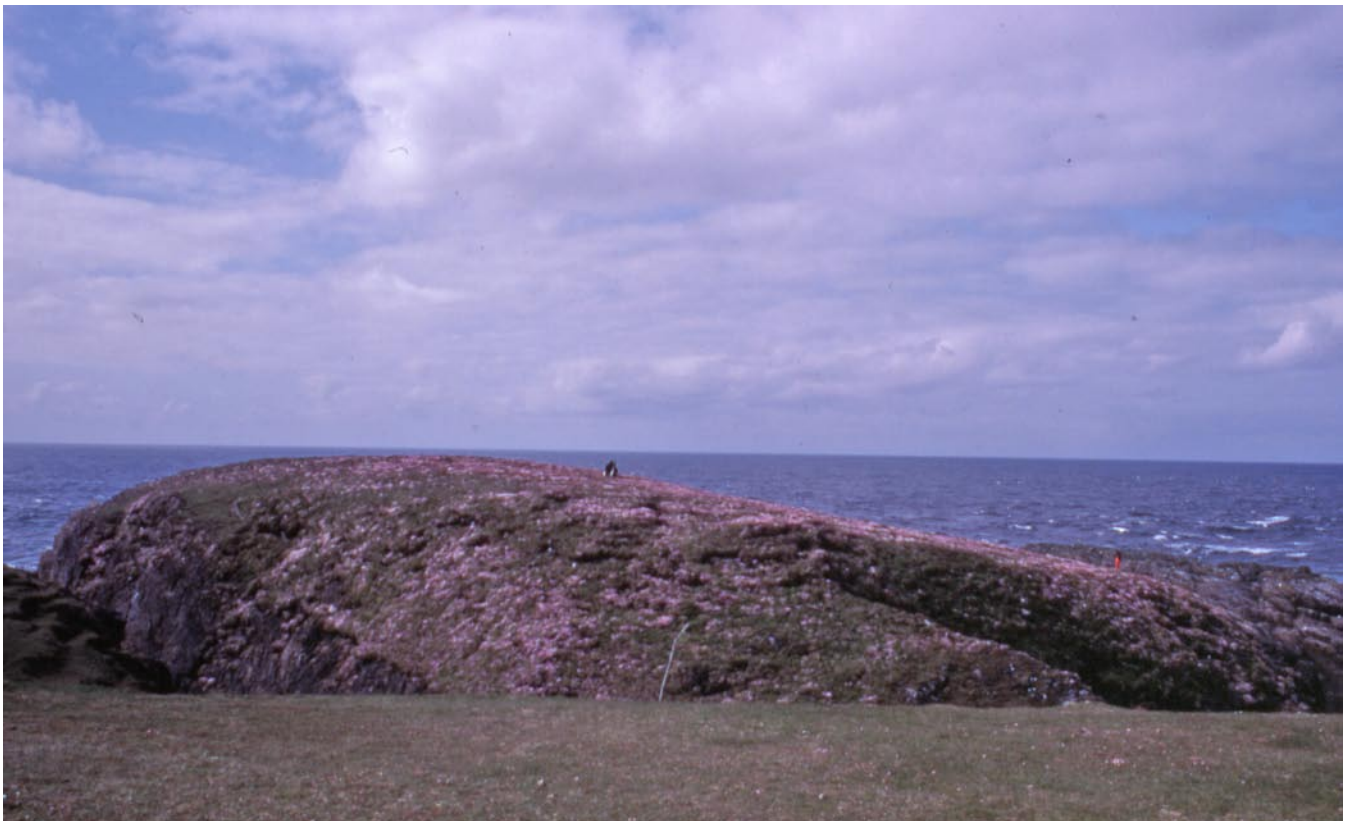
*Illus 38 Eilean nan Luchruban from the south*

The stack or small island of Eilean nan Luchruban or Pygmies Isle (NGR: NB 5078 6600; NMRS no. NB56NW 4; SAM 5878) lies approximately 1km south-west of the Butt of Lewis. The area is characterised by high, incised cliffs of Lewisian metasediment (Burgess & Church 1997, 283).

The stack itself is a cliff-bound island, separated from the mainland by a chasm *c* 30m high and 50m wide. The slightly rounded surface of the island is heavily overgrown with turf and *Armeria maritima* which, ungrazed, forms cushions and tussocks varying in height from *c* 0.2–0.5m, masking the surface of the stack and the contours of the structural remains. The plants are not strongly rooted and are vulnerable to damage from walking. The edges of the stack are used by nesting sea birds, but in 2003 there were a few nests on the upper surface of the stack.

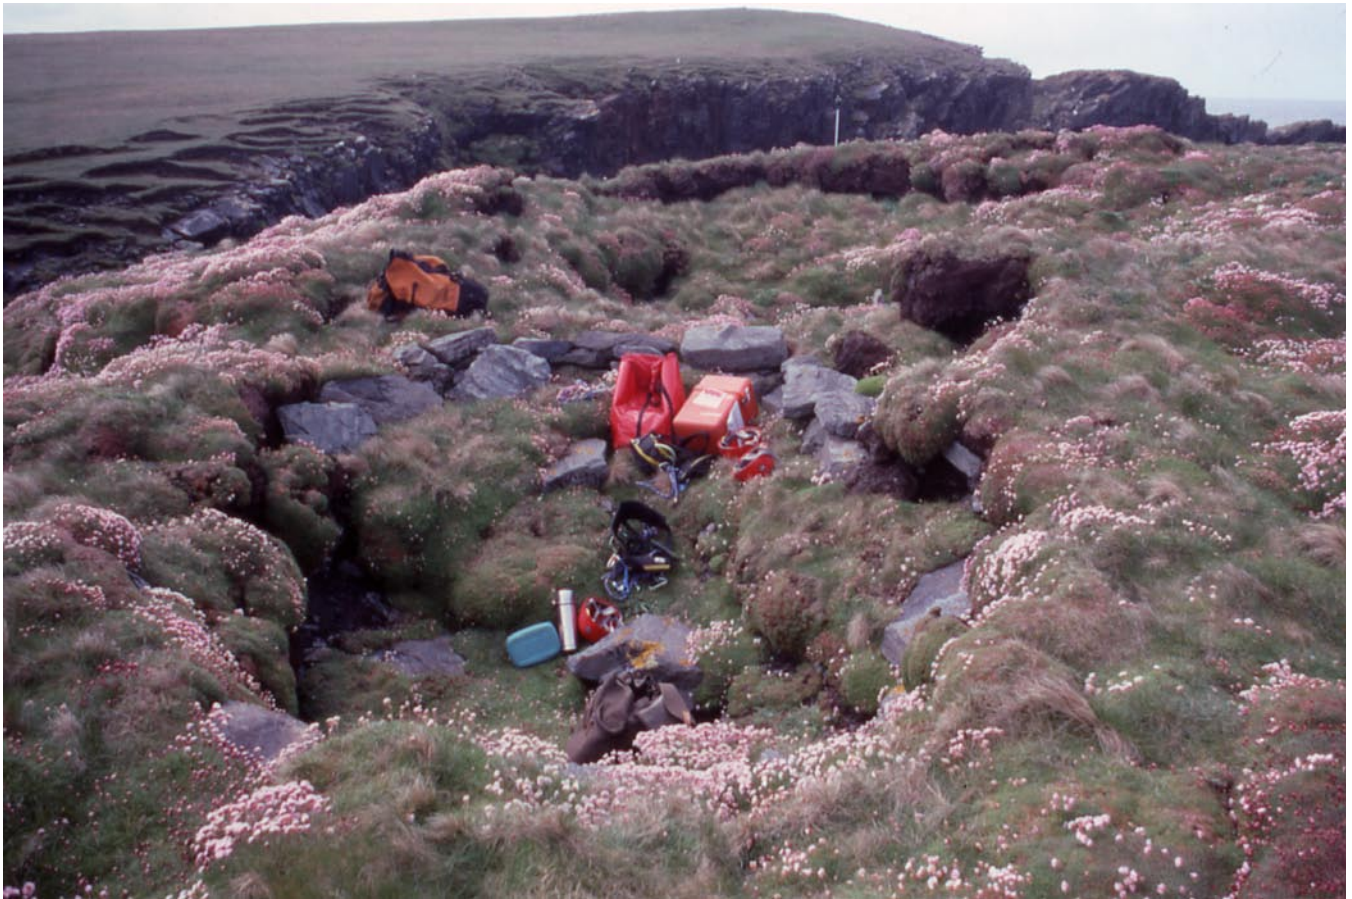
Its internal measurements were approximately 2 × 2.5m. One clearly defined drystone wallface survived a maximum of six courses on the SW-facing side (*illus 42*). The opposing wall formed a curve of loose, irregular stone and was partially obscured by vegetation. This appeared to have been rebuilt recently, and may have been the result of reconstruction of the building after excavation in the early 1900s. There was no sign of the passage exit connecting this structure to Structure B.

*Illus 42 (right) Walling of Structure A, Eilean nan Luchruban from the south*

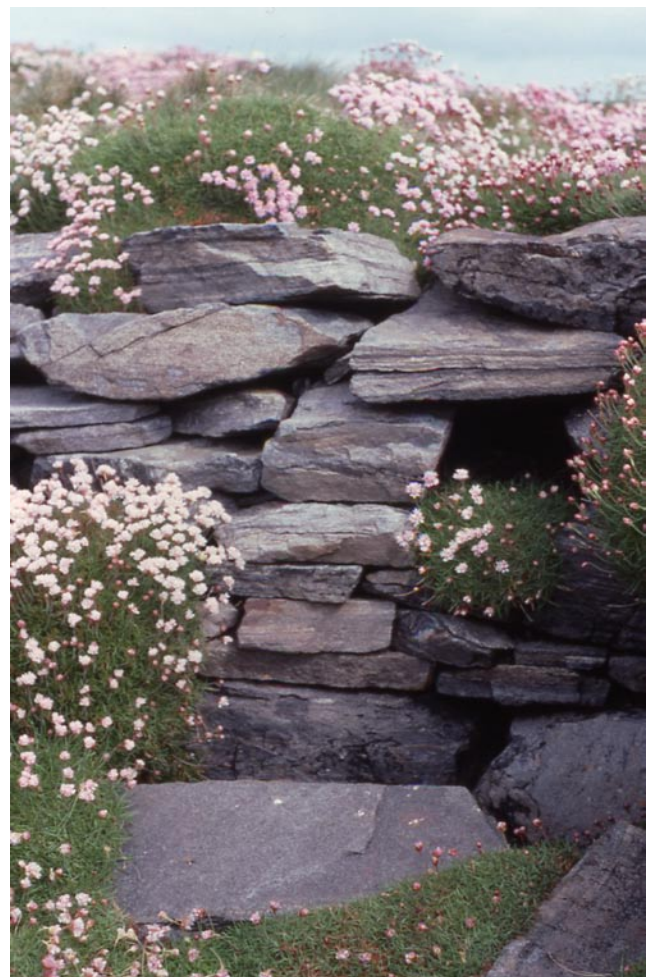
There is a stone-built structure partly dug into the south-east corner of the island, immediately adjacent to the access route used by the survey. An enclosure wall runs around this structure, and there are two slight hollows to the north of this, which may represent further remains below the thick vegetation. Because of the vegetation growth, referred structural measurements below are approximate.

*Illus 40 (opposite) Location map and topographic survey of Eilean nan Luchruban*

The enclosing wall shown on Mackenzie's plan (*illus 39*) was a circular wall, running around the north-west side of Structures A and B, and to the north-east of Structure A before reaching the cliff edge, and curving around to the south-east. There was a small break of c 2m in the wall at this point which was used by Mackenzie and STAC as the access route. The wall began again to the south of Structure B, and curved round the south-west and west sides of this before joining its northern extent (*illus 40*).

STAC survey shows that the enclosure wall is more substantial and circular, enclosing the building formed by Structures A and B. Although the shape of the internal structures is hard to discern, and there is only one visible wall face, the rectangular structure it represents is aligned NE/SW, and runs parallel to the enclosing wall at its south-east side. Indeed, the one visible internal face may correspond to the internal face of the enclosure wall, and when this is considered along with the circular form of the outer wall, the whole structure gives the impression of a roundhouse. Perhaps the passage described by MacKenzie was part of a gallery, now either hidden or destroyed.
