Achanduin Castle, Lismore, Argyll: an account of the excavations by Dennis Turner, 1970–5

David H Caldwell and Geoffrey P Stell

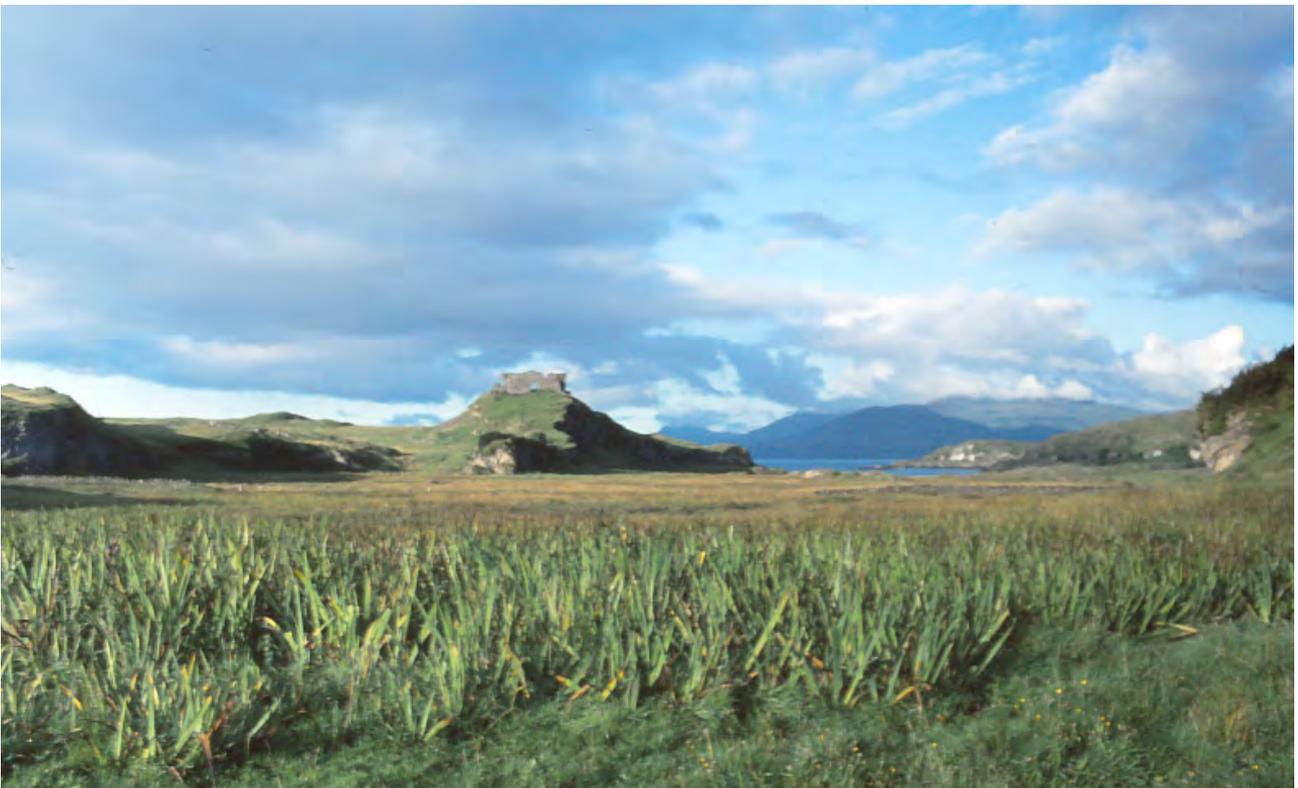
Illus 3 General view from north, 1970 and published in 1975 in RCAHMS, *Inventory of Argyll*, 2, Plate 37A (© RCAHMS. Licensor www.rcahms.gov.uk SC 715133)

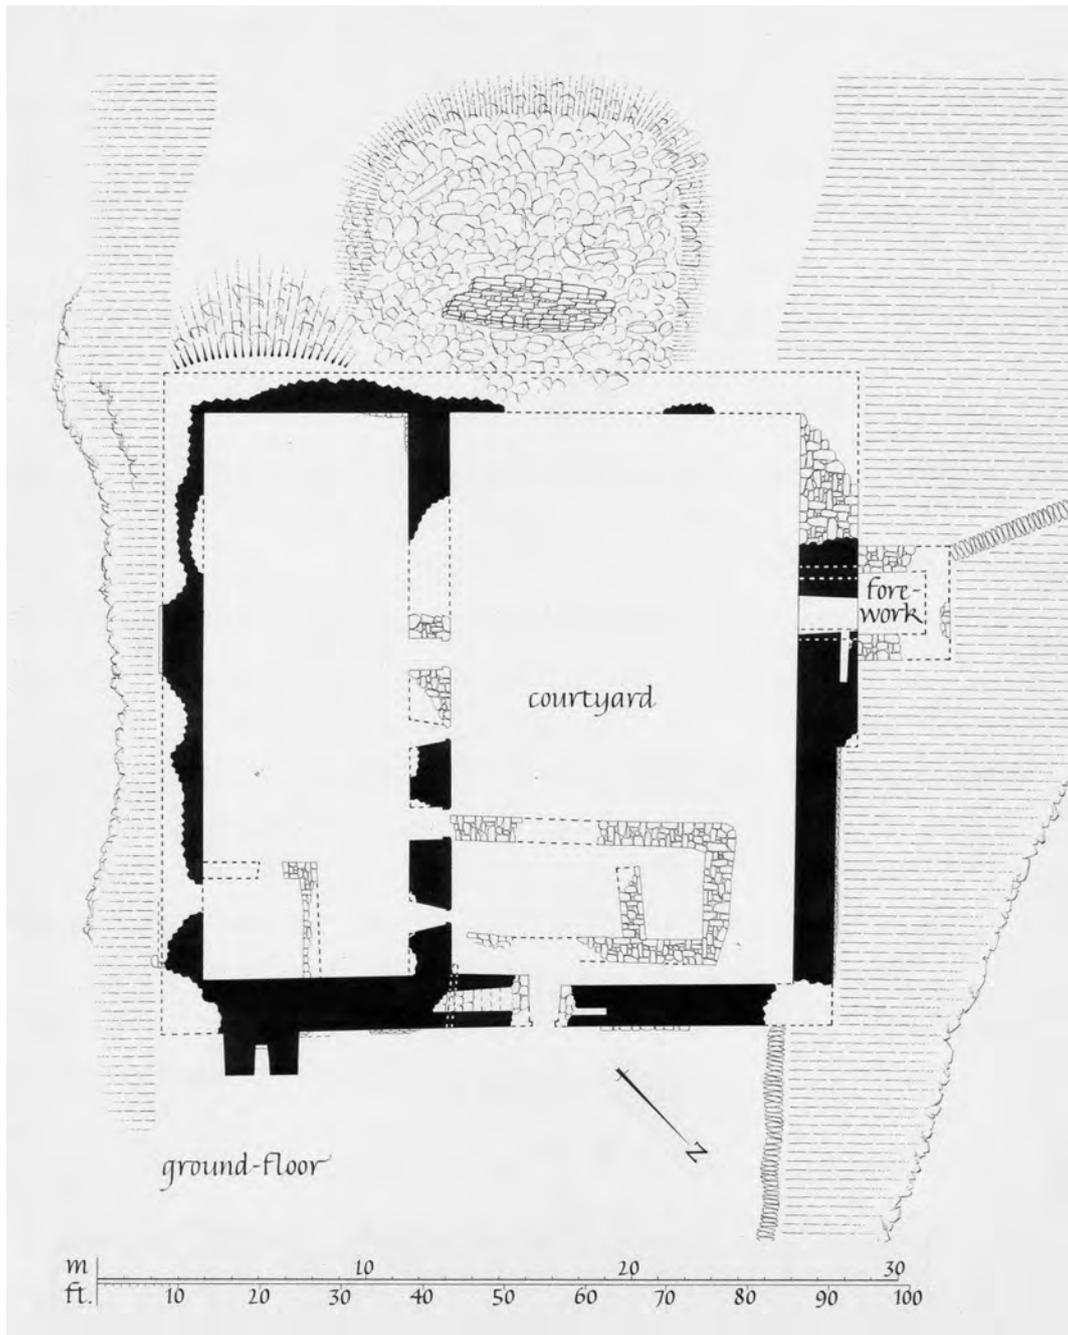
Illus 5 Ground plan as surveyed in 1971 and published in 1975 in RCAHMS, *Inventory of Argyll*, 2, Fig. 159 (© RCAHMS. Licensor www.rcahms.gov.uk DP 037606)

The castle also had an entrance in the north-west wall of the enclosure. Equipped with a drawbar socket in the north-east ingo and having an internal width of 1.4m, this entrance gateway is located to the south-west of the garderobes in the north-west wall. Before excavation this appeared to give access to a curious, bastion-like feature which then became understood as a small forebuilding defending the doorway. Approach from the exterior was via a stone-built platform which on excavation was found to incorporate a pit measuring about 2.2m square and almost 2m deep. It was evidently designed to be covered by a movable platform or drawbridge. This forework replaced an original timber platform whose twin putlog holes passed completely through the curtain wall (Illus 5) and are partially blocked by

Excavation in 1970 revealed a doorway 5.2m from the north-east end of the wall (Illus 5, 13–14): the dressed masonry of its north-east jamb survived to a height of about 1.2m, being wrought with a 100mm chamfer on the external arris and a 30mm chamfer on the arris of the rebate. A second doorway, serving the south-west part of the range, was exposed in 1971. The ground floor of the range was lit by at least two windows to the courtyard, one on each side of the north-east doorway. Of the window to the south-west, only the sill survived, but that at the

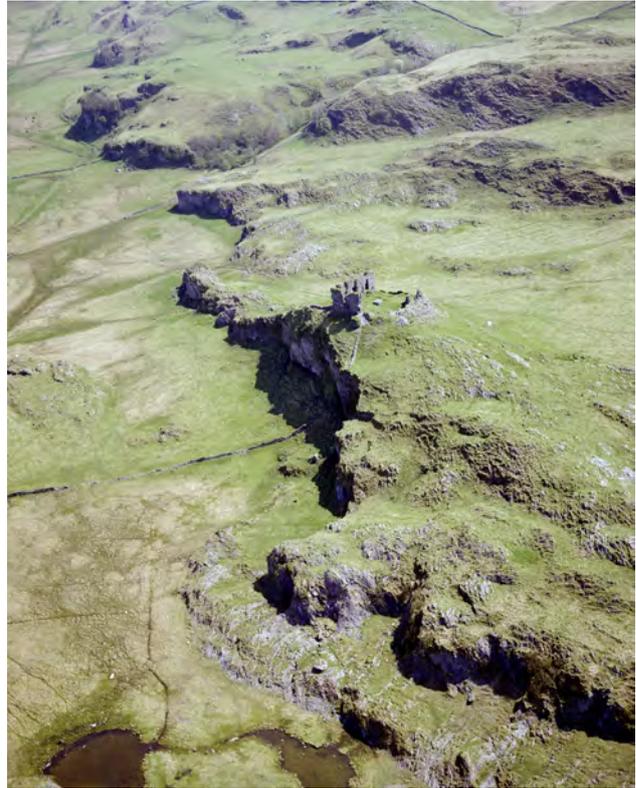
Illus 6 Aerial view from west, 1977 (© British Geological Survey/NERC. Licensor www.scran.ac.uk 000-000-147-870-R)

The island of Lismore is largely comprised of hard Dalradian limestone which gives rise to a soil and landscape unique in this part of the Highlands. The well-drained hillsides with their fertile soils are covered in short grass, cropped by grazing animals, and are renowned for the wild flowers that thrive on the limey conditions. The highly folded Lismore limestone outcrops freely in the vicinity of the Achanduin site, particularly in the sea cliffs, and is used in the rubble construction of the castle (Illus 6–7).

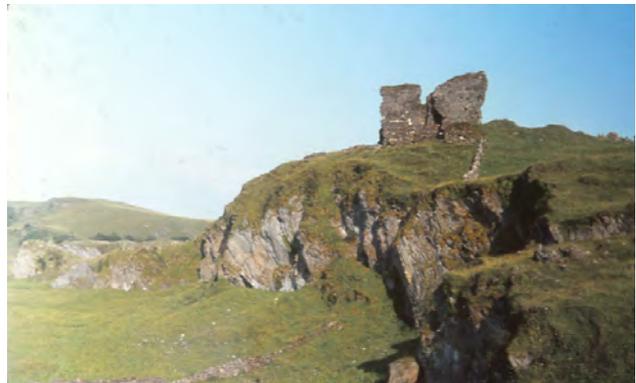
Illus 7 Cliffs on the north-western flank of the site, c 1970

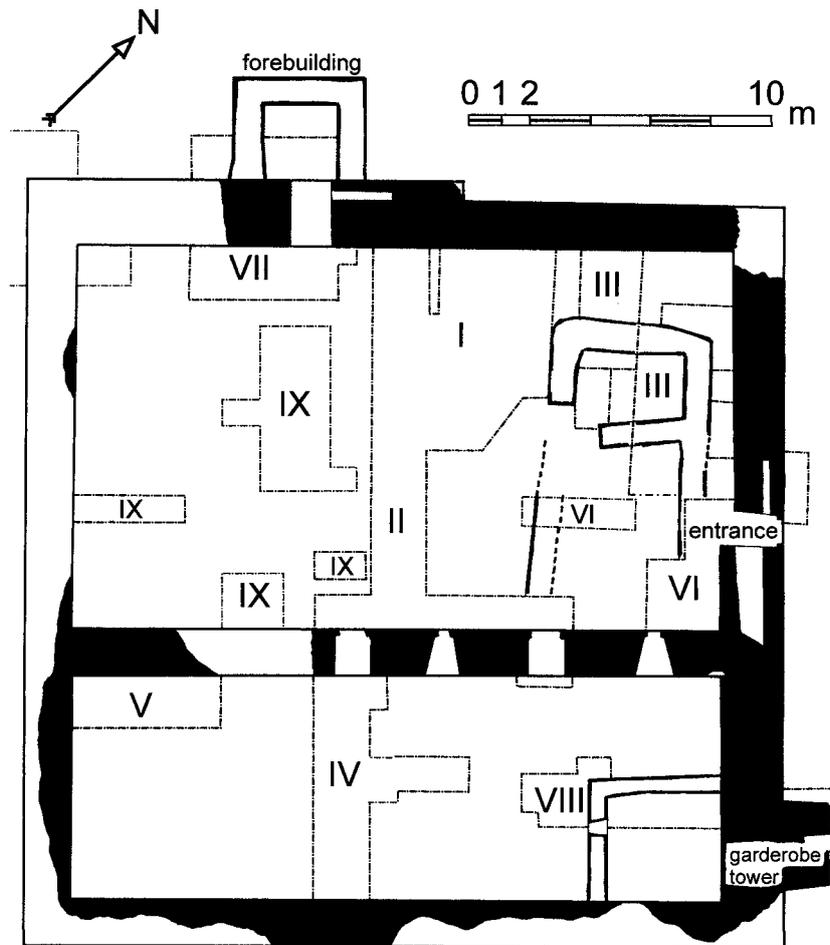
Illus 8 Ground plan showing layout of excavated areas

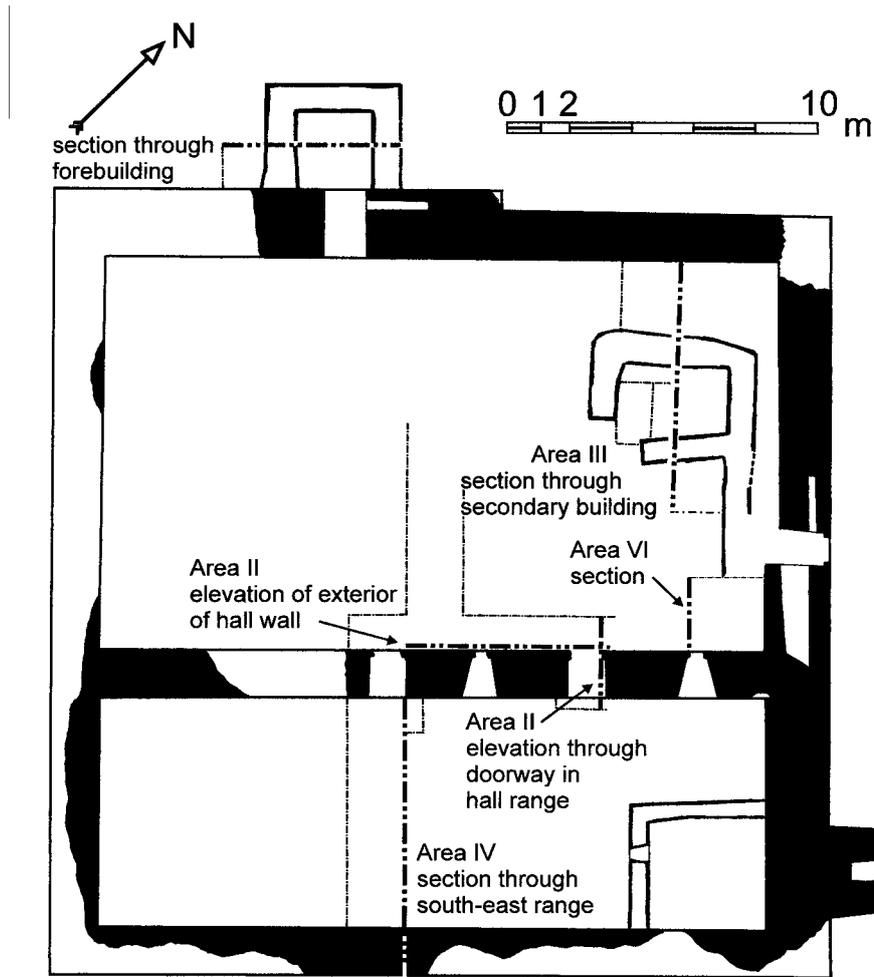
Illus 9 Ground plan showing location of sections illustrated in DJT's report

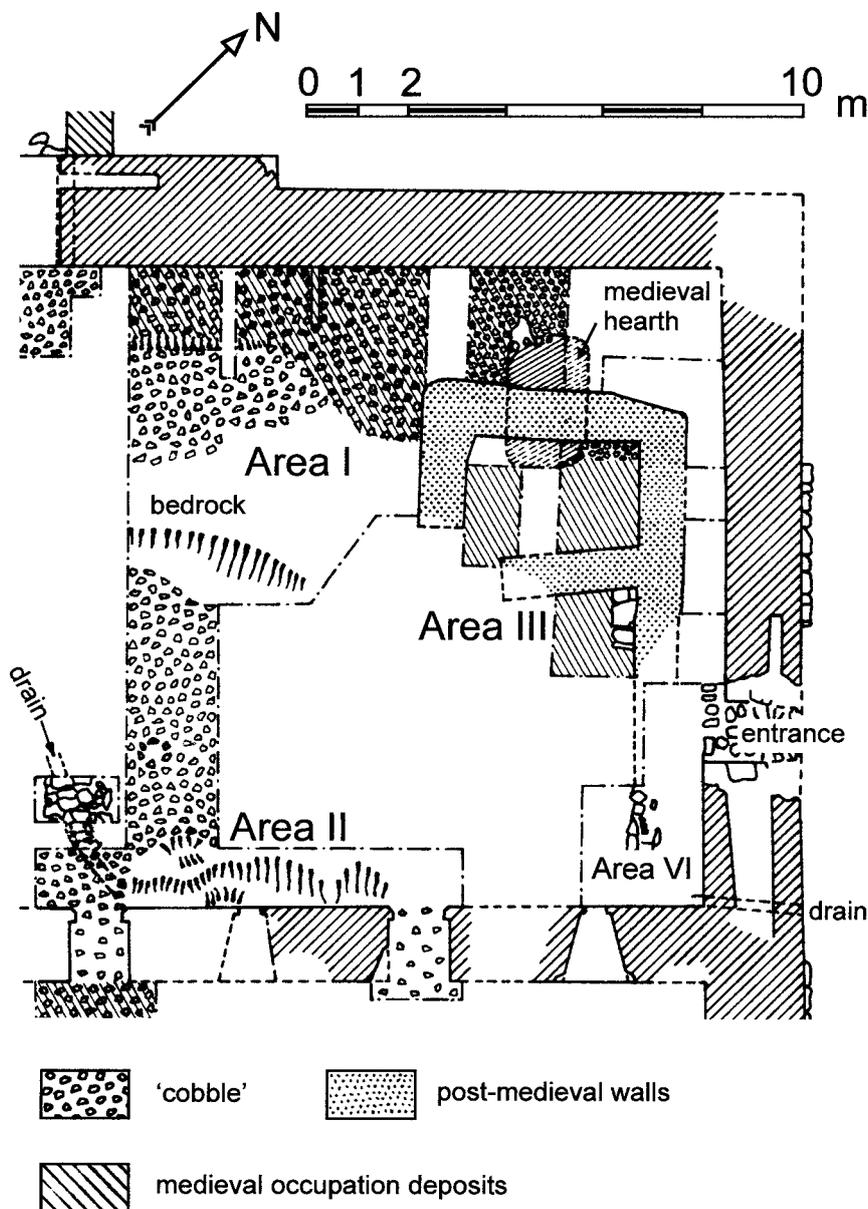
Illus 10 Plan of excavated Areas I-III and VI

Area II (1970–3; Illus 10) began on 18 August 1970 as a trench measuring six feet (1.83m) wide running south-eastwards from Area I to the wall of the hall range, its south-western flank being a continuation of the south-western side of Area I. Four days later, on 22 August, a trench measuring four feet (1.22m) wide along the face of the hall range was started, all of which was backfilled between the following 2 and 4 September. Two seasons later, on 30 July 1972, about two feet (61cm) of backfill was removed from Area II, and a trench measuring four feet by twelve feet (1.22m by 3.66m) was laid out immediately

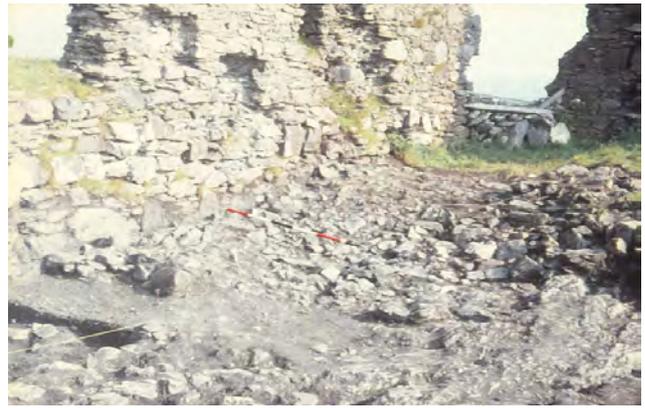
Illus 11 View of collapsed masonry in excavated Area I from south, August 1970

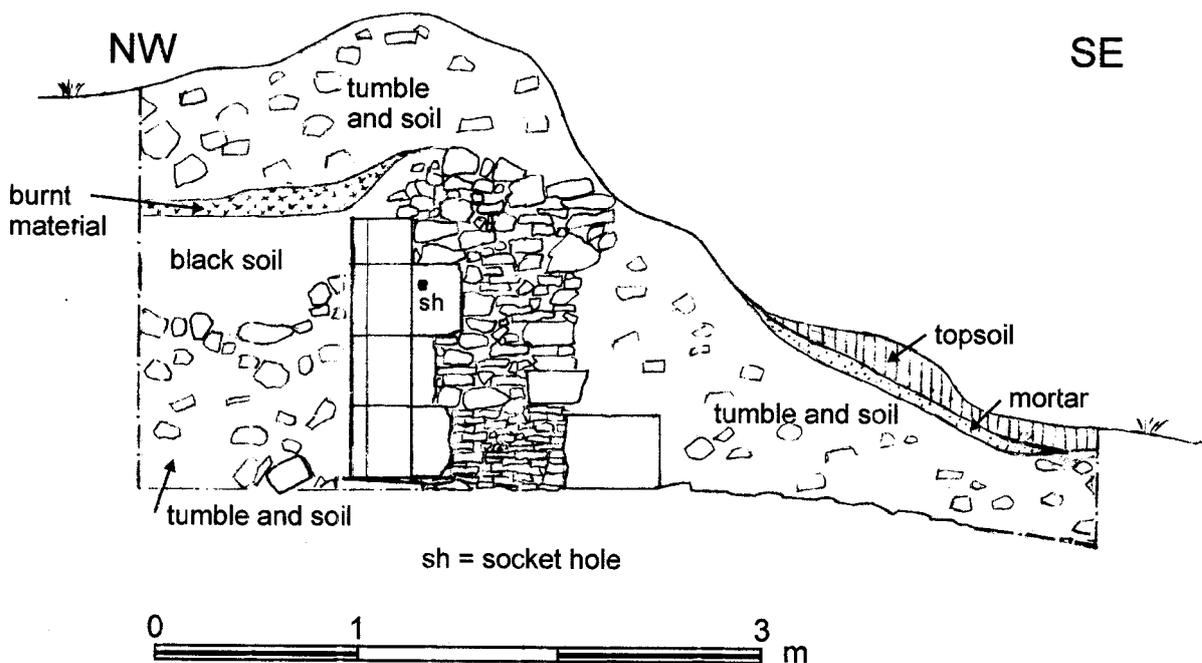
Illus 12 Section through hall doorway in excavated Area II

Illus 13 and 14 show the elevation of the external (north-west) face of the south-east (hall) range as excavated in Area II. Illus 12 is a section along the north-west jamb of the north-east door into the hall range. It shows a layer of ‘burnt material’ below the ‘tumble and soil’ enveloping the ruined wall, and above ‘black soil’ within the area of the secondary

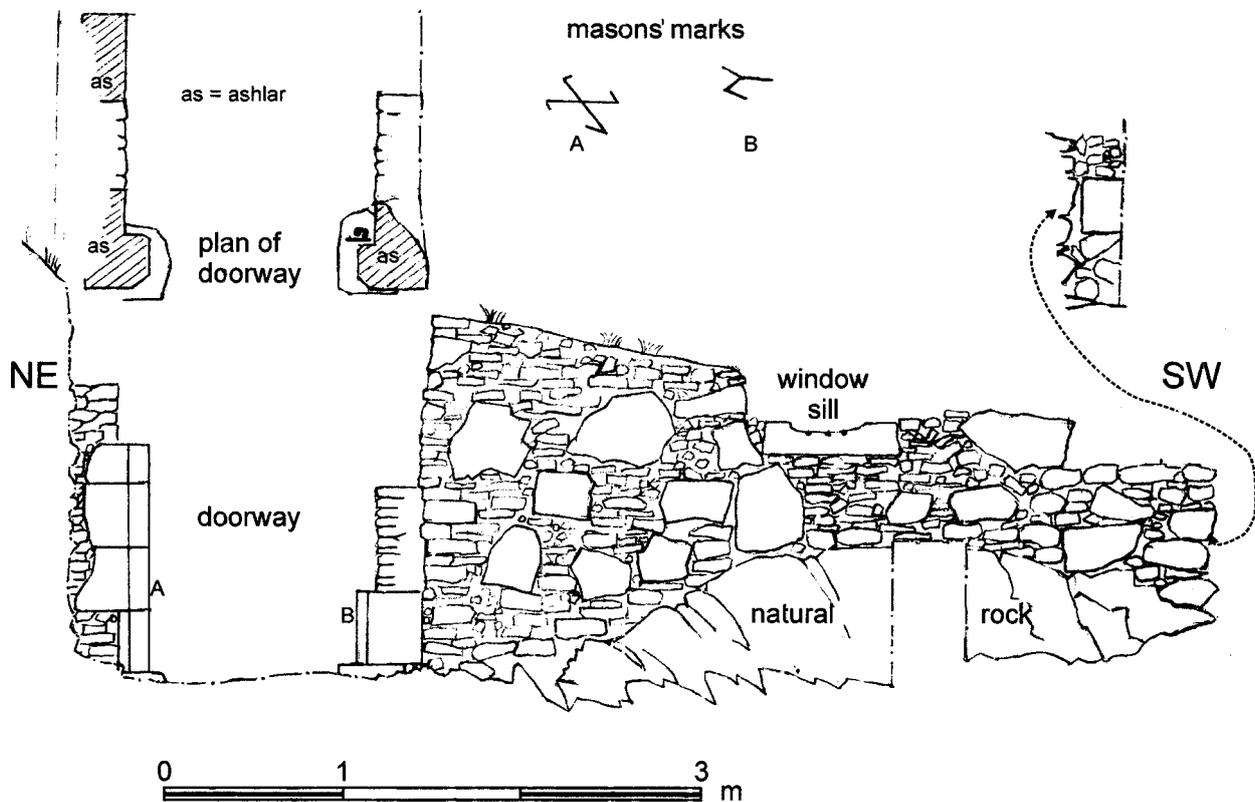
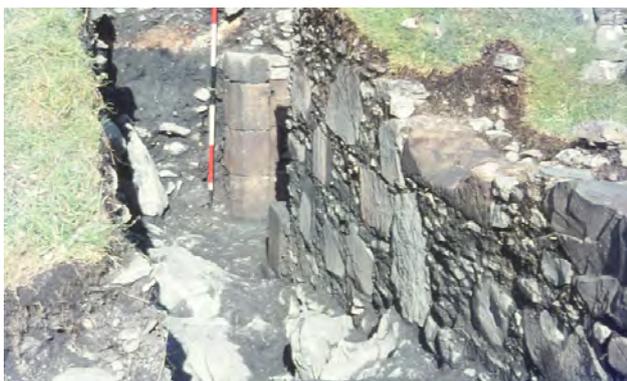
(Above) Illus 13 Elevation of external (north-west) face of south-east (hall) range in excavated Area II

(Left) Illus 14 View from west of exposed external face of south-east (hall) range in excavated Area II, September 1970

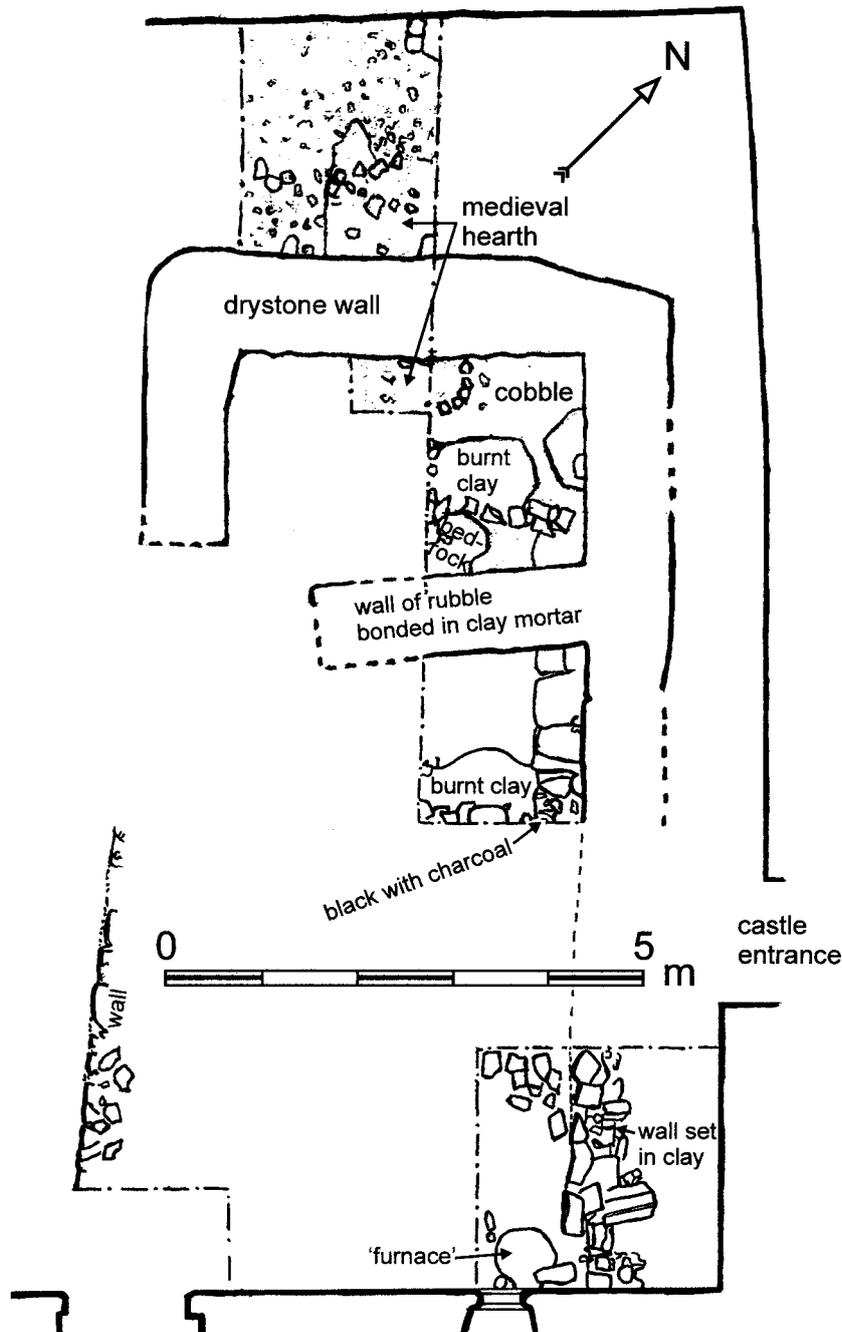
Illus 15 Plan of excavated Areas III and VI

Area III (1970–2, 1975; Illus 15) was also first opened up on 18 August 1970; a trench measuring six feet (1.83m) wide was laid out north-eastwards from Area I against the north-western wall of the castle. In the 1971 season a trench which was designated Area III-N traced the external face of the secondary building around the north corner on 19 August, and on 24 August an operation to clear ‘tumble’ outside the E corner was begun in Area III-E. Except for a square of burnt clay at the north corner of the south-eastern chamber, all parts of Area III were backfilled on 23 August 1972, but on 17 August 1975 trenches in Areas III-N and III-E were temporarily reopened and re-examined.

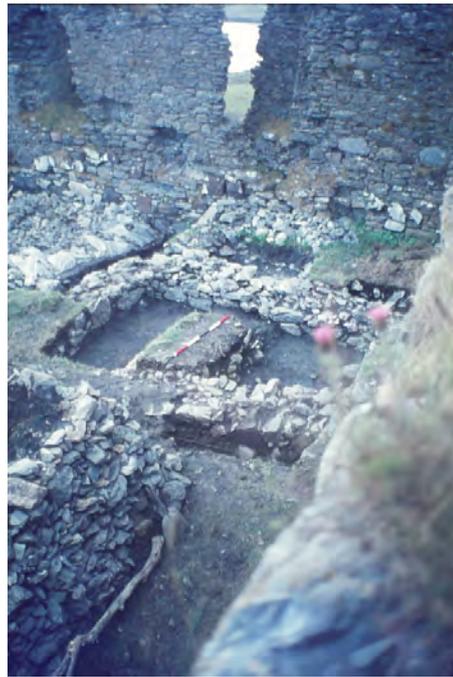
Illus 16 High-level view from east of excavated Area III, September 1971

Unlike Areas I and II, the excavation of Area III led to the uncovering of substantial features, most notably the secondary building mentioned above (Illus 16, 17). It was sub-rectangular on plan with walls of drystone surviving a few courses high, and occupied a position parallel to the north-east enclosure wall. Excavation in Area III and later in Area VI established that it effectively blocked access to the north-east entrance gate and that it utilised the ruined courtyard wall of the hall range as its end wall. It measured about 9.5m by 3.5m internally, and its walls appeared to have been planted over medieval remains of occupation. A partition wall, dividing this building into two unequal chambers, was

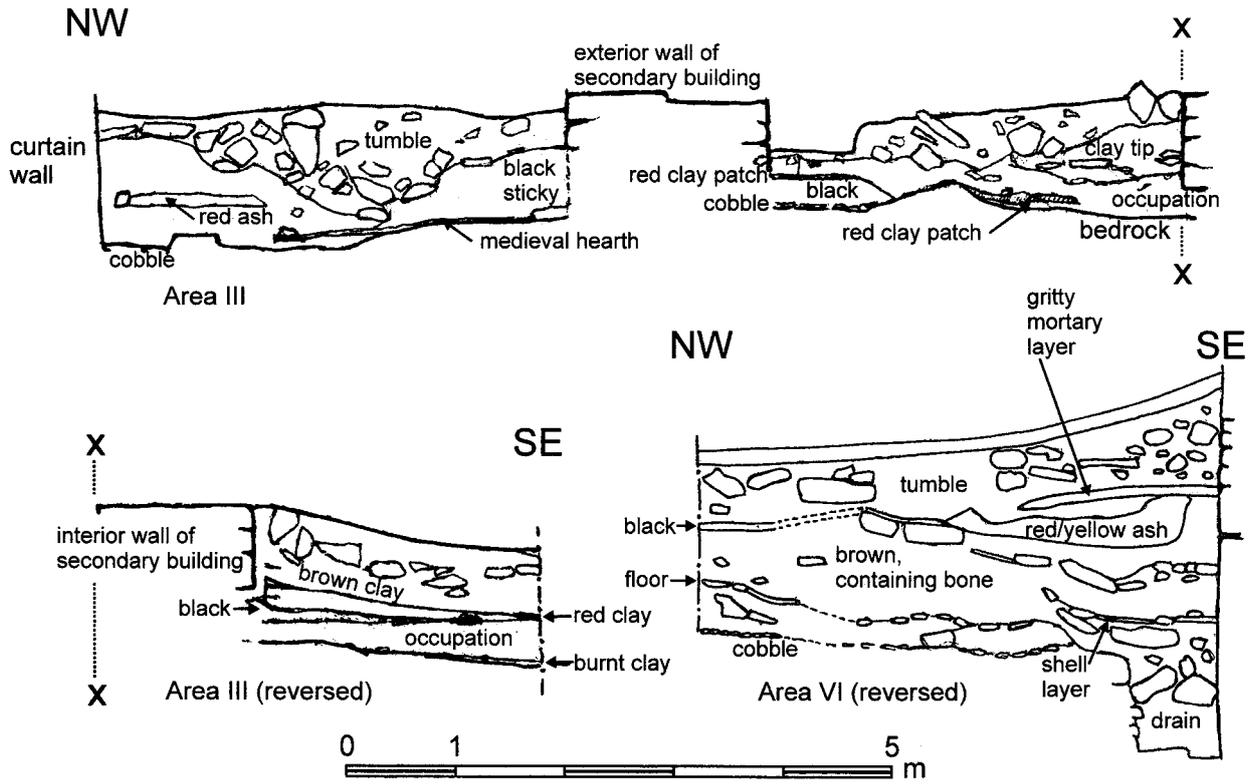
Illus 17 Sections in excavated Areas III and VI through secondary building and earlier deposits

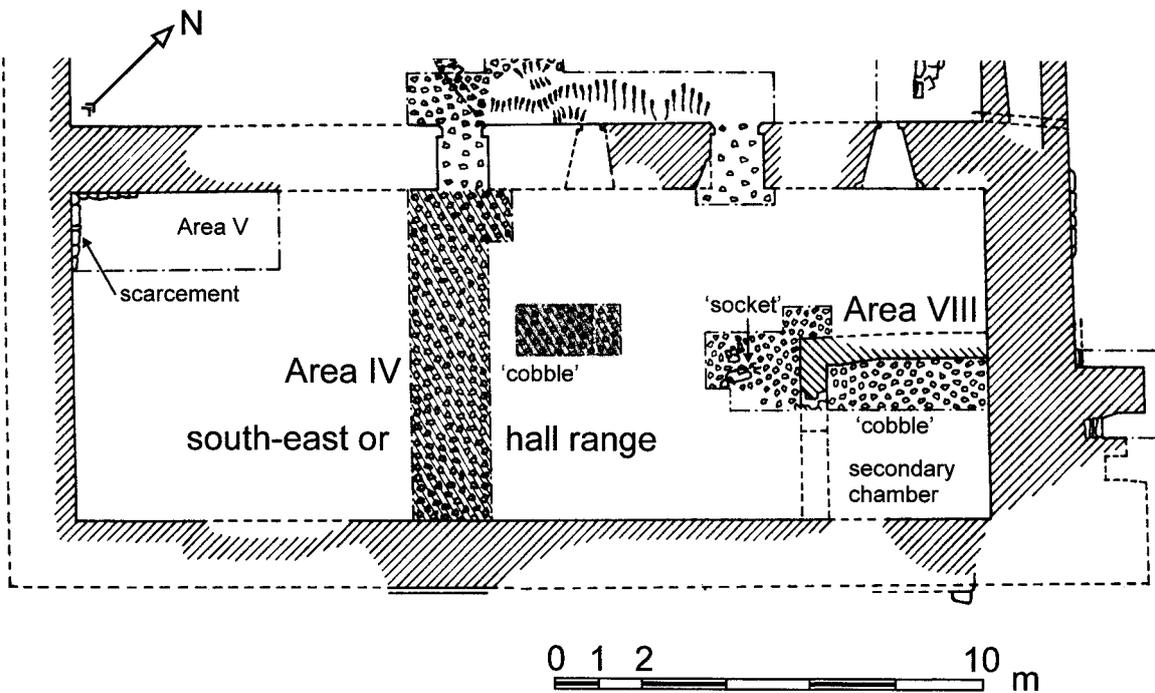
Illus 18 Plan of excavated Areas IV, V and VIII in south-east (hall) range

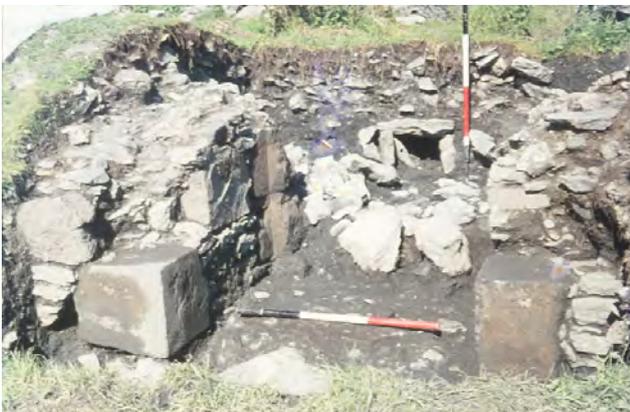
(Left) Illus 19 View from within south-east range through doorway, showing drain in Area II

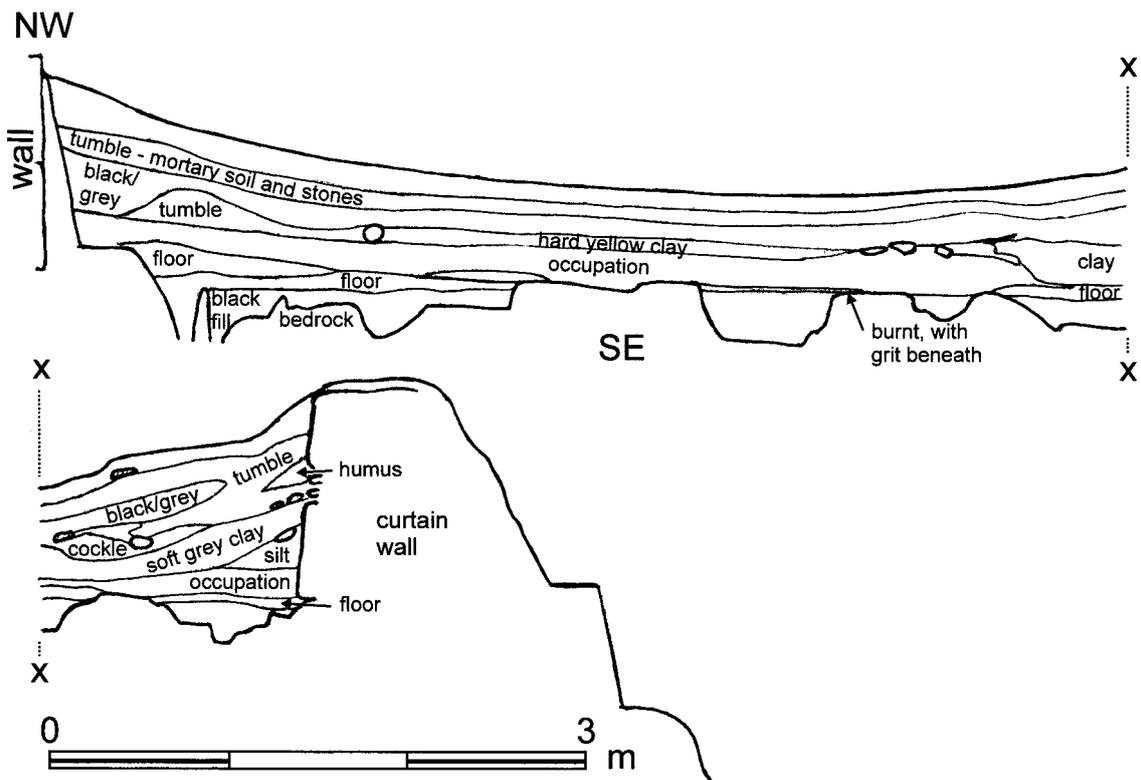
(Below) Illus 20 Section through south-east (hall) range in excavated Area IV

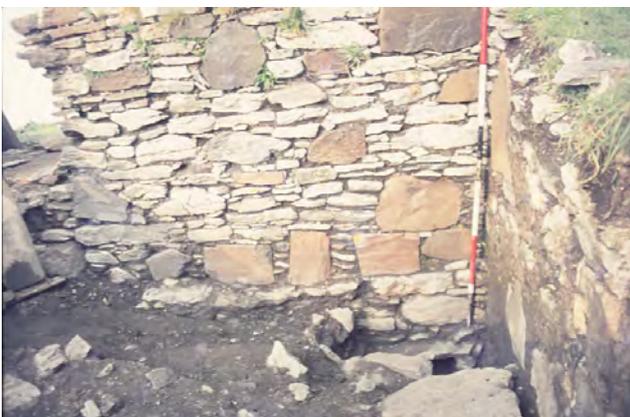
Illus 21 Excavated Area VI from south-west, August 1974

Excavation in Area VI also led to the discovery of a drain (Illus 21), passing from the east corner of

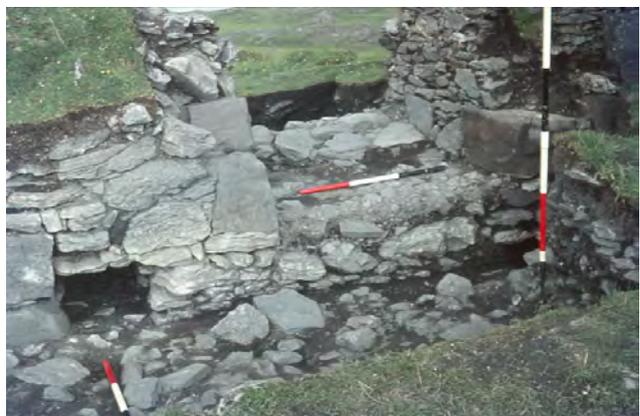
Illus 22 Excavated Area VII from south-east, August 1972, showing castle entrance with drain to left and 'cobble' surface exposed

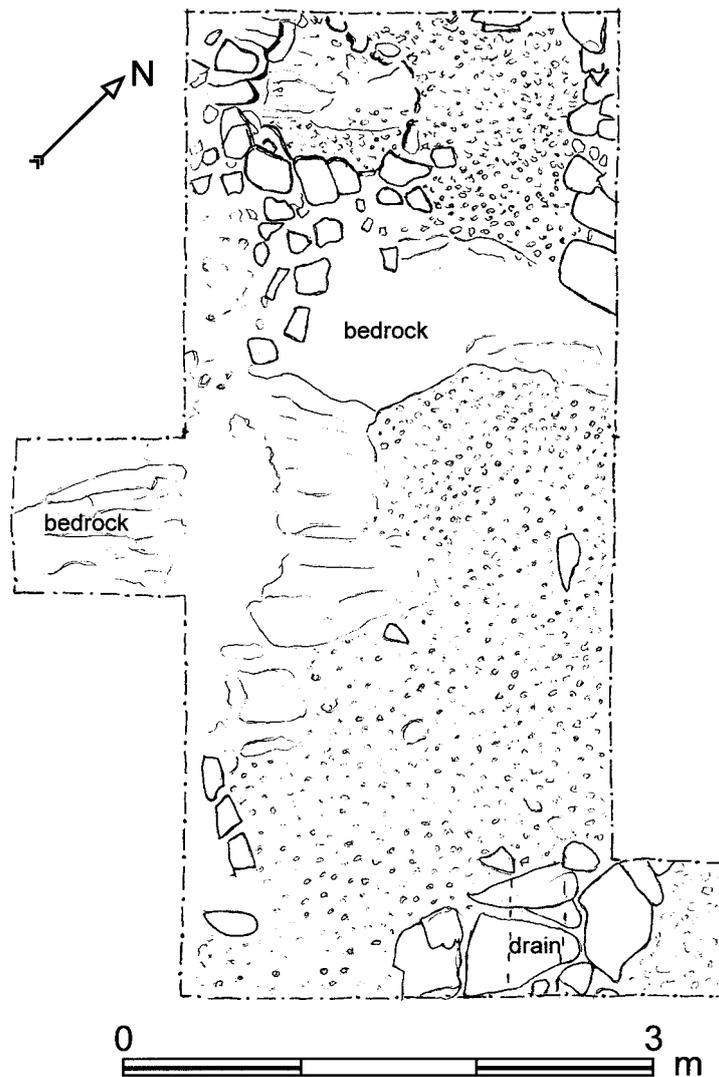
Illus 23 Plan of excavated Area IX-a-c-d

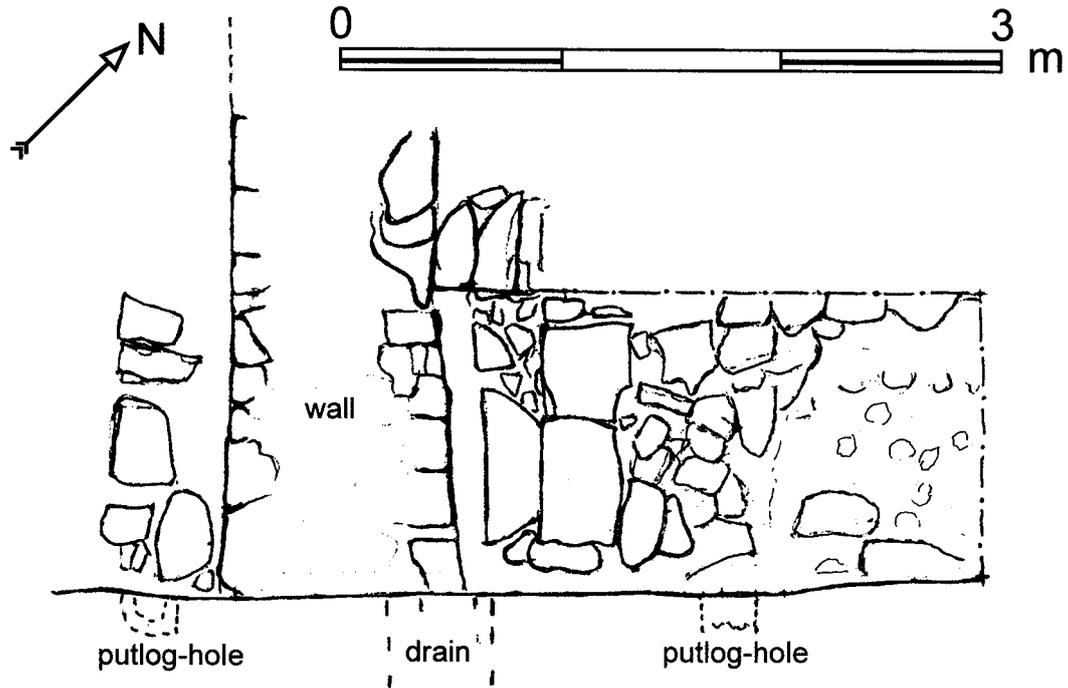
Illus 24 Plan of excavation in forebuilding

Outside these nine main areas, DJT identified three specific features which were excavated and defined to a greater or lesser extent during the 1972-3 seasons: (1) a forebuilding associated with the gateway in the north-western wall (Illus 24,

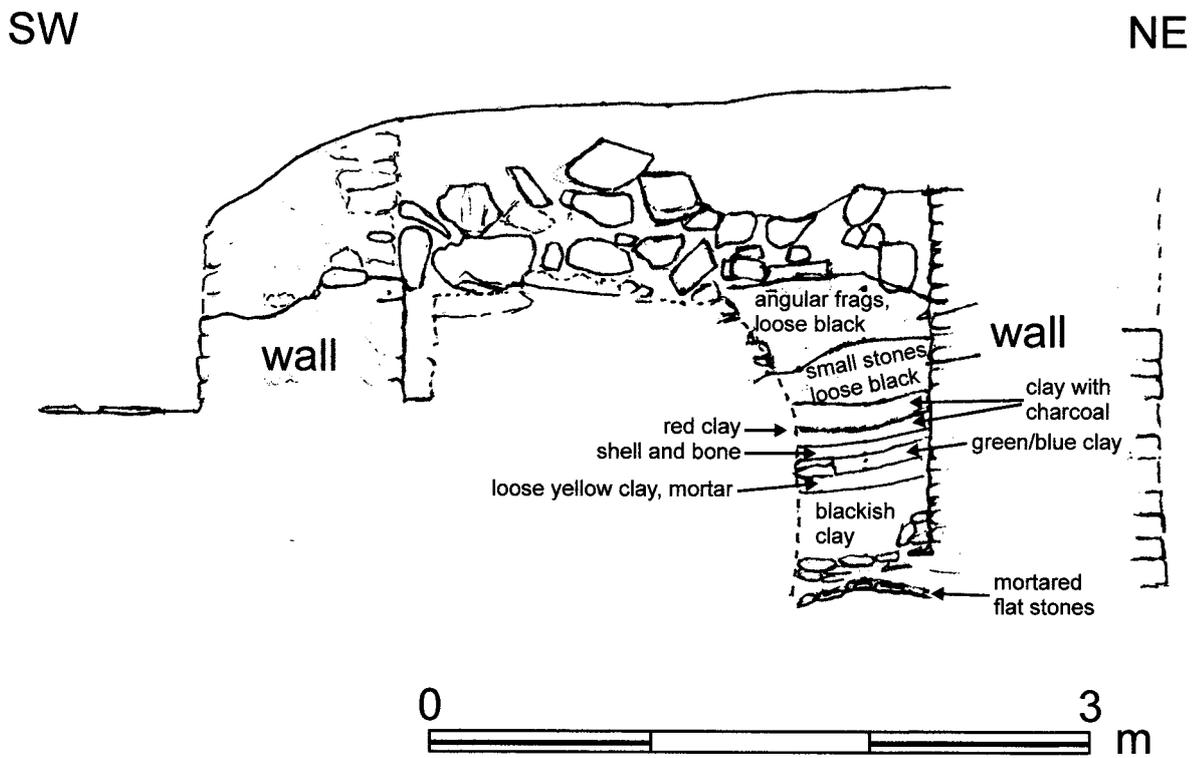
Illus 25 Section through the deposits in the excavated forebuilding

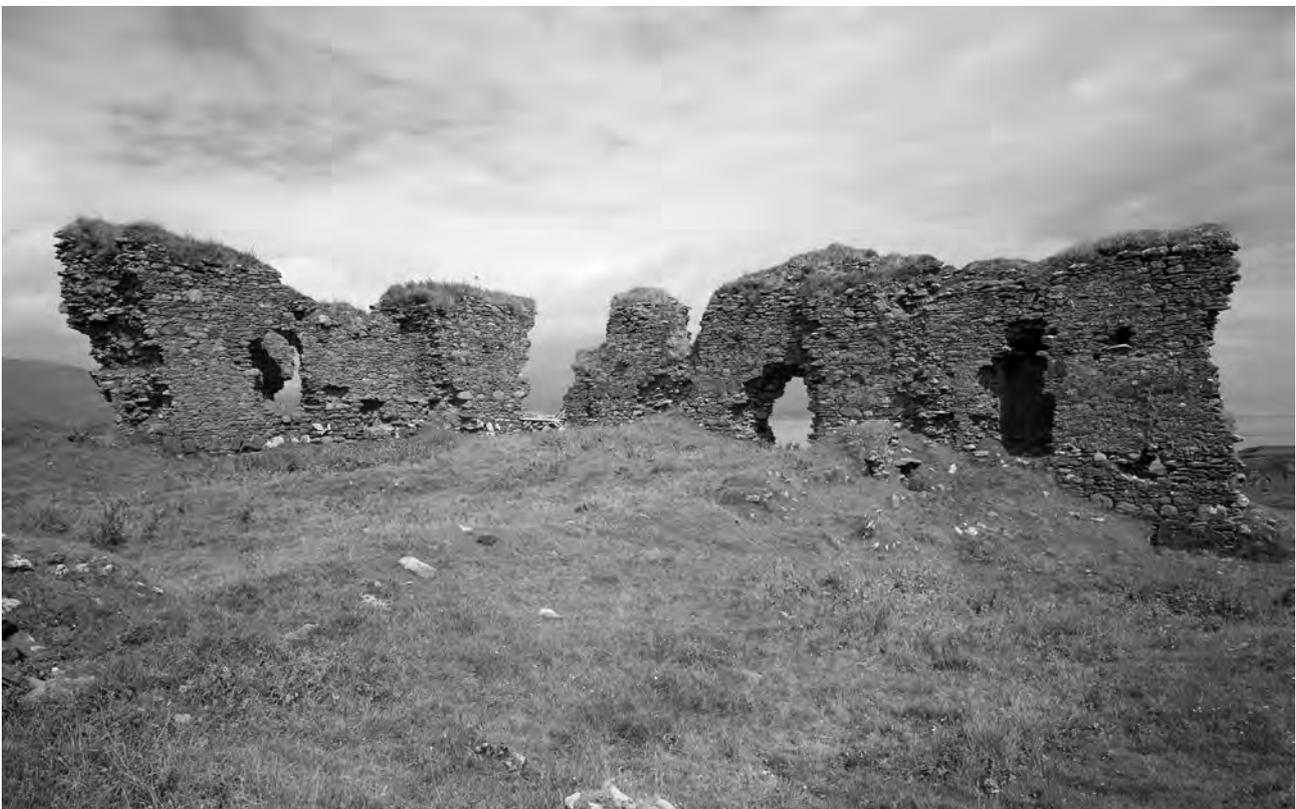
Illus 26 Interior of courtyard from south-west, 1972 and published in 1975 in RCAHMS, *Inventory of Argyll*, 2, Plate 38A (© RCAHMS. Licensor www.rcahms.gov.uk SC 1445519)

excavation, the buildings within the courtyard could only be seen as tumbled walling. A two-storeyed range along the south-east side of the courtyard was clear, while windows high in the north-east curtain and two large garderobes in the thickness of the north-west wall appear to have been provided for a substantial two-storeyed block in the north corner (Illus 26).

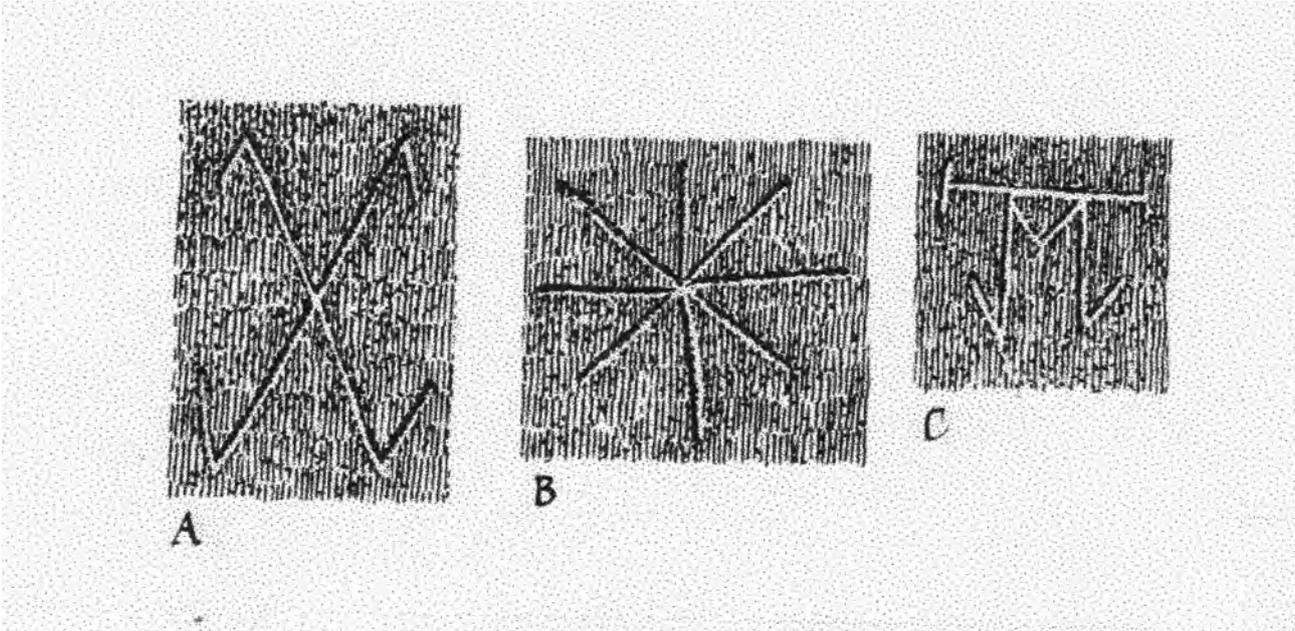
Illus 27 Masons' marks as published at 1:5 scale in 1975 in RCAHMS, *Inventory of Argyll*, 2, Fig. 161; A and B, south-east hall range; C, detached fragment (© RCAHMS. Licensor www.rcahms.gov.uk DP 196315)

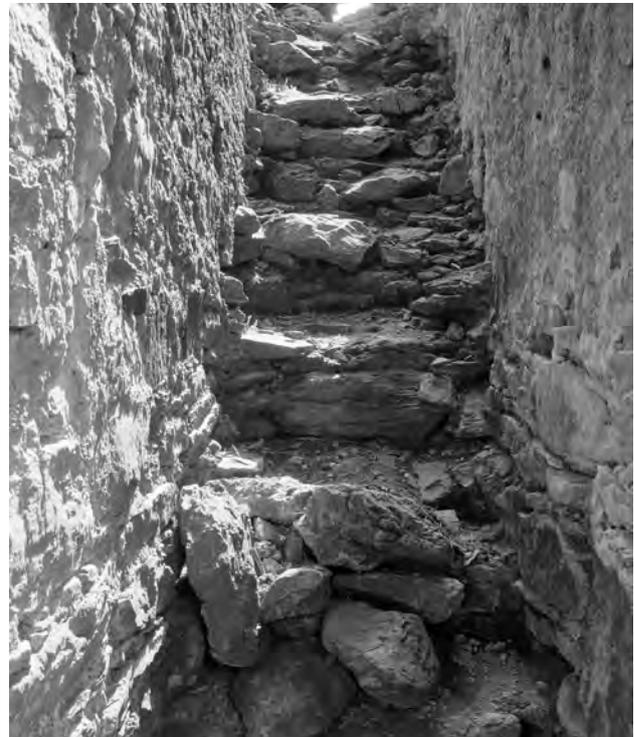
Illus 29 Intra-mural stair in north-east wall, 1970 and published in 1975 in RCAHMS, *Inventory of Argyll*, 2, Plate 37B (© RCAHMS. Licensor www.rcahms.gov.uk SC 1445518)

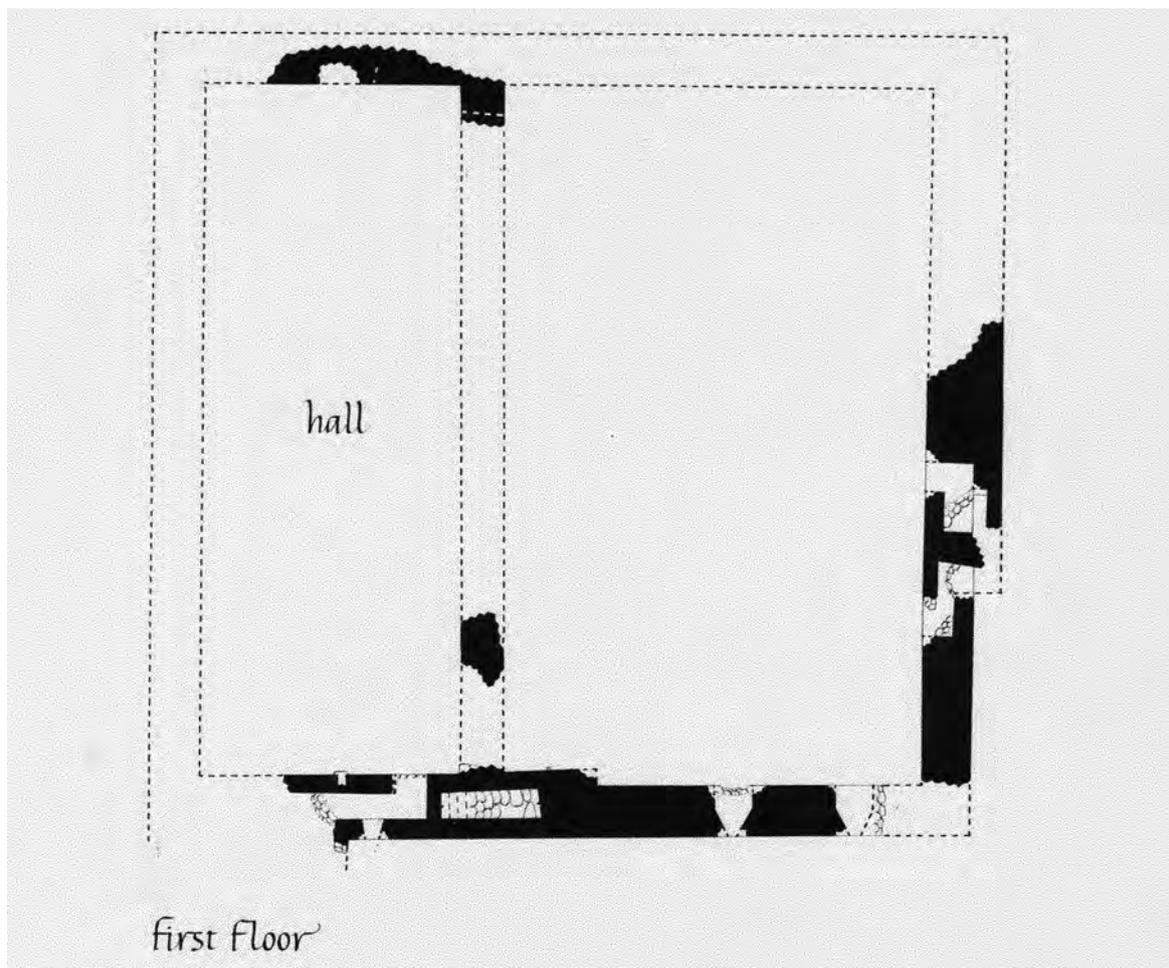
Illus 30 First-floor plan as surveyed in 1971 and published in 1975 in RCAHMS, *Inventory of Argyll*, 2, Fig. 160 (© RCAHMS. Licensor www.rcahms.gov.uk DP 196316)

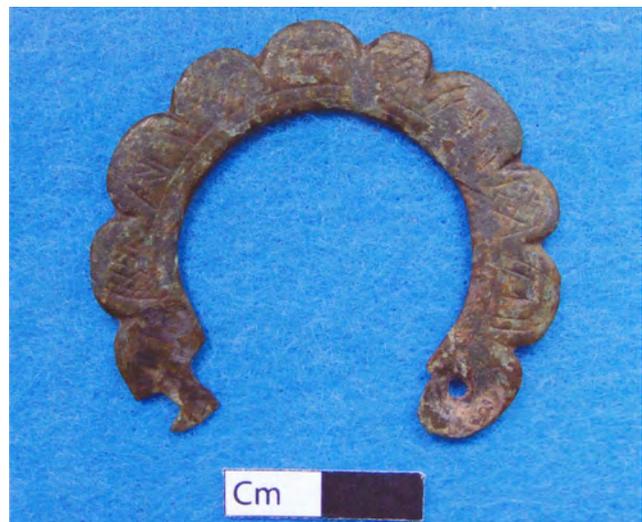
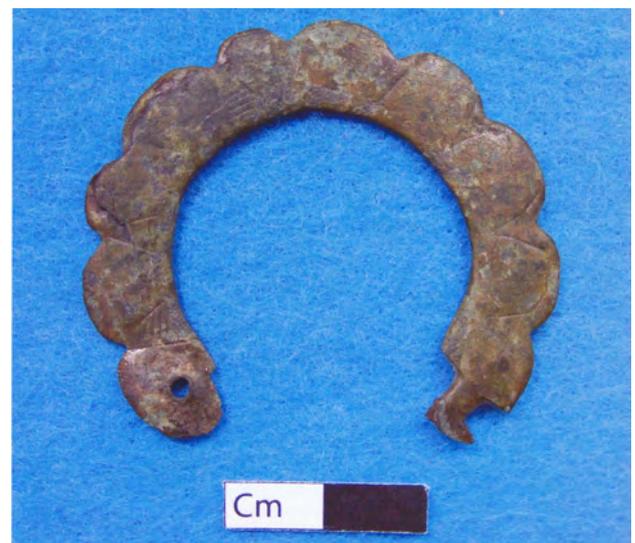
Illus 32 Brooch no. 1/lxxxiii, front (top) and back (bottom) (Stuart Campbell)

► 1 (lxxxiii) Brooch Cu alloy

Ring brooch with flat hoop with scalloped outer edge, part missing, with pierced, possibly secondary, rivet hole; engraved on obverse with hatching and geometric designs, and on reverse with hatched triangles. Diam: 44mm.

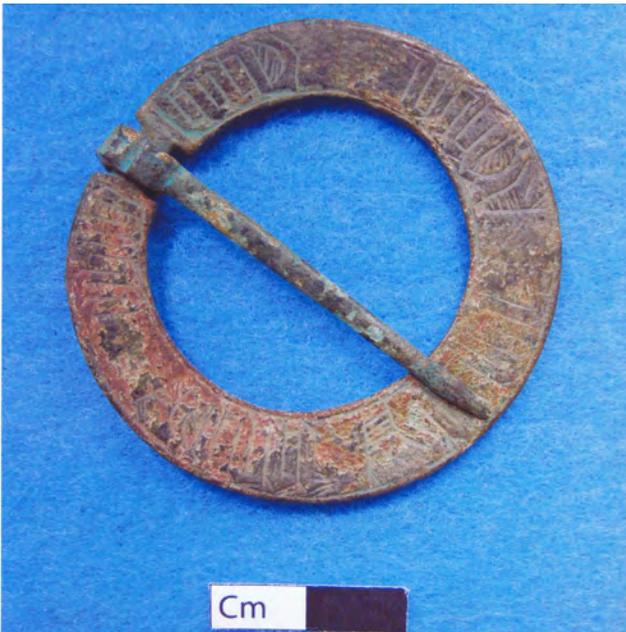
Illus 35 Brooch no. 4/lxxxi (Stuart Campbell)

► **4 (lxxxii) Brooch Cu alloy**

Ring brooch with flat hoop, 7–9mm wide, cast as

one, with replacement pin. It is engraved with five groups of poorly executed black letters, apparently reading, from the right of the pin head: 'inrid', 'inrid', 'inrid', 'inrid', 'domn'. The 'inri' abbreviation occurs widely in medieval contexts and stands for 'Jesus Nazarenus Rex Iudeorum', Latin for Jesus of Nazareth, King of the Jews. The letter 'd' and the following 'domn' are Latin abbreviations for 'Dominus', Lord. There are geometrical motifs between the groups of letters, now difficult to distinguish. Diam: 45–47mm.

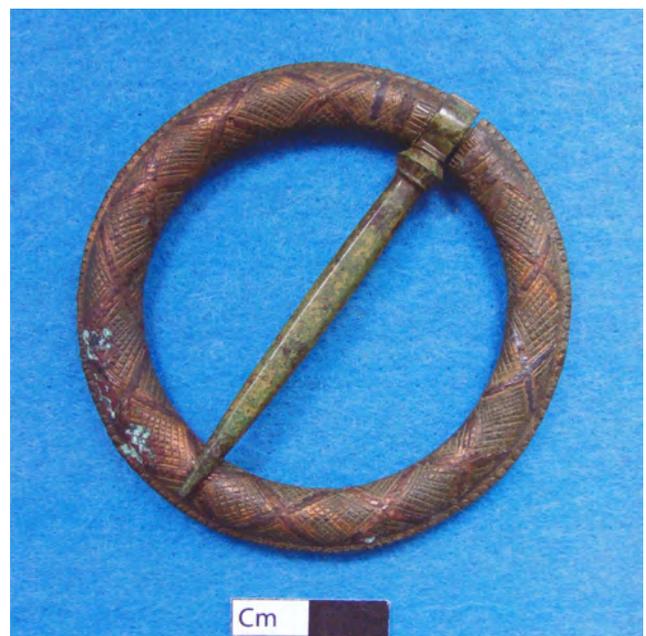
Illus 37 Brooch no. 6/lx, front (top) and back (bottom) (Stuart Campbell)

► **6 (lx) Brooch Cu Alloy/niello**

Ring brooch, the hoop cast in one, oval in cross-section with an outer collar. It is decorated on the obverse with inlaid niello saltires reserved against cross hatching; on the reverse are niello chevrons; the collar is stamped with annulets on the obverse and has engrailed beading on the reverse; the pin is surmounted by a fluted knob and has a barrel-
