Achanduin Castle, Lismore, Argyll: an account of the excavations by Dennis Turner, 1970–5

David H Caldwell and Geoffrey P Stell

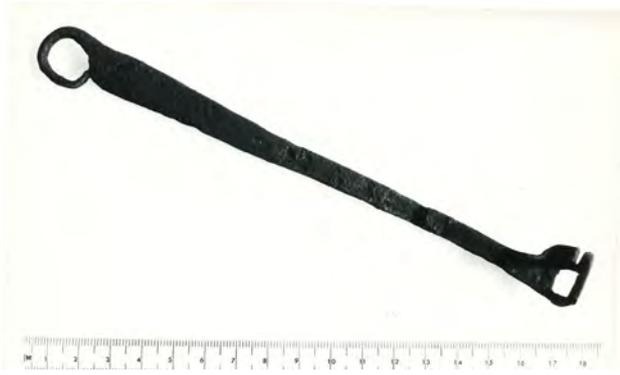
Illus 44 Padlock slide key

► **17 (ccxxxvii) Padlock slide key**

The bit, for a two- or three-spined spring, is set laterally to the shank and has a looped terminal (Goudall type A padlock key, see Franklin &

Goudall 2012: 156). L: *c* 190mm.

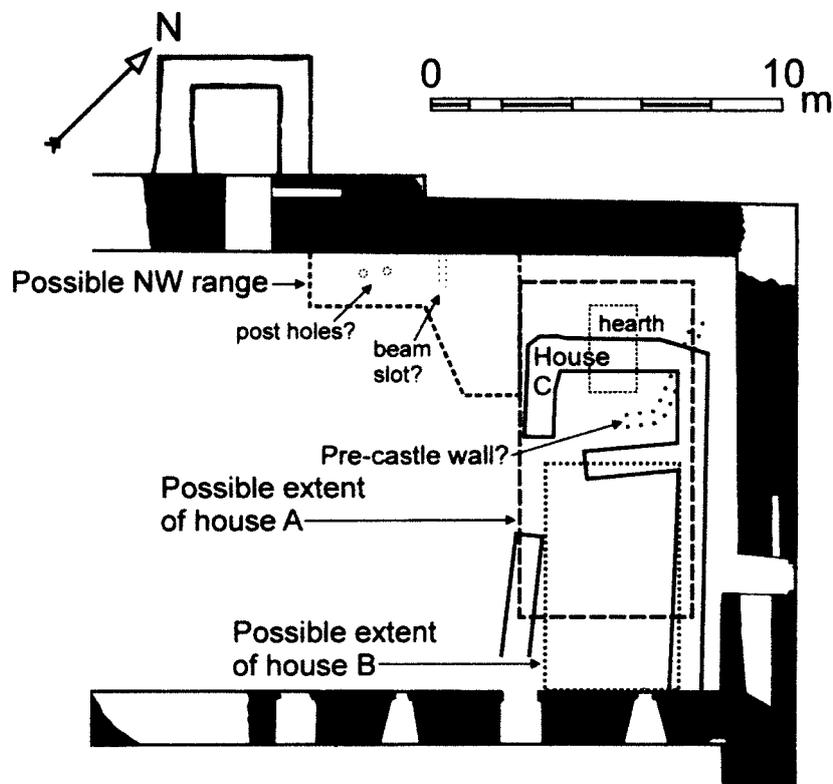
Illus 48 Plan showing traces of medieval structures in the north corner of the courtyard and along the north-west curtain wall

There appears to be more evidence for medieval structures in the north corner and along the north-west curtain wall than DJT's account suggests (Illus 48). The accumulated evidence from Areas III and VI of charcoal (from worked wood), nails and burnt daub points persuasively to rather more substantial structures than he recognised, probably timber-

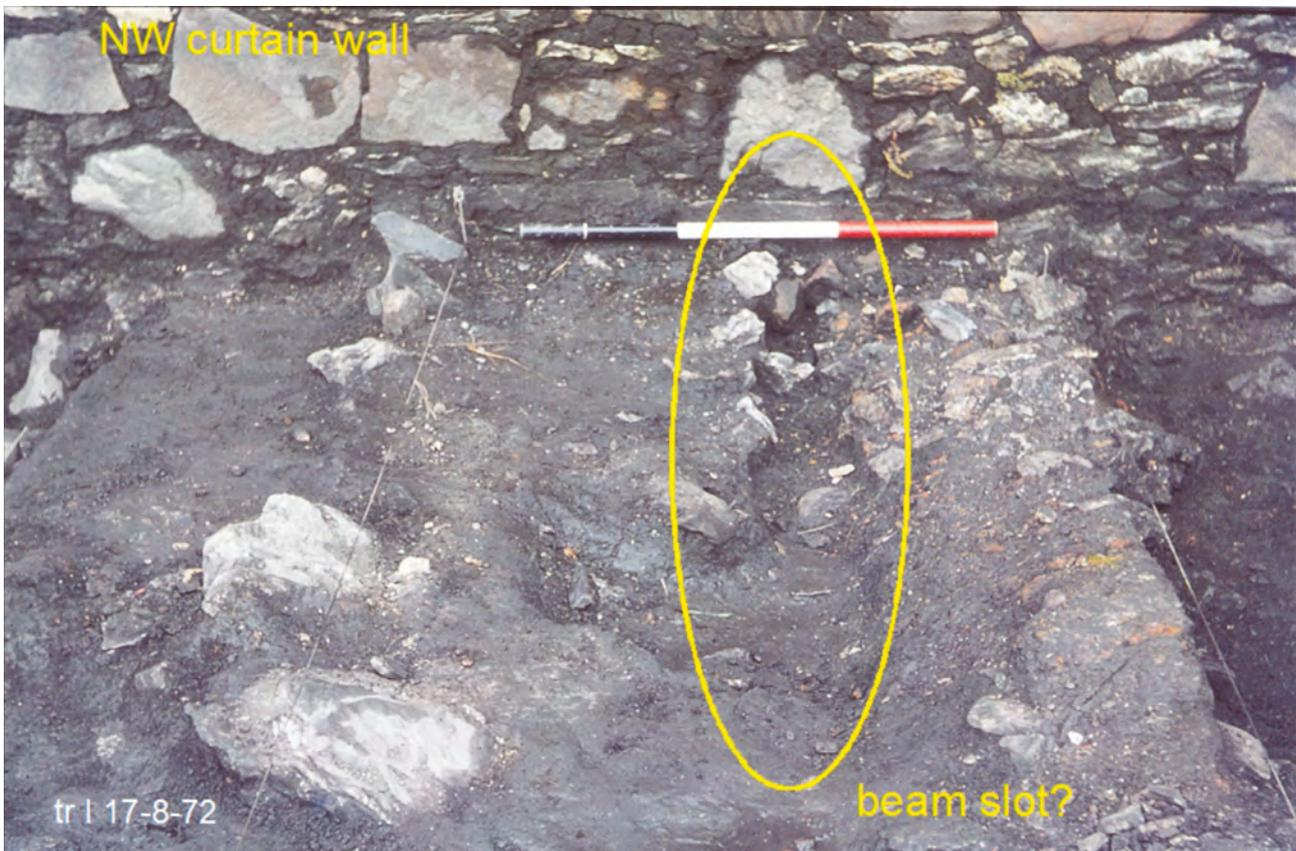
Illus 49 Evidence of a north-west range in Area I

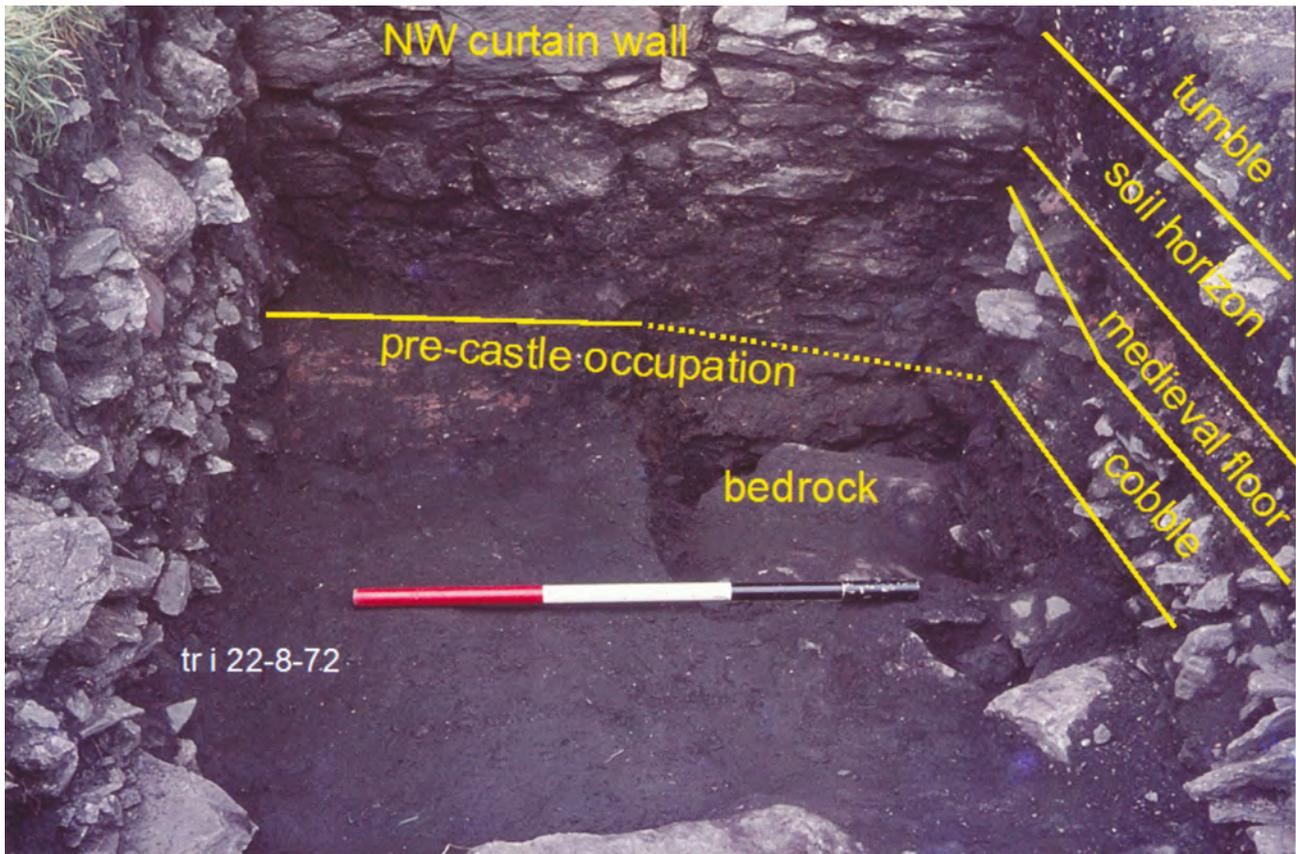
Illus 50 Evidence of pre-castle occupation in Area I

There is an intriguing possibility that DJT actually excavated part of the wall of a pre-castle building, visible in photographs and plans of Area III as an alignment of small earth-fast stones, about 0.3m wide, running approximately north-south before turning east-west. It ran under the north corner of the post-medieval house and appeared to be protruding through the floor of a medieval
