## 2 Introduction *by Gordon Ewart*

The extensive ruins of Dundrennan Abbey lie to the east of Dundrennan village, east of the A711, the road between Dalbeattie and Kirkcudbright (*illus 1*). The abbey buildings occupy an artificially enhanced terrace to the north and west of a sharp bend in the course of the Abbey Burn (*illus 2 & illus 3*). The selection of this site exploited the naturally rising profile of the west side of the valley, as well as the lowest lying area of well drained ground within the valley. The A711 road and the present village of Dundrennan occupy a further terrace upslope from the abbey site, and define the likely maximum extent of the entire abbey precinct. The building in 1874 of the present manse, now a private house with gardens to the north and formerly an orchard to the west, saw the clearance of abbey structures towards the south-west of the complex. These post-medieval buildings towards the southern end of the abbey terrace appear to confirm the viable extent of ground suitable for building, and probably closely echo the

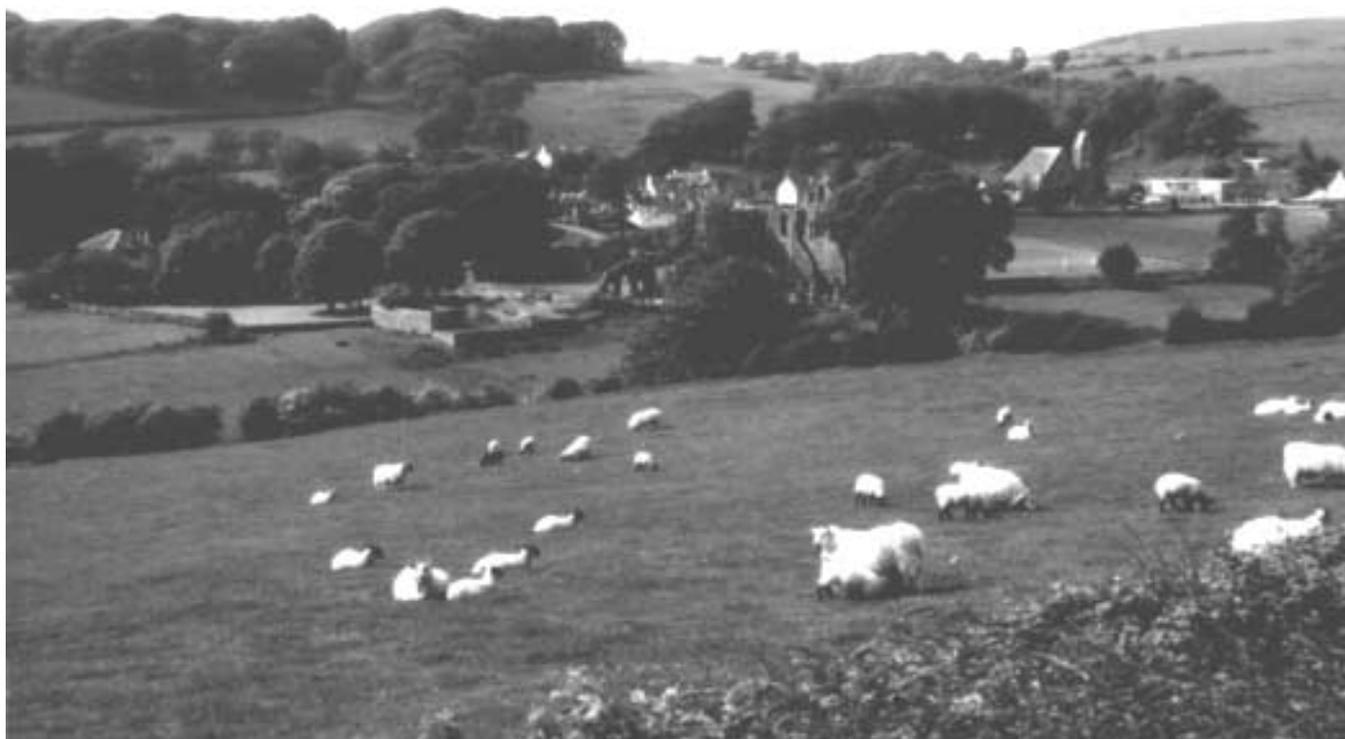
*Illus 2 View of the site from south-east*

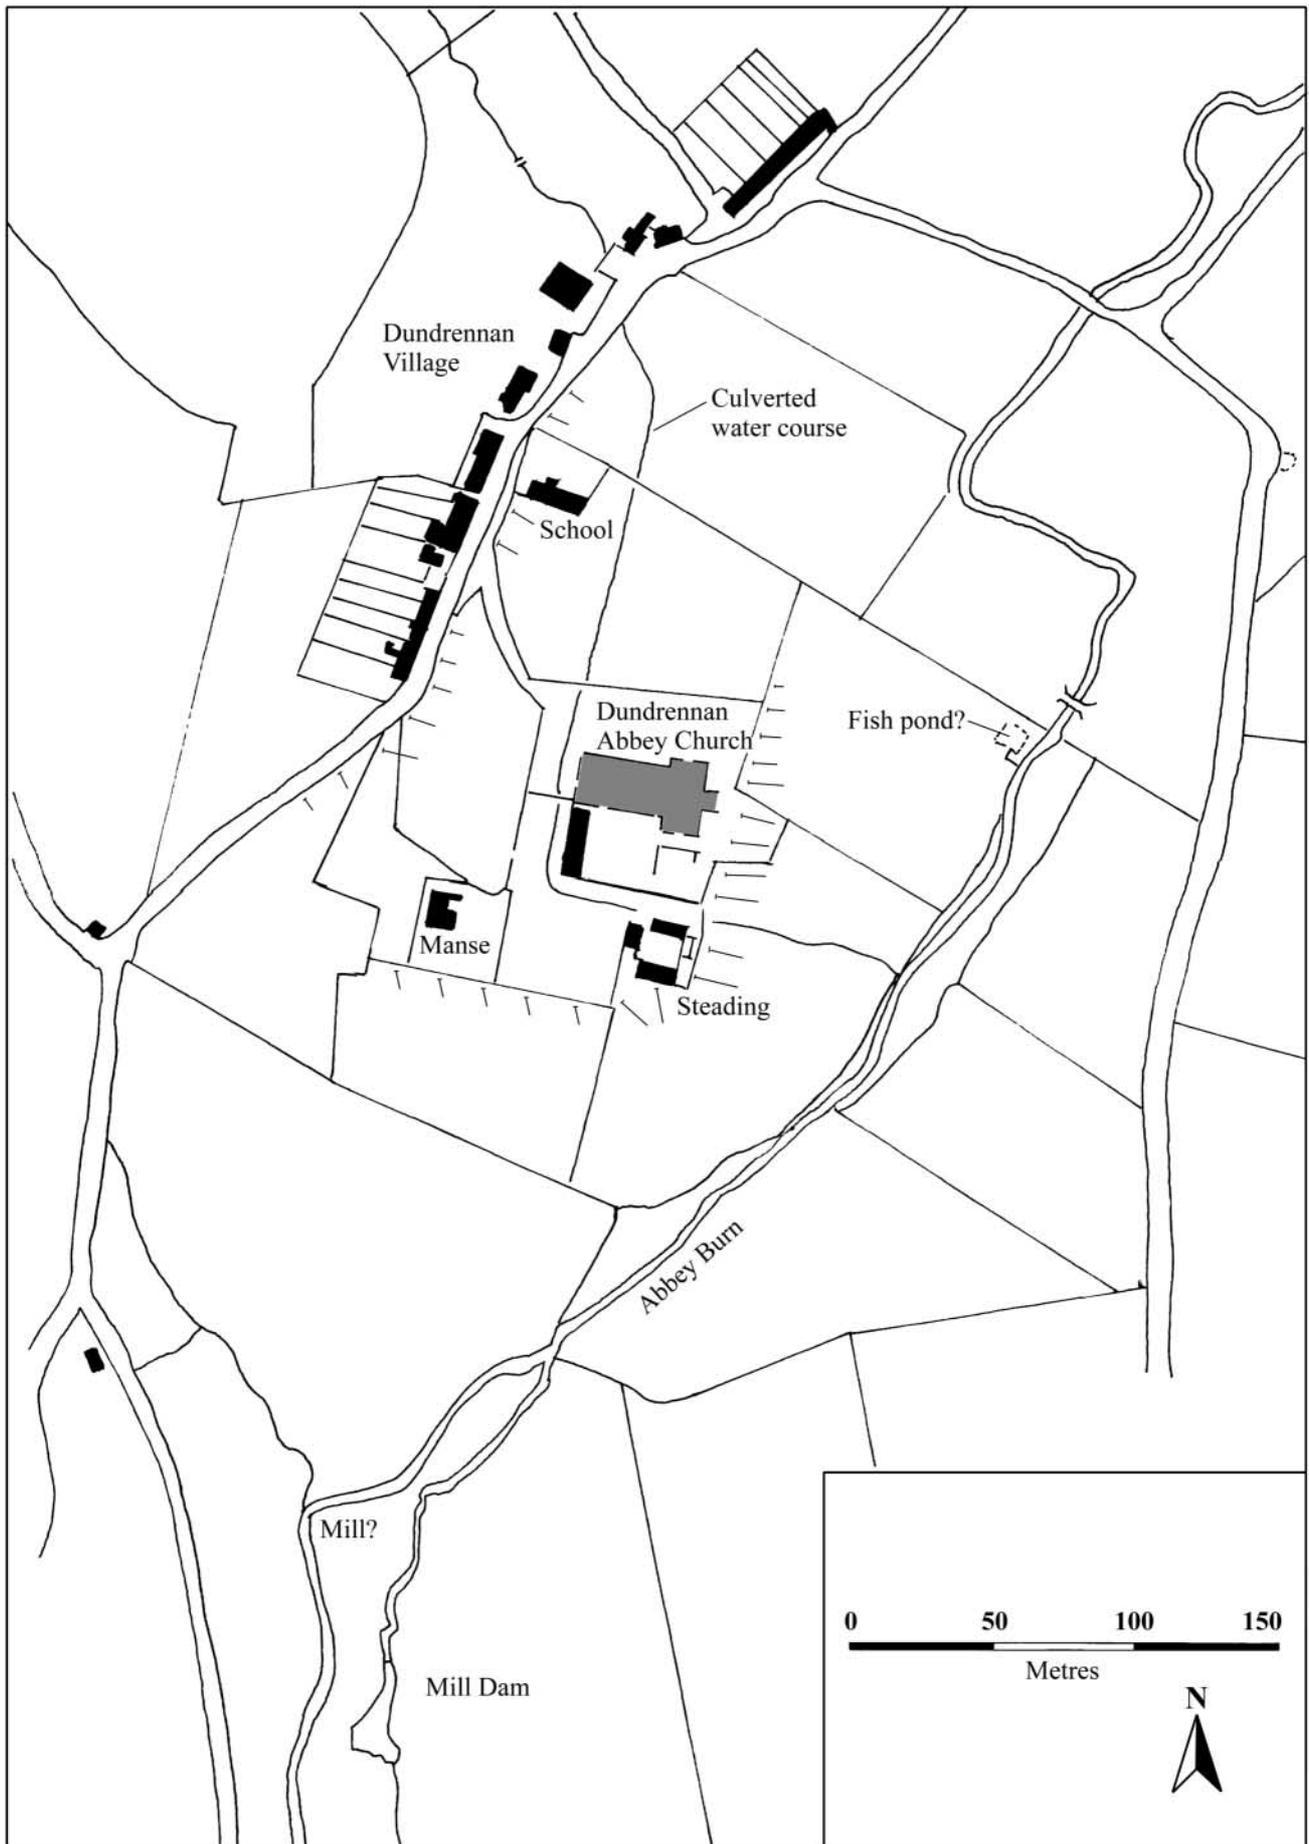
*Illus 3 Dundrennan Abbey and environs (Based on the Ordnance Survey of 1908)*

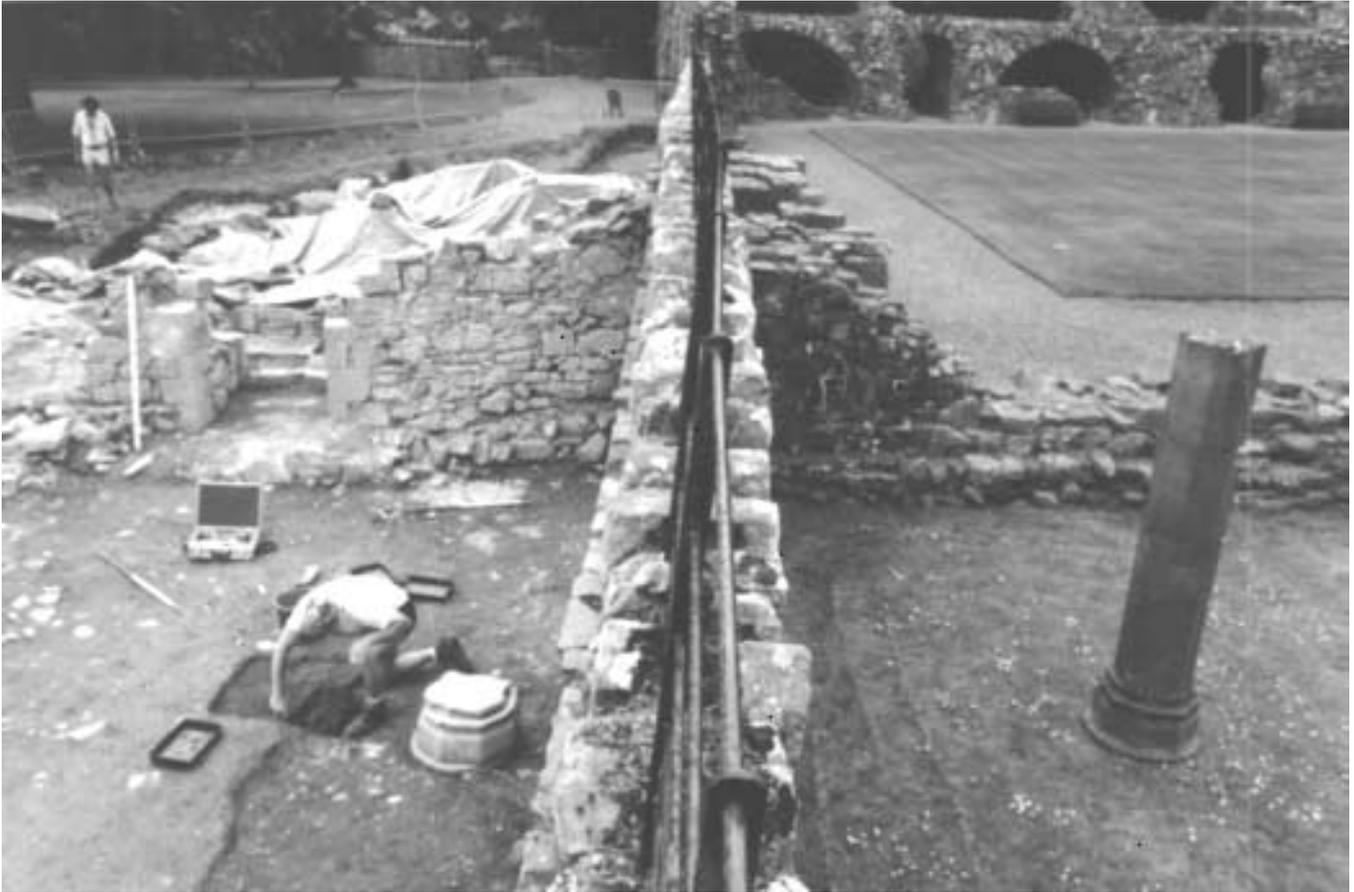
*Illus 4 Room 4 under excavation, from west*

The village and abbey occupy a wide area within the steep-sided valley of the Abbey Burn. Much of the cloister still survives alongside the abbey church, although many of the stone buildings have been robbed for local house building and drystone dyke construction. The south range however, prior to the recent programme of work, was virtually completely hidden, with only the doors from the cloister to the refectory, kitchen, warming house etc being visible within the area defined on the south side by a 19th-century boundary wall separating the manse from the ruined abbey (*illus 4 & illus 5*).

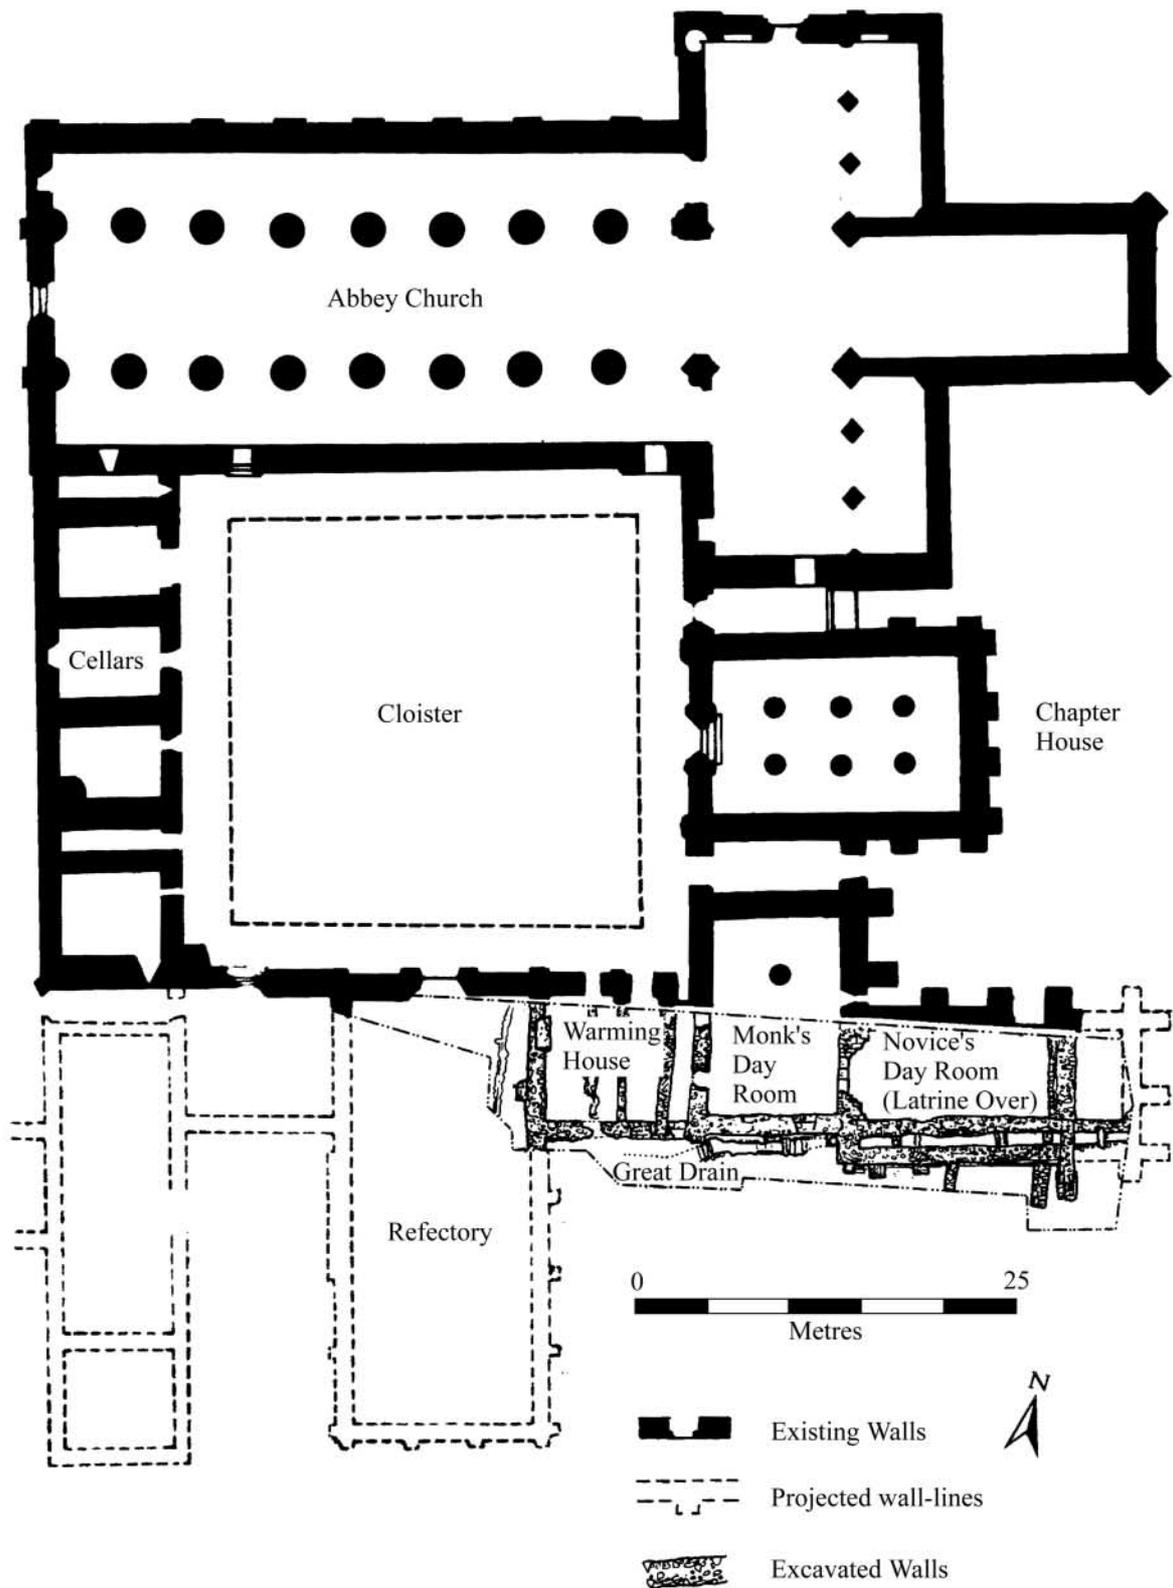
*Illus 5 Principal rooms of the abbey and the area of excavation*
