4 Archaeological stratigraphy *by Gordon Ewart*

4.1 Introduction

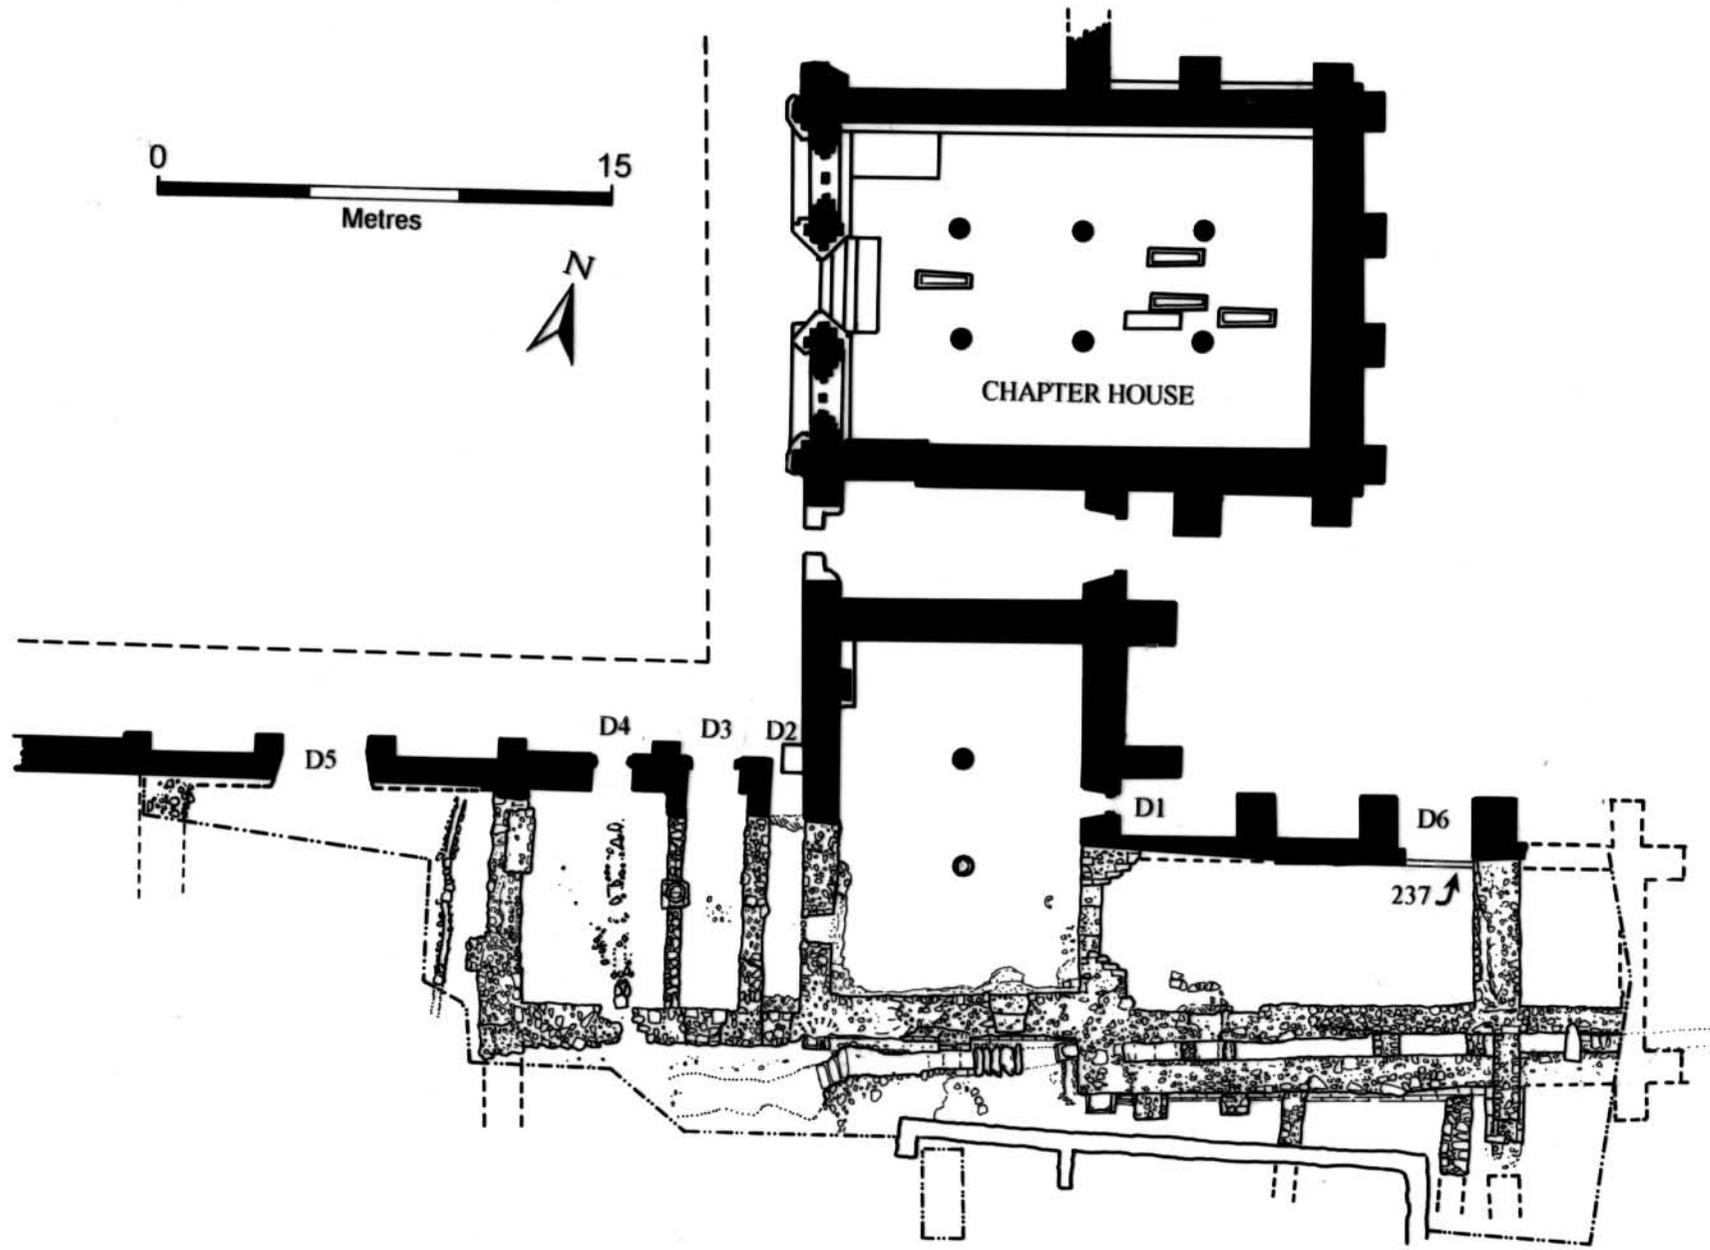
Illus 9 The excavation area, all periods, showing doorways mentioned in the text

Two window embrasures were evident in the north wall, with a doorway (D6 on *illus 9*) lying 2 m further east. The windows were at least 1.2 m wide, with the door being 1.9 m wide internally. All three of these features were later blocked. A further feature, surviving from the primary build of room 5, was a recess or aumbry (context 163) lying towards the west end of the room, within the thickness of the south wall. The recess later suffered structural collapse, and was subsequently reduced in size and blocked (Period III, below). Originally it comprised a well-formed, wide-arched niche, standing above floor level to a maximum height of 1.47 m, and being 1.2 m wide. It was built into the fabric of the south wall (context 169). There were indications that the recess had featured a door or shutter, in the form of a bolt-hole surviving in its west side. The modifications enacted on room 5 during Period III (below) obscured the general plan of the Period II building, but it is likely that the north windows and doorway were complemented in the earlier phase by a further window at the east end of the chamber. Thus, there would have been a symmetrical series of embrasures which were generously proportioned internally, offering good light within the room.

Room 1 was formed by a partition wall (context 003) within former room 10, incorporating the Period II pillar base (context 040), and creating a chamber measuring 4.76 m by 6.66 m. At this time the Period II drainage channel (context 051) was recut to form a stone-lined channel (context 022) measuring 380 mm wide by 280 mm deep, running straight out towards the new cloister doorway (D4 on *illus 9*).

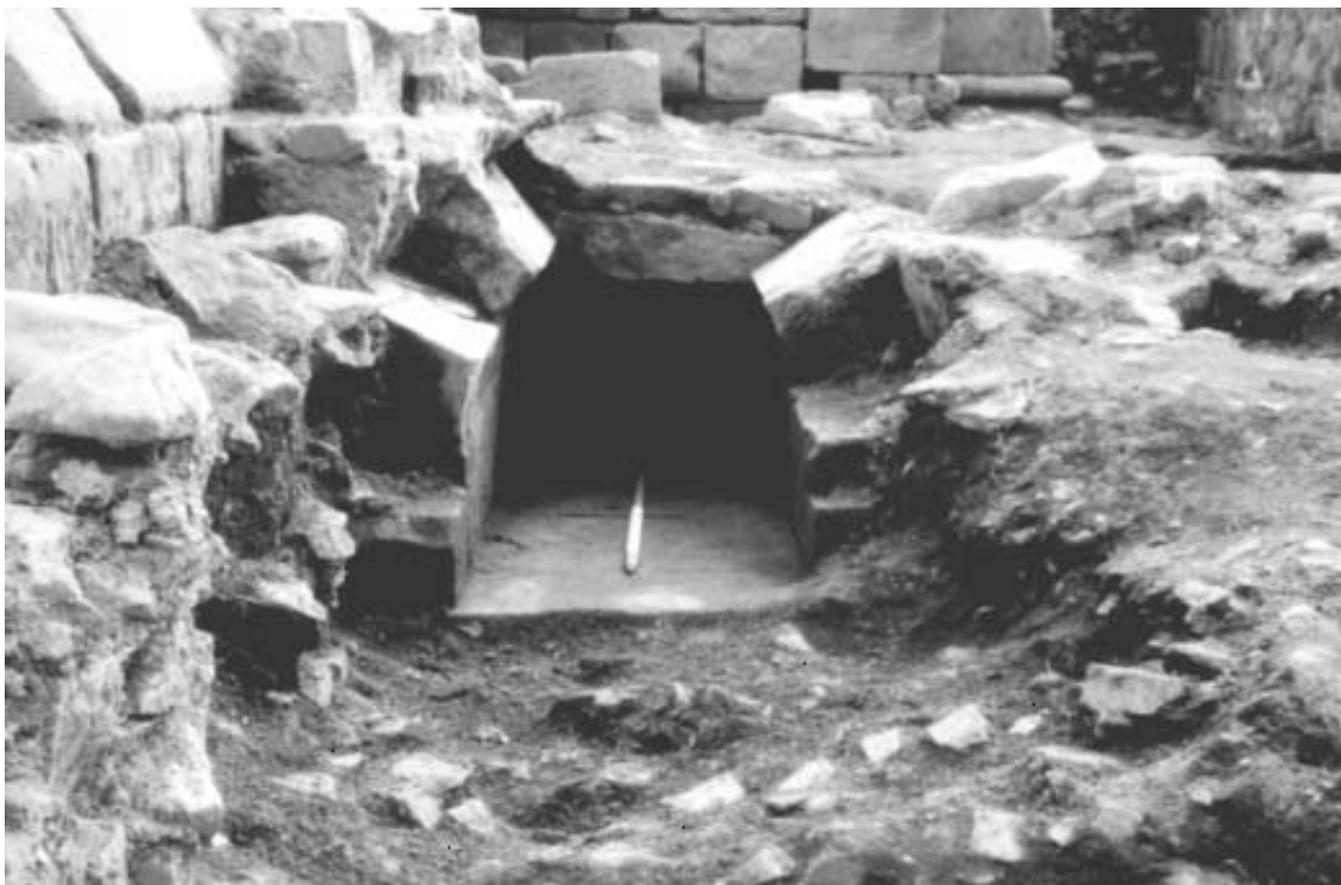
Illus 11 The great drain below a buttress (context 056), from east

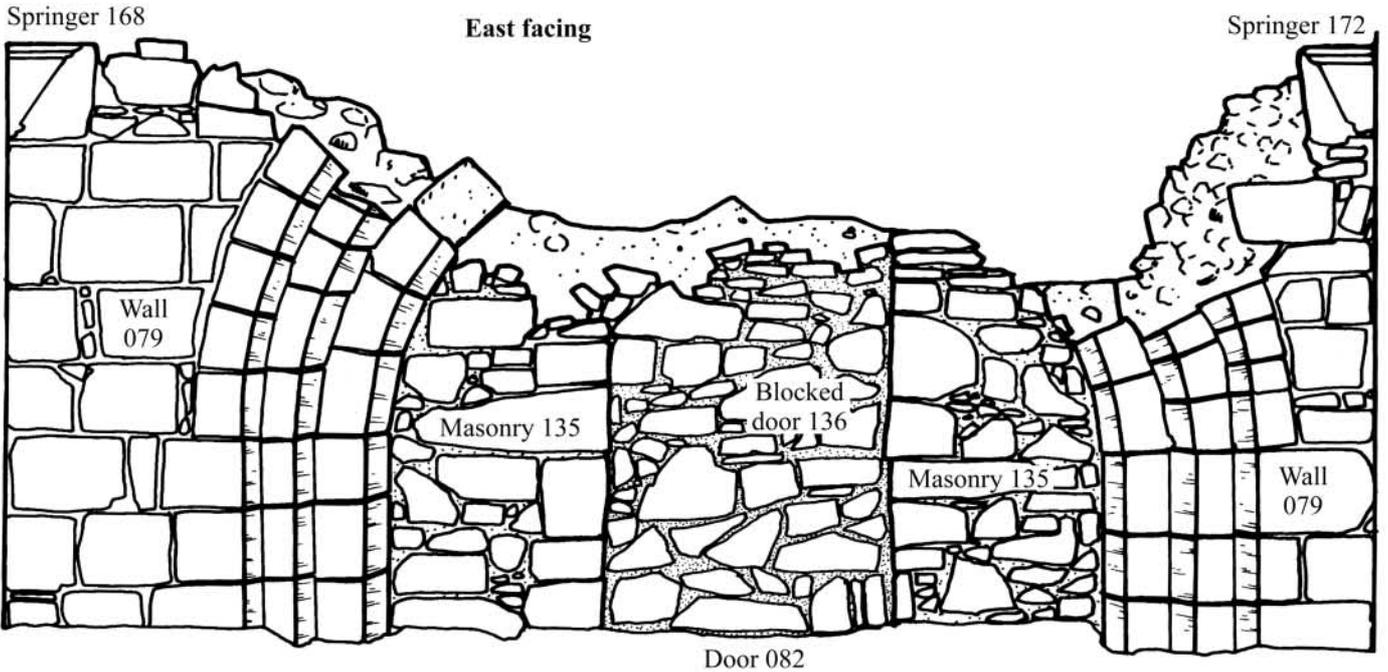
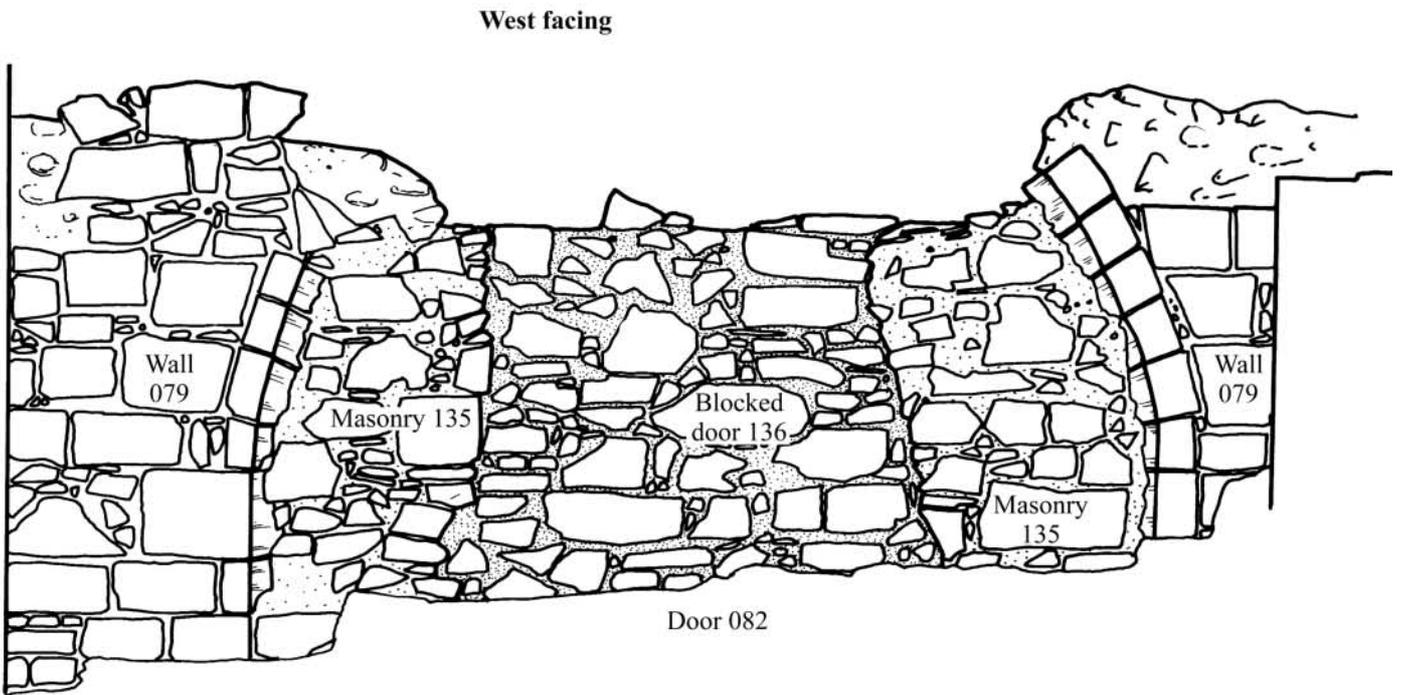
Period II - Contexts 079, 082, 168, 172
Period IV - Context 135
Period V - Context 136

Illus 14 Elevations of the west door, room 5/6

The ceiling comprised four rib-vaulted bays, springing from the corners of the room and wall faces. The majority of the rib vault fragments found during the excavation came from this room (see 9. Architectural fragments). Only two of the finely-carved springers located at the north-west and south-west interior corners of the room remained *in situ* (contexts 172 and 168 against west wall 079; see also *illus 14*).

The west arch in room 6 was reduced in size by the addition of masonry (context 135 on *illus 14*). The remaining opening measured 1.1 m in width, an appropriate size to receive a door. This appears to demonstrate how, for the first time, the open access between rooms 4 and 6 was removed, suggesting that separate functions were now served by these once closely-linked chambers.

As part of this general blocking of doors and windows, it is likely that the reduced Period IV doorway (context 135 on *illus 14*) was sealed completely at this time by inserted masonry blocking (context 136), restricting access to room 6 to the Period II north door alone.

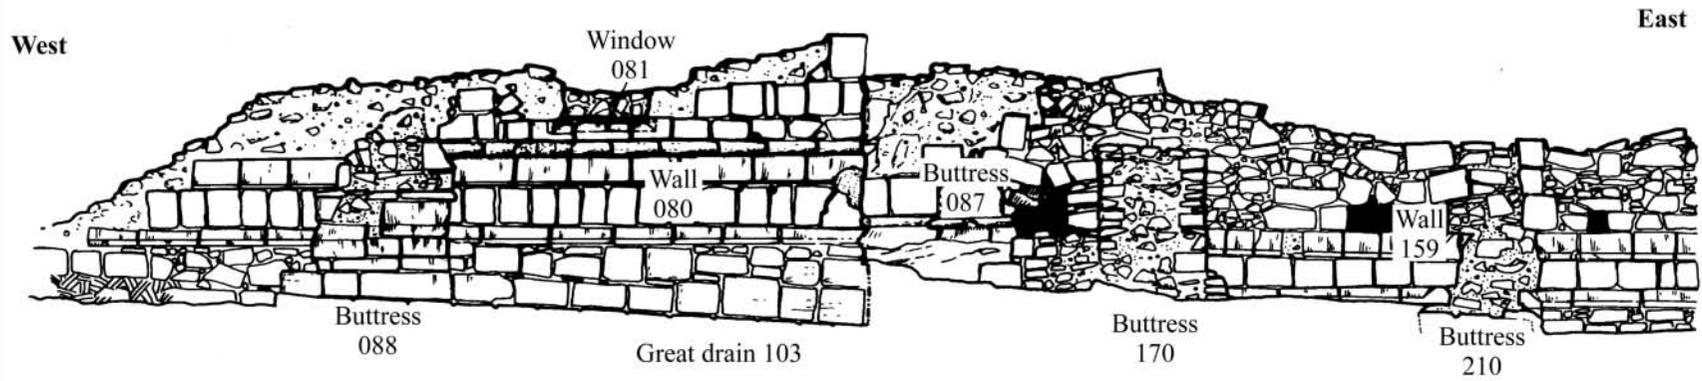
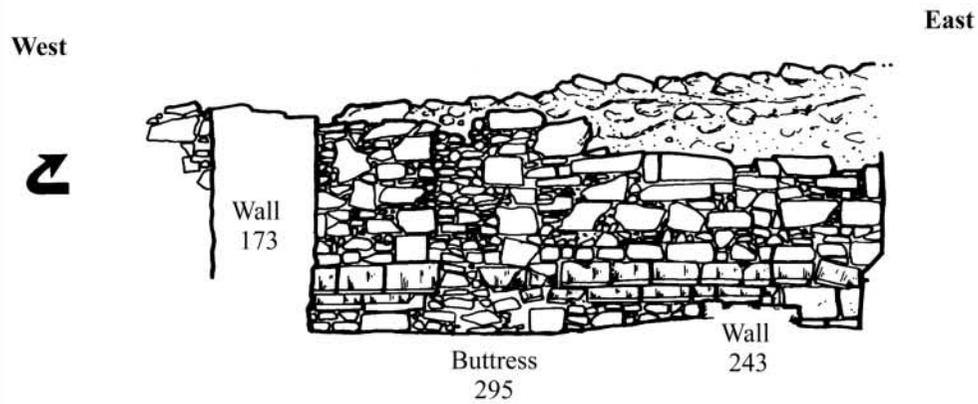
Period I - Context 103
 Period II - Contexts 080, 081, 087, 088, 159, 210 & 295
 Period III - Contexts 170, 173 & 243

Illus 17 Elevation of the south façade of the room 4 and room 5/6 complex

A single window embrasure (context 081; see also *illus 17*) survived in the south wall, possibly one of a pair, the western equivalent having been removed in the general robbing of that part of the wall. As excavated, window 081 had clearly been modified and ultimately blocked, but as laid out originally it formed a splayed opening, expanding inwards, varying from 1.03 m to 1.39 m in width. The primary work for the window could be distinguished from later blocking, being of superior construction, and featuring the same well-tooled sandstone details noted in door 013. The likely double-windowed plan for the south wall of room 4 was also implied by the position of buttress 088 (see also *illus 17*) which was located centrally along the south face of wall 080. The windows were likely to have been symmetrically

This remains of this chamber was almost completely robbed and were also obscured by the building of the manse. The chamber was represented archaeologically by its west and east walls (contexts 173 & 243; see also *illus 17*), which were built against the outside face of room 6 and the latrine block. The walls were characterised by their crude build, and also by their distinctly oblique alignment when compared with the general plan of the Period II structures (they lay slightly north-east/south-west in alignment). The chamber was comprehensively damaged by the construction of the manse stable yard so that no internal floor deposits survived, nor was there any indication of access to the building. The surviving walls defined a structure less than 5 m wide, and it is possible that room 12 was intended to supplement the reduced space within the latrine block in some way.

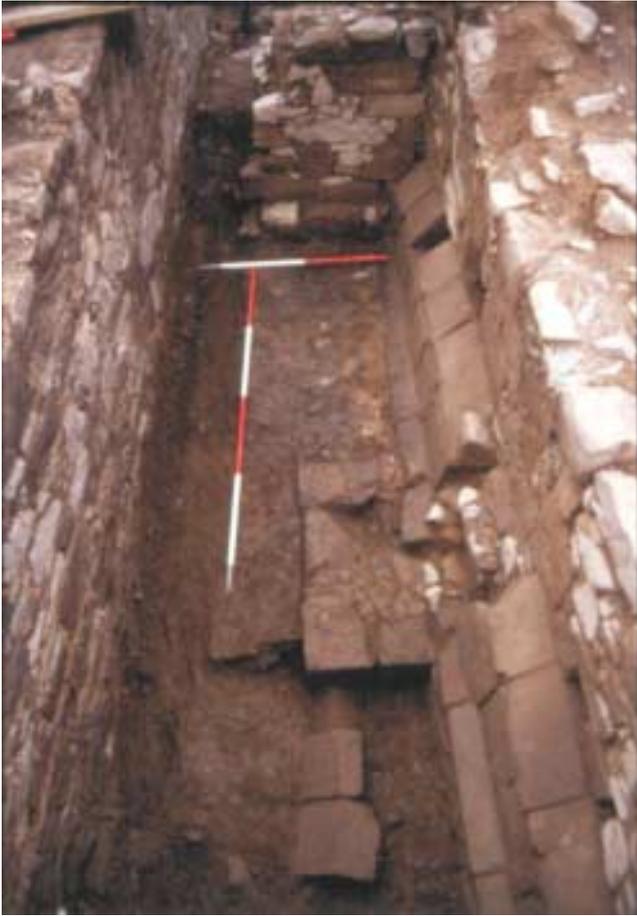
Illus 18 The south wall of room 5/6, showing Period II and III buttresses

Only two of the Period II south buttresses were revealed in plan (contexts 087 and 210) and both would be replaced by larger structures during Period III (contexts 170 and 173, *illus 17*). The scar of a third buttress could also be seen in the south elevation (context 295 on *illus 17*) and probably belongs to Period II. These buttresses were relatively light,

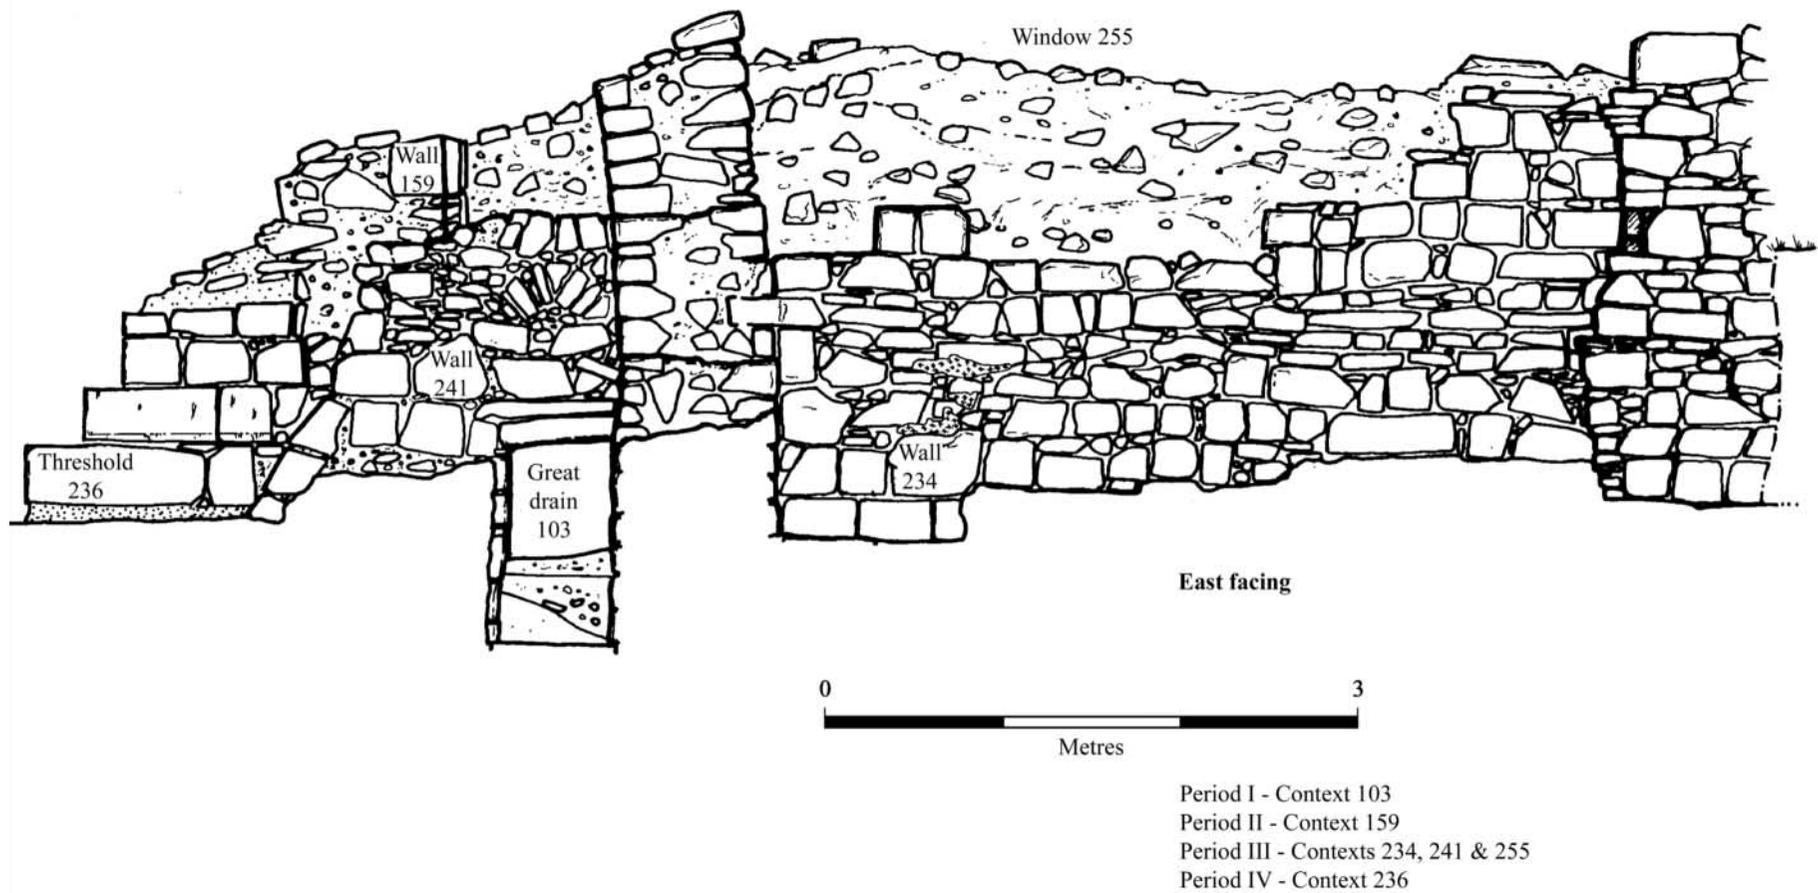
Illus 19 Elevation of the east-facing end-wall of Room 6

The need for capping, together with the remnants of a floor and threshold (context 236 on *illus 19*), are all probably best seen as evidence of a crude building (room 7) abutting the extreme south-east corner of the latrine block, possibly a timber lean-to structure. The presence of the threshold at least indicates that this was a roofed building and that access was from the west side, though the gap between this building and room 12 was very narrow, being only 1.1 m wide.

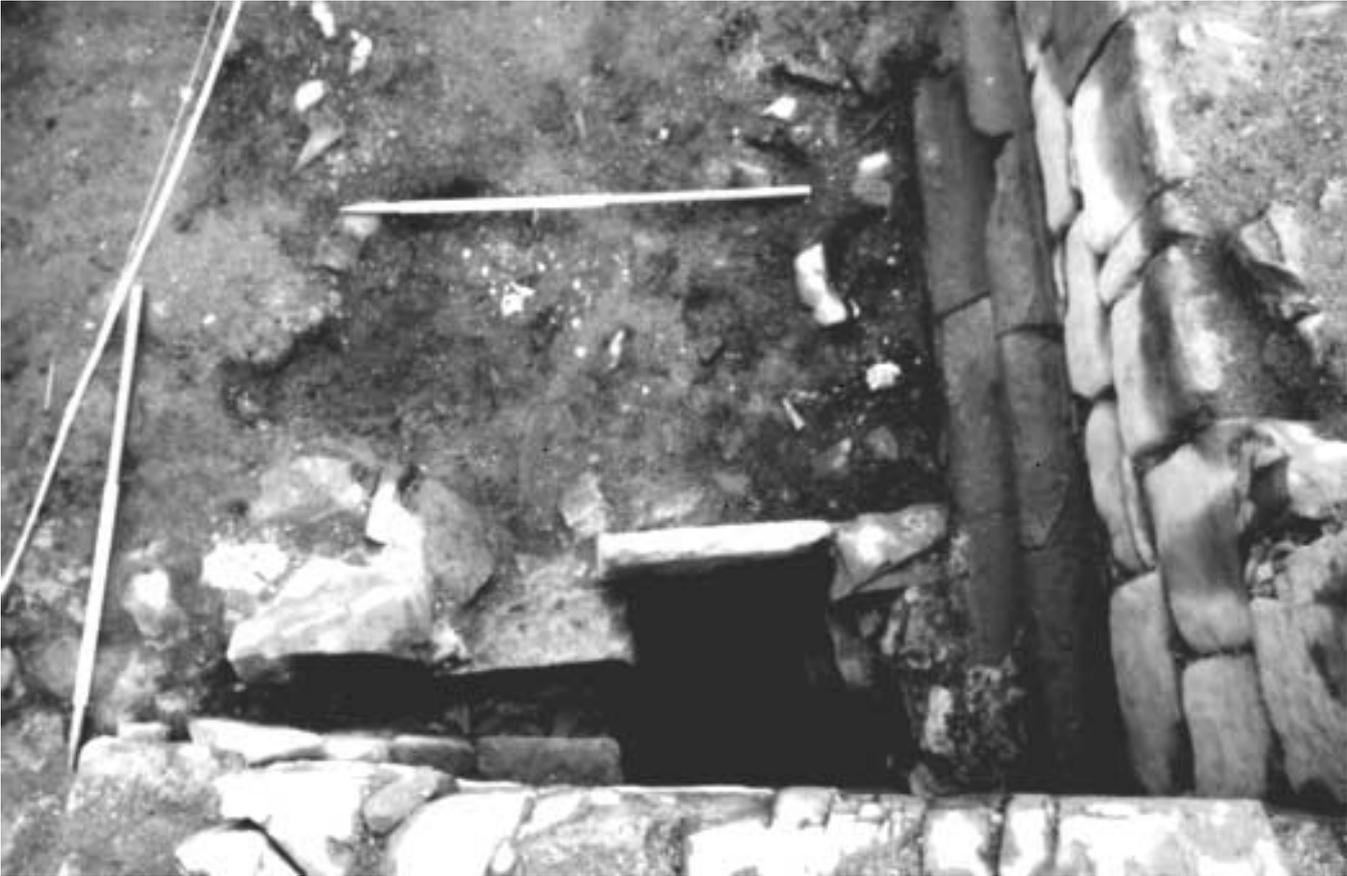
Illus 22 Period IV garderobe (context 089)

garderobes with associated pits. Of the two garderobes, one (context 089) was located towards the external junction of the south wall of room 4 with the west wall of room 6. The feature comprised a circular hole cut through a single block, over an angled

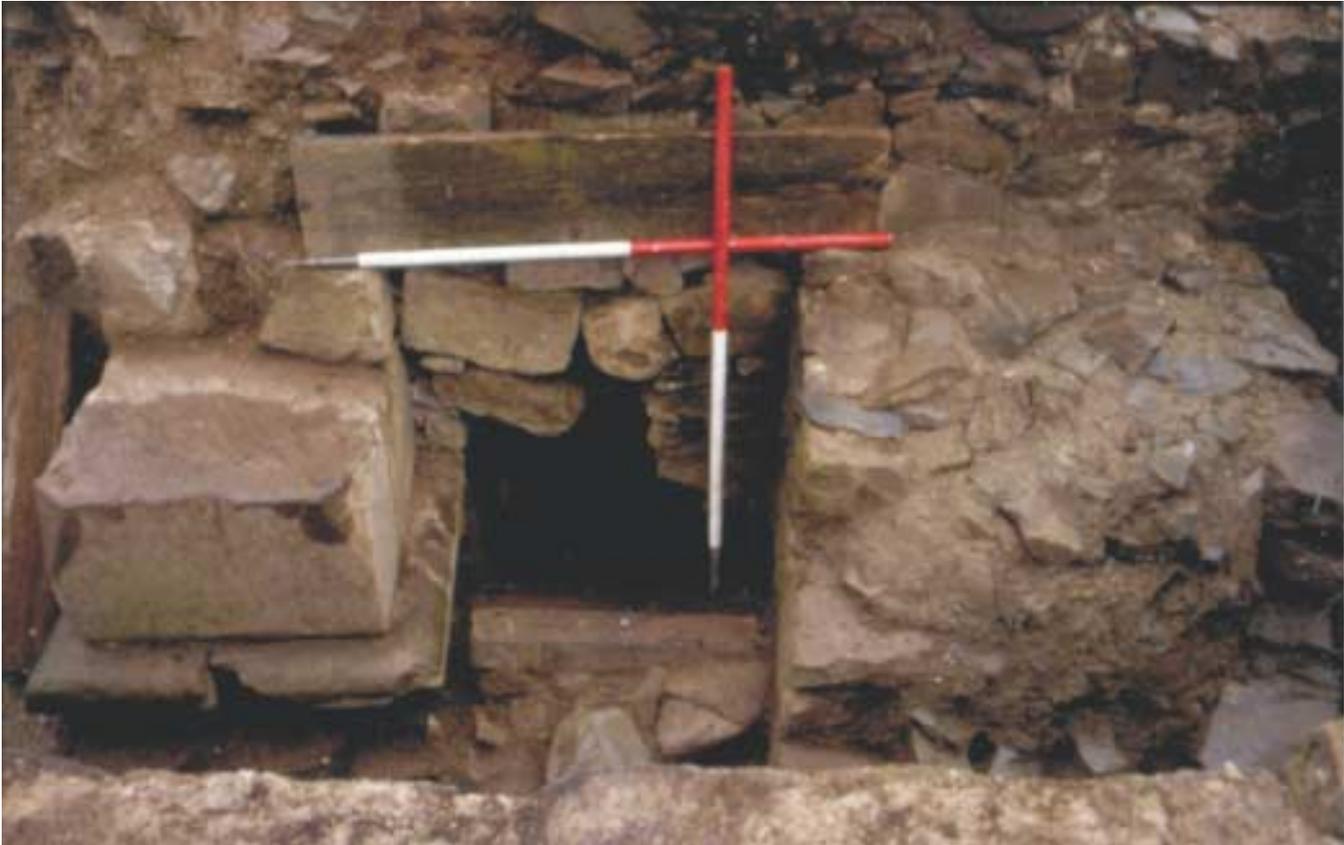
Illus 23 Period IV garderobe (context 090)

base, emptying into the great drain from the west. Crude pitched slabs formed a simple drain into the pit from the south. The second garderobe pit (context 090) was located between two Period II buttresses 088. It comprised a single rectangular shaft over an angled base, emptying into the great drain from the south. Both garderobes were marked by the re-use of older masonry fragments in their construction, and both seem to have served the first floor chamber above room 6. This implies that two discrete privies were in use, located towards the south-west corner of the upper chamber, the communal latrine stalls of Periods II–III now having been sealed over. It is also likely from this point onwards, up to the abandonment of the abbey, that the flow of water into the great drain at the extreme south-east corner of the site was not necessarily constant, if indeed any water now flowed through the channel at all. Water-borne silts were in evidence in the drain fill, along with material washed from the demolished structures above. Thus, the infill of the drain in the vicinity of the garderobes was probably periodically dug-out, rather than being flushed out by water in the drain. The last *in situ* garderobe fill was localised and quite distinct from the general mass of water-borne material both above and below it. Some of this type of material may well have formed part of the primary dumping over the nearby drain covers.

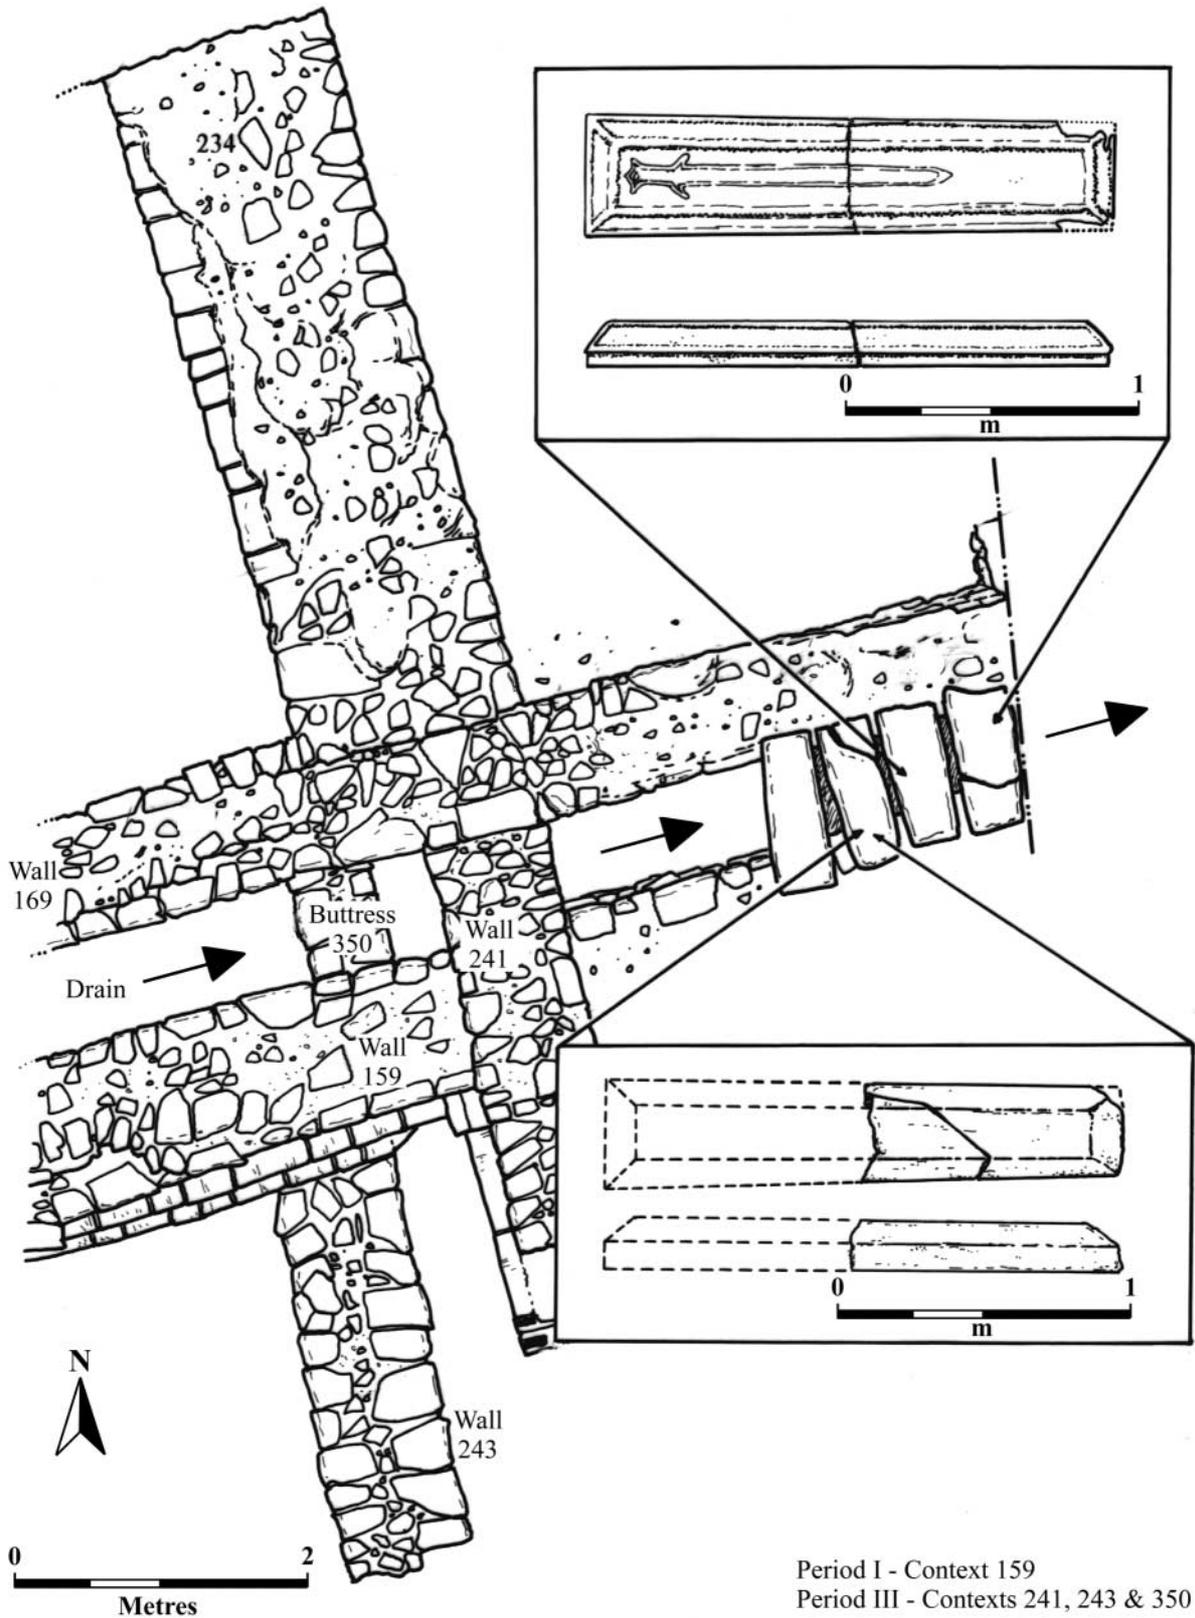
Illus 24 Re-used grave slabs over the great drain

After the realignment of the east wall of the latrine block undercroft in Period III, the easternmost 4 m of the Period I great drain no longer featured as part of the latrine complex and was reduced to being a simple drainage channel. At this stage the capping of this section of the drain was introduced, partly laid over a spread of occupation deposits which lay to the south of the drain channel. Significantly, the capping for the drain was formed primarily by broken grave slabs, recycled from the adjacent monastic graveyard. One of these slabs, which was broken in two to form part of the drain capping, featured a finely-carved sword motif (*illus 24*). Evidently, high-status graves in the abbey were being robbed of their grave slabs as a convenient material for more basic uses elsewhere.

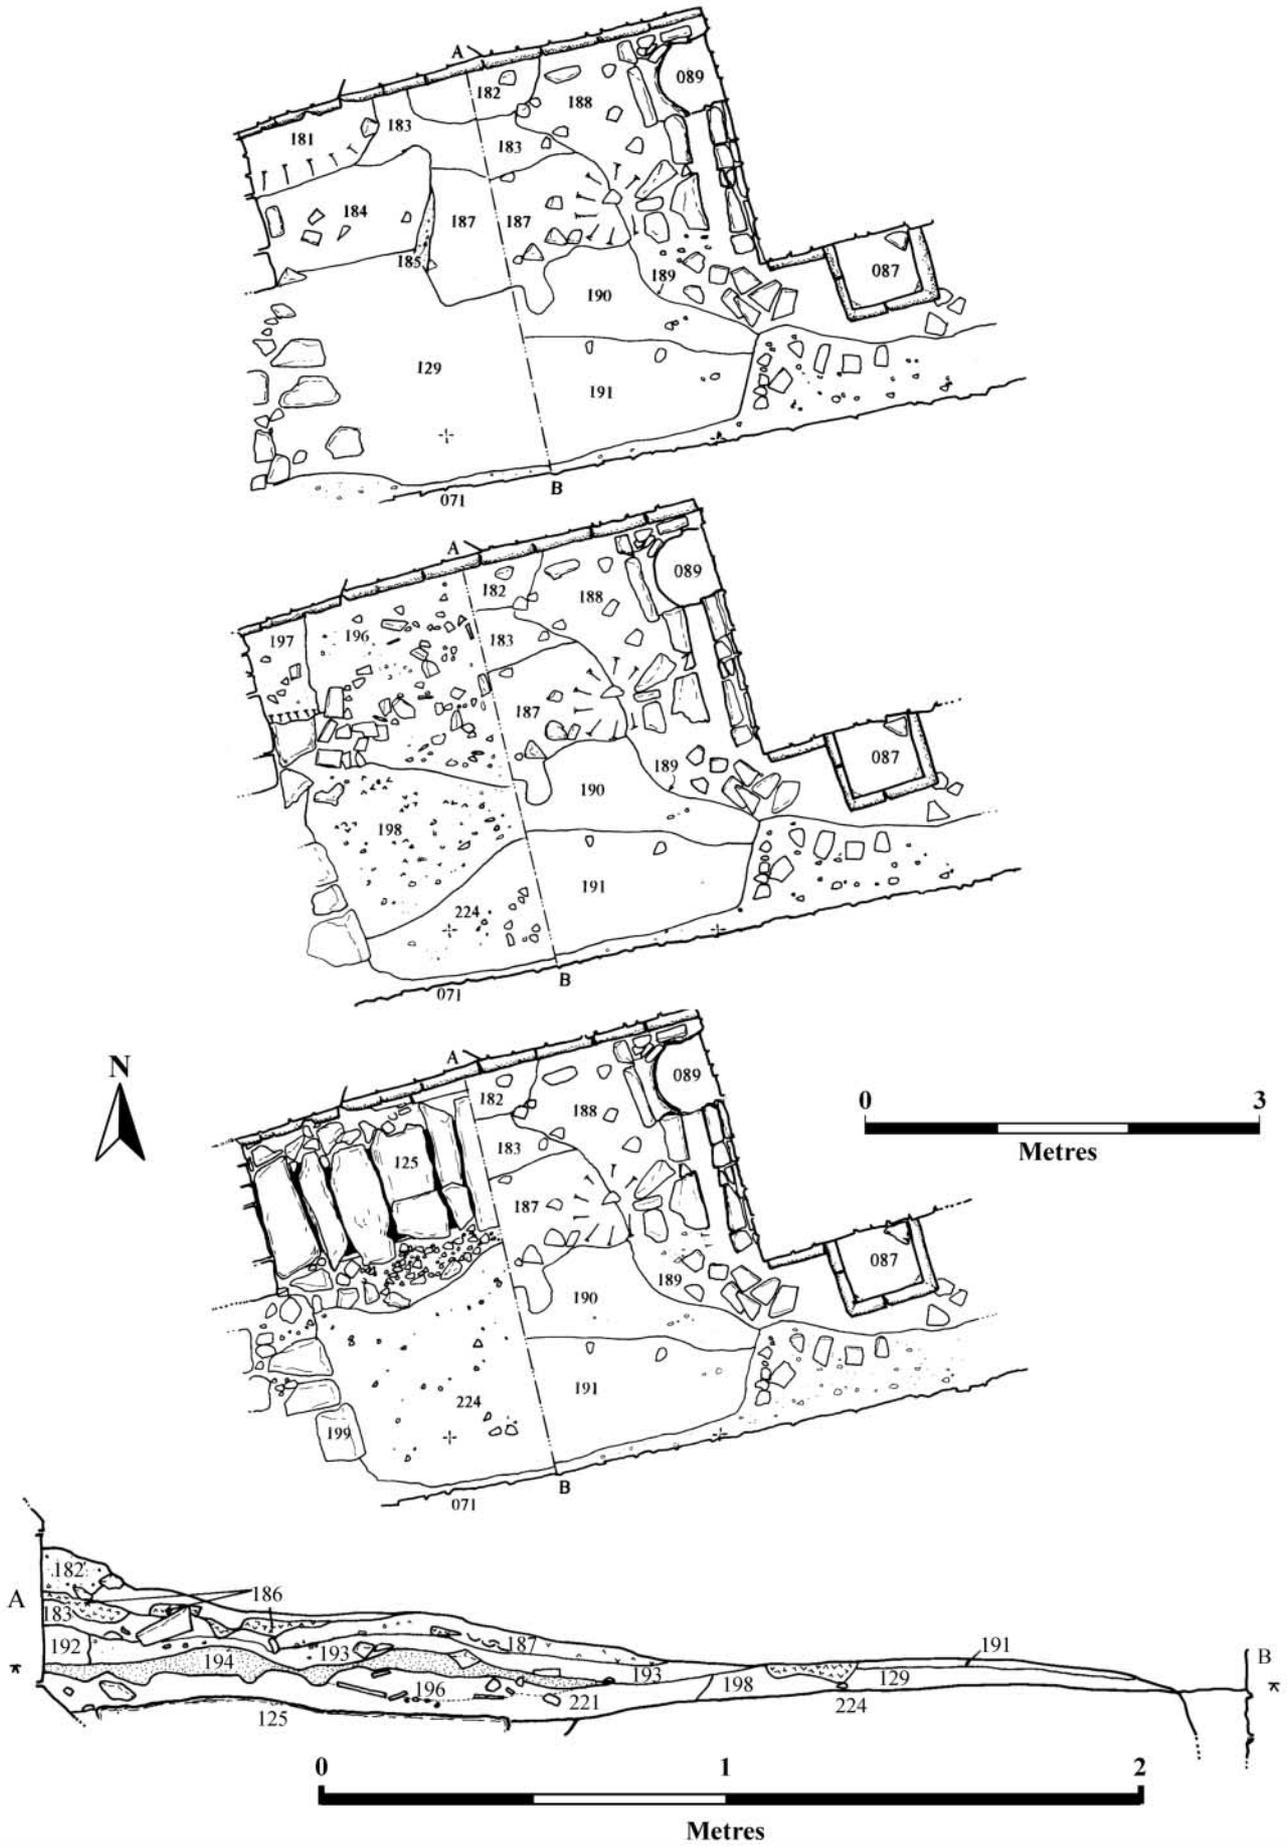
Illus 27 Midden group, plans and section

4.7.1 Middens (*illus 27*)

The drain capstones were bedded in recycled drain fill (context 222) and were sealed by two main groups of deposits. The primary group (contexts 196, 197 & 198) all featured peat ash and animal bone mixed with increasingly clay- and mortar-rich spreads towards its upper surface. The primary series of dumps were in turn sealed with a spread of roof slates set in gravel (contexts 194 & 195). The later sequence of dumping featured increasing amounts of peat ash and charcoal as well as large

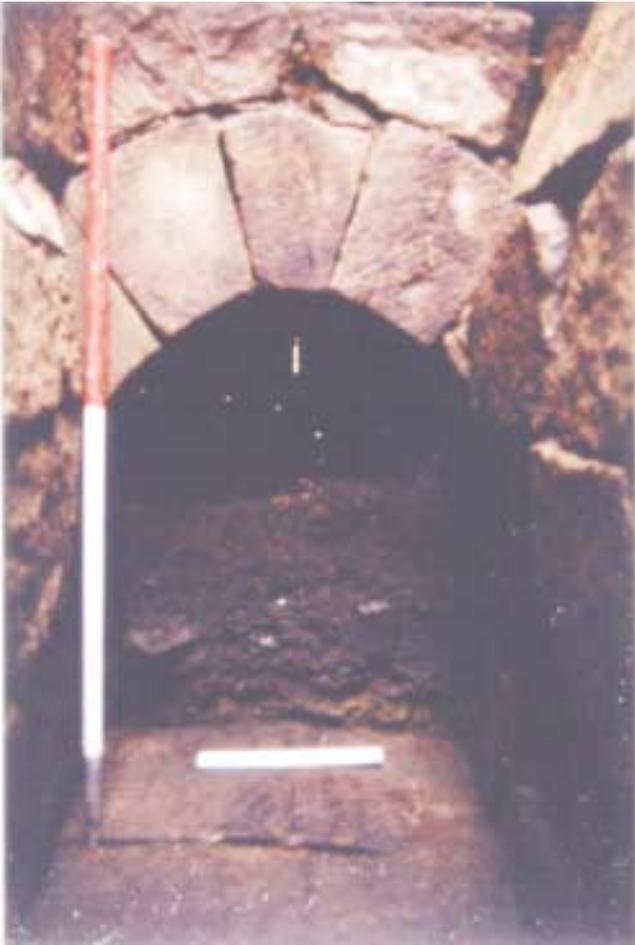
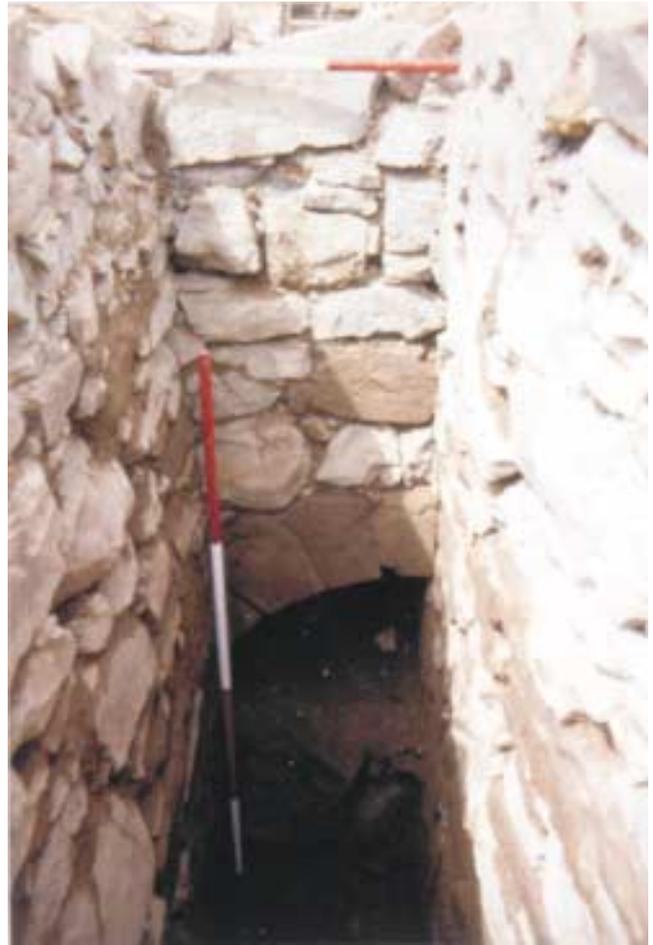
Illus 28 (top left) Great drain fills

Illus 29 (top right) Great drain fills

Throughout the drain, the basal fills were generally similar sand- and gravel-rich water-borne deposits. These in turn were sealed directly at the east end of the drainage channel by rubble collapse. However, at the west end of the drain there was a distinct, almost peat-like sediment both overlying and sealed by more typical water-borne material. This sequence appeared to be the result of an accumulation of waste, probably associated with the use of the nearby garderobes (contexts 089 and 090), between intermittent periods of freely running water within the drain. The suggestion of periodic flooding is confirmed by the evidence of the detailed environmental analysis of drain fill samples, where soil conditions, plant species and insect remains suggest occasional inundation rather than consistent water flow.

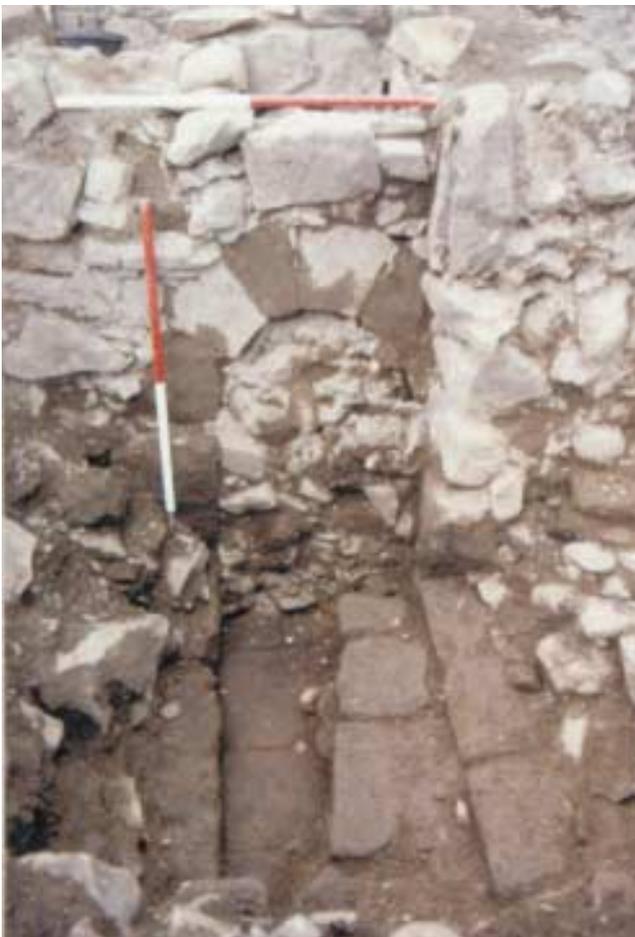
Illus 30 (lower left) East end of the great drain, before excavation
