## 3 Results by John A Lawson and David Reed

### 3.1 Phase 1: Construction of the Flodden Wall (early 16th century)

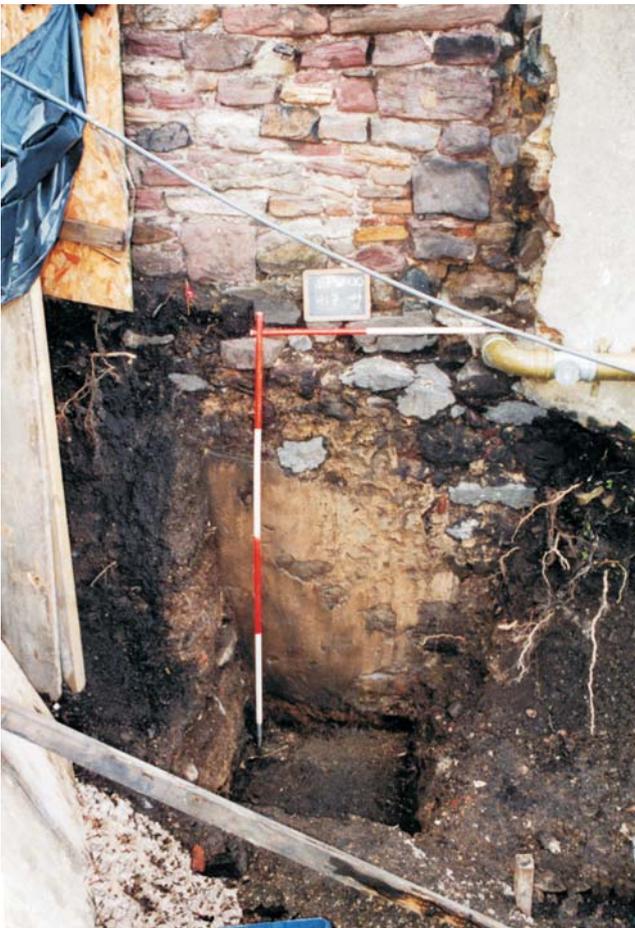
*Illus 6 West-facing elevation of the Flodden Wall and the Phase 2 & 3 walls, showing Test-Pit C*

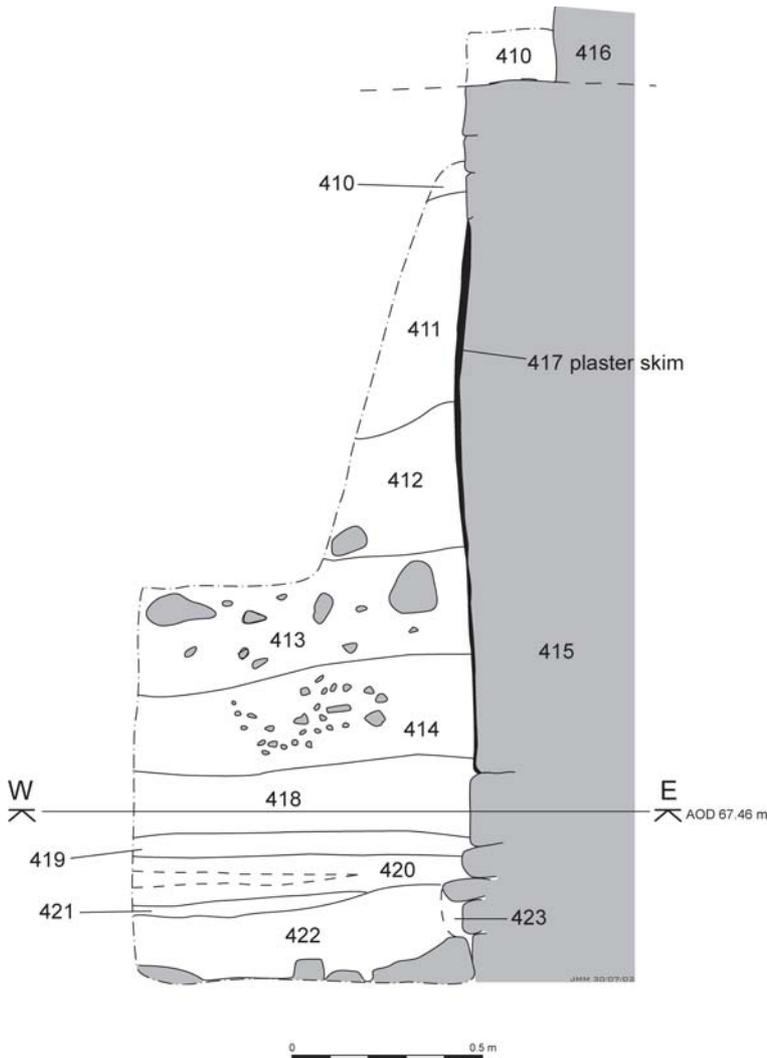
*Illus 7 Test Pit C: south-facing section (context 415: Phase 2 rebuild)*

Within Test Pit C the foundation trench (context 423) for the 18th-century rebuild of the Flodden Wall (wall 415) was identified as cutting an earlier deposit of dark pink-brown clay ([Illus 7](#), context 422). This layer contained both midden material (animal bone and oyster shell fragments) and quantities of rubble. The rubble comprised large angular sandstone and igneous blocks similar to those used in the construction of the Flodden Wall. Although no dating evidence was recovered, the stratigraphic evidence indicates that this layer formed the outer ground surface contemporary with the Flodden Wall.

yellow-cream in colour and containing noticeably fewer quantities of sand and grit inclusions. Wall 415 was also narrower than the earlier Flodden Wall (501) averaging 0.80m in width in comparison to 1.10m for Wall 501. The narrow foundation trench (context 423) for wall 415 was identified within Test Pit C (Illus 7), cut into the underlying ground surface (422) that had built up against the Flodden Wall (501).

A uniform levelling layer (Illus 7, context 421) of hard pink-brown, sandy-clay was deposited

overlying the irregular surface ground surface 422 to the west of the Flodden Wall, prior to the construction of the later 18th-century building associated with wall 415 and plasterwork 417 (described above). Overlying this layer was a 0.13m thick bedding layer (420) for mortar floor 419. This deposit consisted of a firm dark grey-black, sandy silt containing lenses of sandy mortar and also contained artefacts dating to the 18th century. These included 'hand-made' brick fragments, pottery, clay pipe stems, a fragment of window glass and an undecorated copper-alloy button (finds analysis throughout by John A Lawson). Context 420 overlay both the foundation trench for the rebuilt wall 415 and the clay levelling deposit (421). A 0.07m deep floor surface (419) comprised of a hard, friable, cream-coloured lime mortar was subsequently laid over the bedding layer and abutted the internal wall-surface 417. Also contained within the floor surface were lenses of coal, charcoal and coal ash.

The sequence of demolition/construction and levelling deposits associated with the creation of Granny's Green was recorded within Test Pit C (Illus 7). Overlying the Phase 2 mortar floor 419 was a compact deposit of dark grey-brown, silty-sand containing coal and ash and numerous artefacts (context 418). The artefacts included fragments of 18th–19th century pottery and clay pipe stems, a fragment of window glass, fragments of pantile, animal bone and a copper-alloy circular button. Overlying context 418 and also abutting the Phase 2 plaster rendering (context 417) was a 0.20m depth of loose, cream coloured, mortar fragments and rubble (context 414). Context 414 contained three 19th-century clay pipe stems (one stamped 'Burns of Leith') and one bowl ('Thomas White of Edinburgh', date-range 1867 x 1880s).

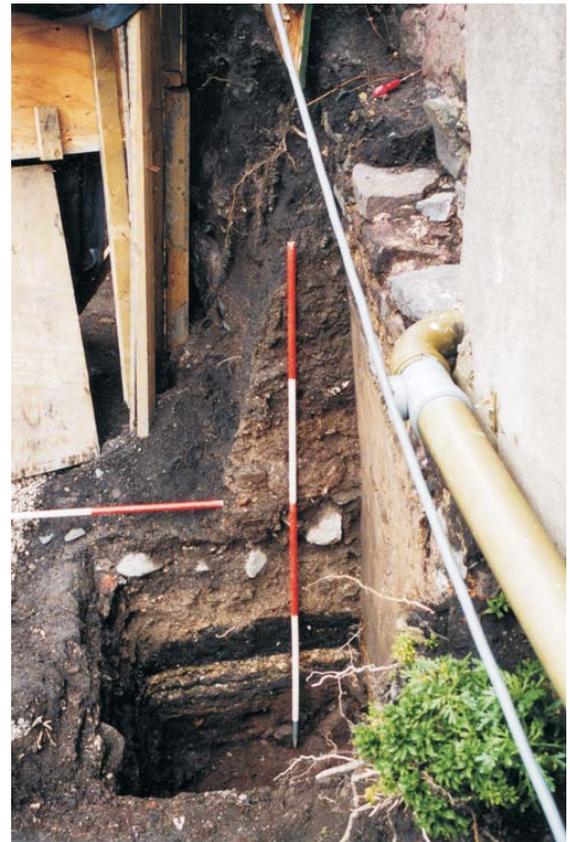
*Illus 8 South-facing section of Test Pit C, same view as Illus 7*

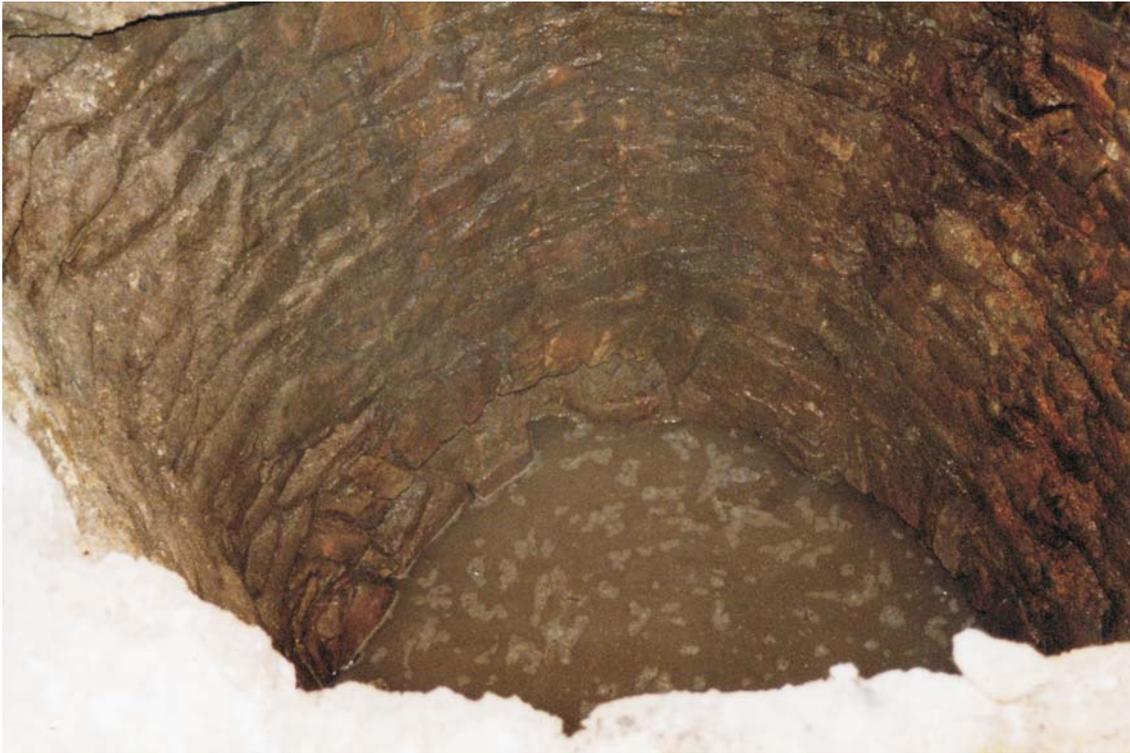
*Illus 9 The well at the Black Bull, showing the two vaulted feeder drains*

A watching brief was undertaken during the relaying of the ground floor of the Black Bull public house. The results showed that the area had been truncated down to the natural reddish-brown clay. However one significant archaeological feature was recorded: well 204, towards the rear (north) of the building (Illus 9). This well (diameter 1.94 m: Illus 10) was constructed from roughly dressed stone blocks. It had been capped at some point in the last century and the water table was observed at approximately 2.5m below the top of the well.

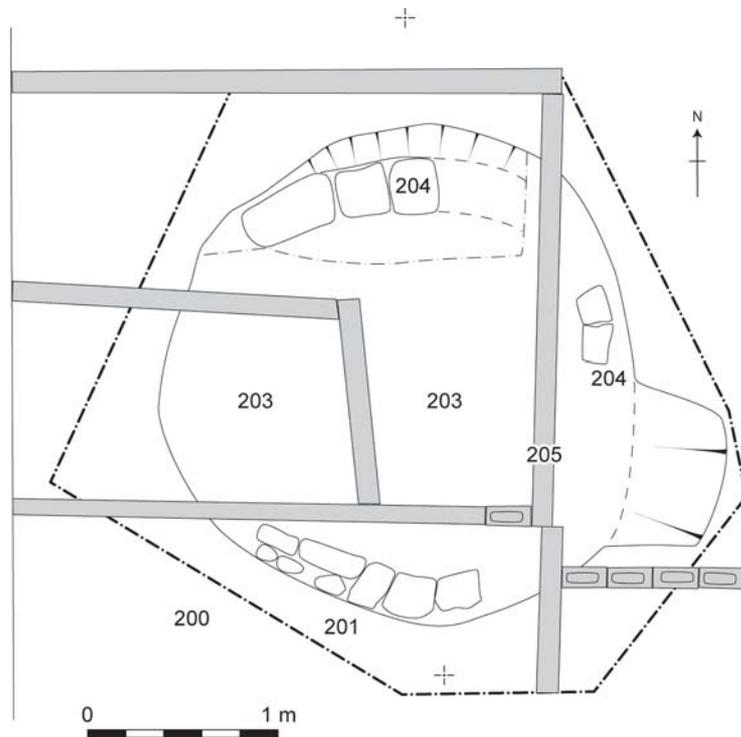
*Illus 10 Plan of the Black Bull well (modern floor joists shown in grey)*
