4 The Archaeological Investigations

4.1 Excavations in the South Choir Aisle, 1981

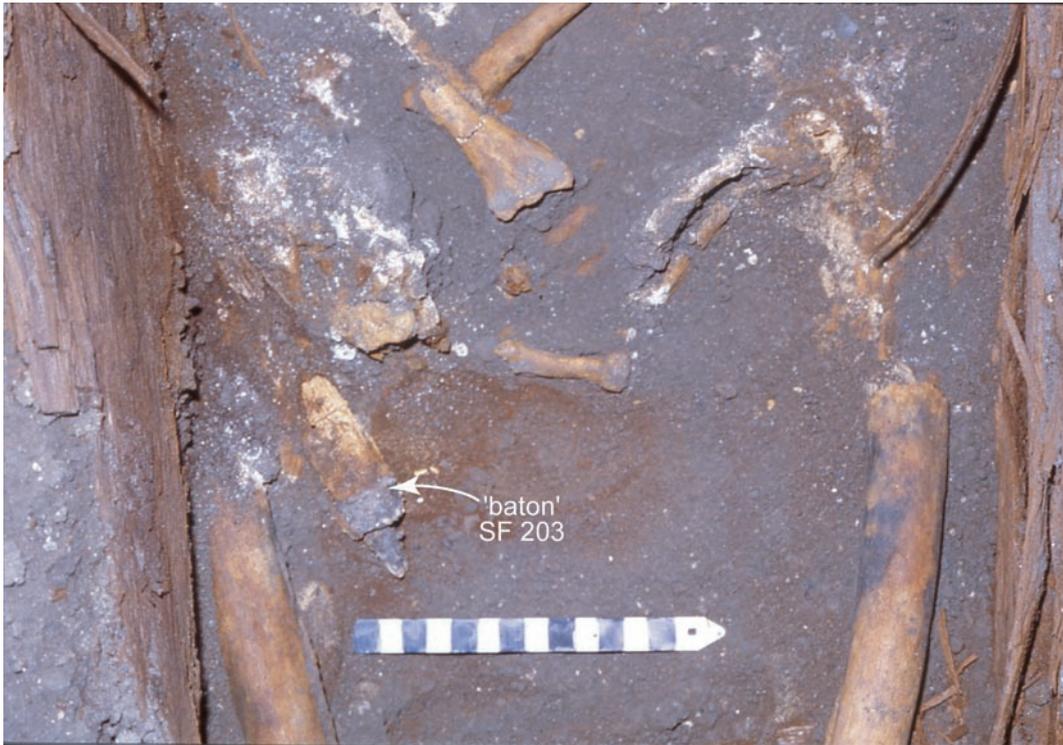
Illus 14 Skeleton 31 showing 'baton' on pelvis

grave fills. Each contained a wooden baton within the grave fill, in direct association with the body; for SK31 (a female), it lay on the pelvis (*illus 14*), perhaps originally held in the hands; the baton with SK43 (a male) lay on the feet (*illus 15*). SK31 was contained in a wooden coffin, but SK43 was not.

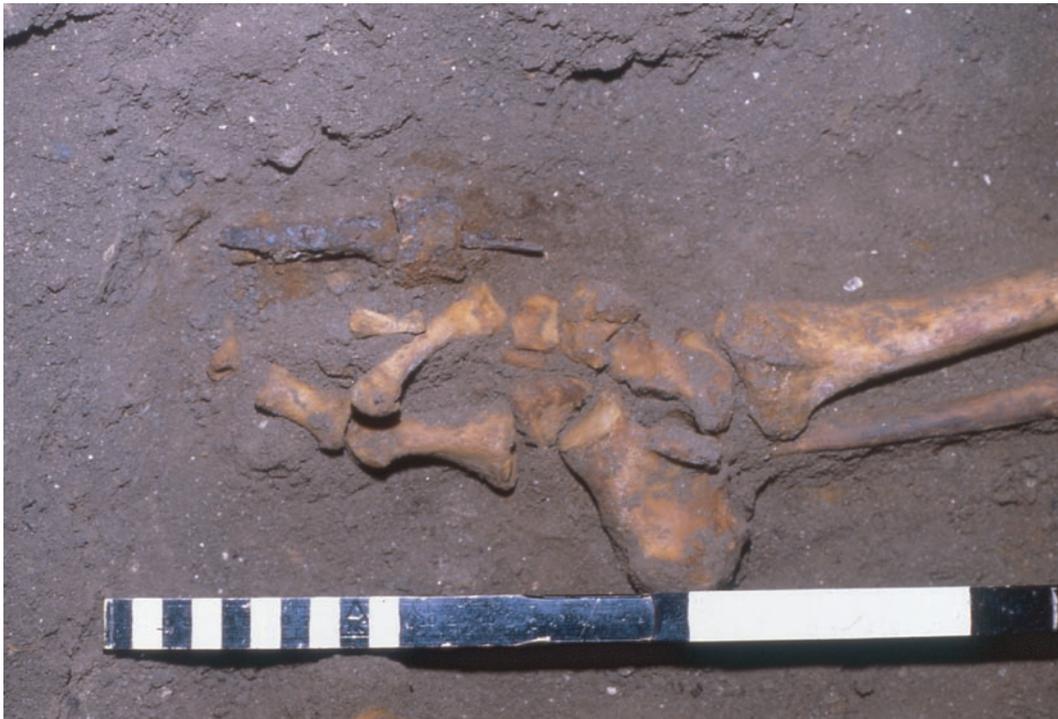
Illus 15 'Baton' in situ on feet of Skeleton 43

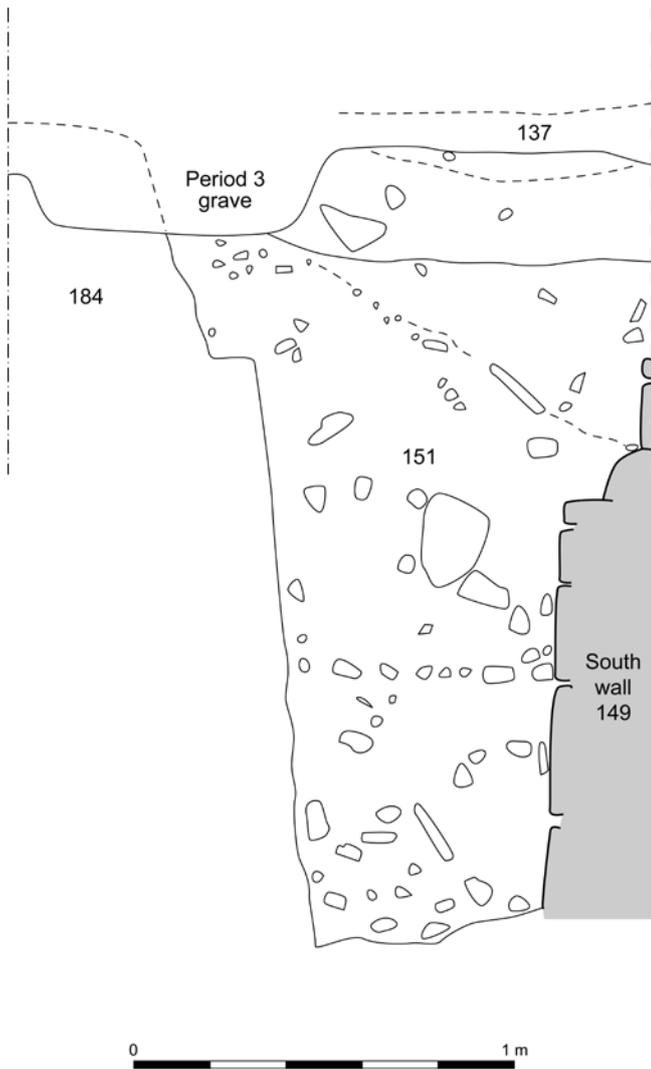
Illus 16 Section through Period 3a construction trench (C151) for south wall (C149)

The foundations of the south wall (C149; *illus 16*) of the Choir Aisle were exposed at one point only in the main excavation, for reasons of structural safety. The foundation trench (C151) cut through the deposits of Period 2 and was *c* 0.65m wide at the top at this point, tapering to *c* 0.30m at its base, with

a surviving depth of *c* 1.10m. Four rubble masonry foundation courses projected 0.10m from the face of the wall above. The original south wall was also seen in a geotechnical trial pit in 1977 (shown as TP wall 3 on *illus 17*, and in section on *illus 18*).

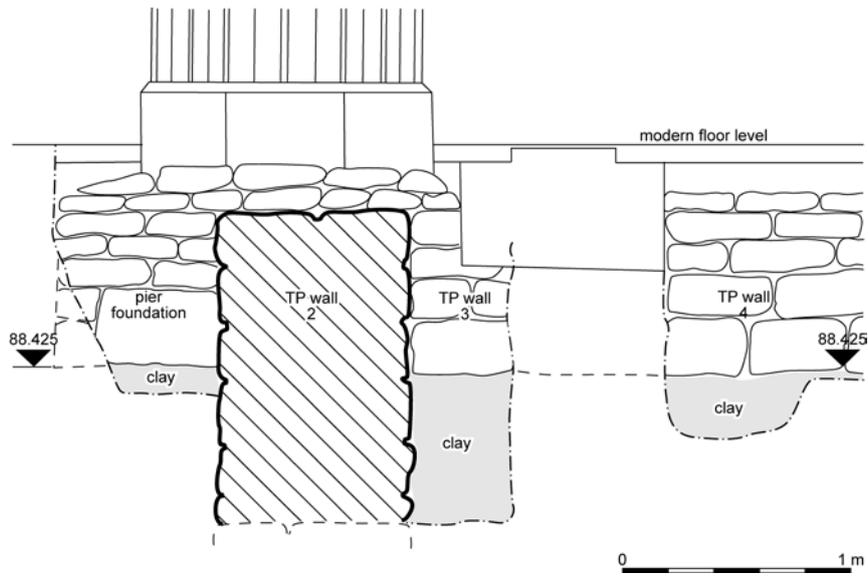
Illus 18 Section of 1977 trial pit TP4

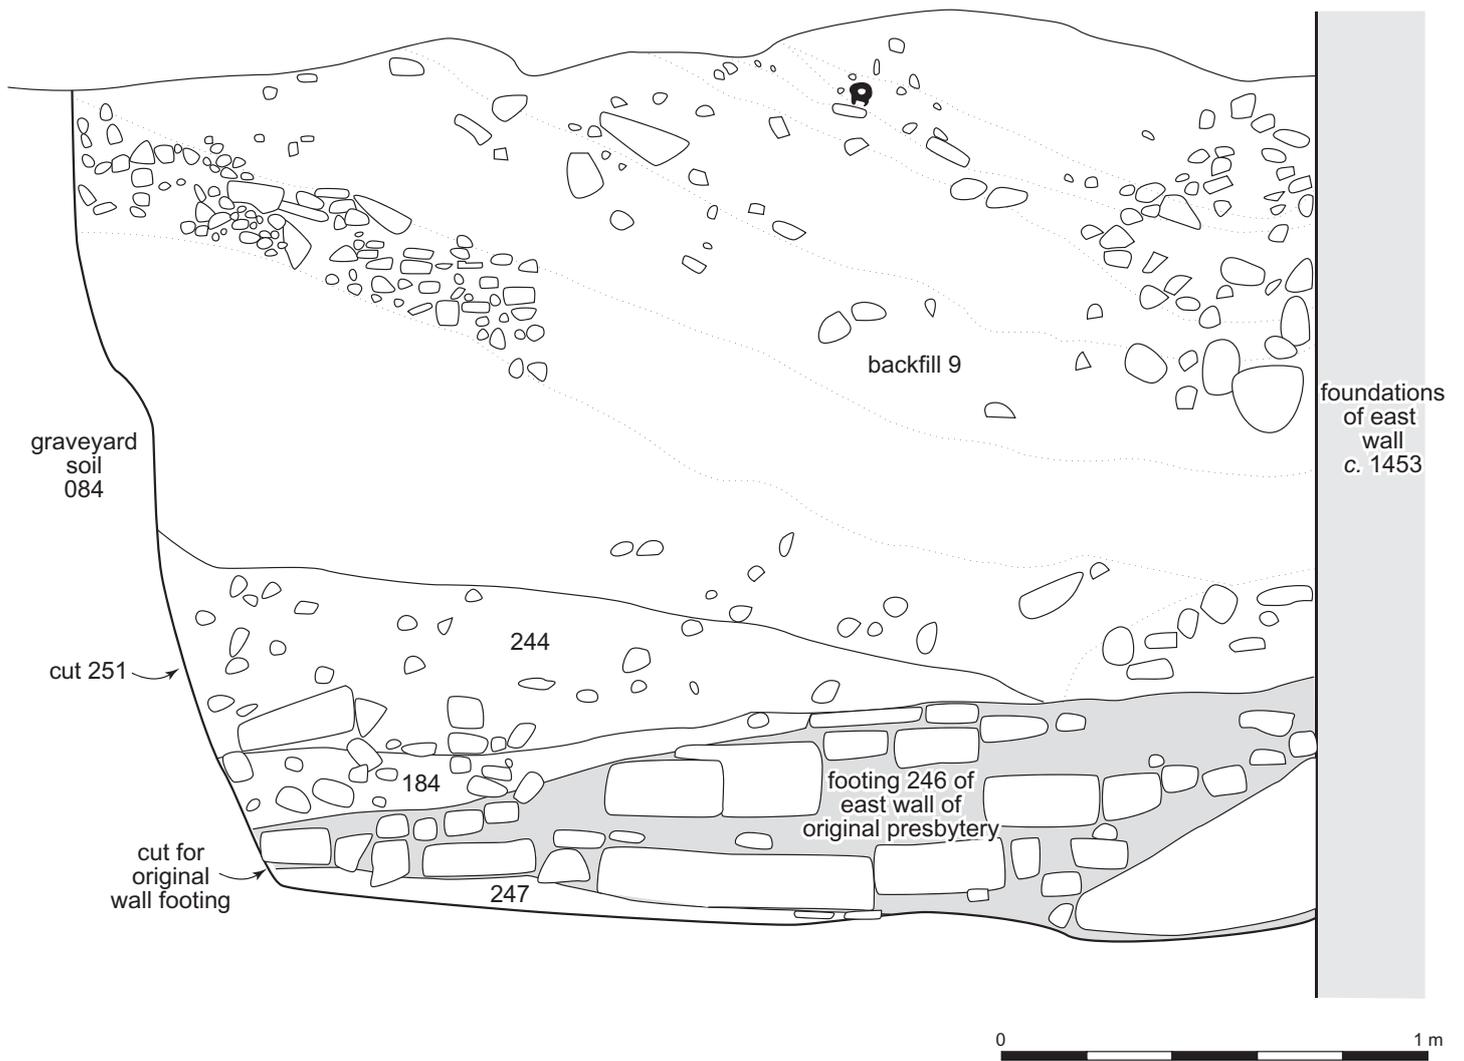
Illus 19 Section across robber trench (C251) of east wall (C246)

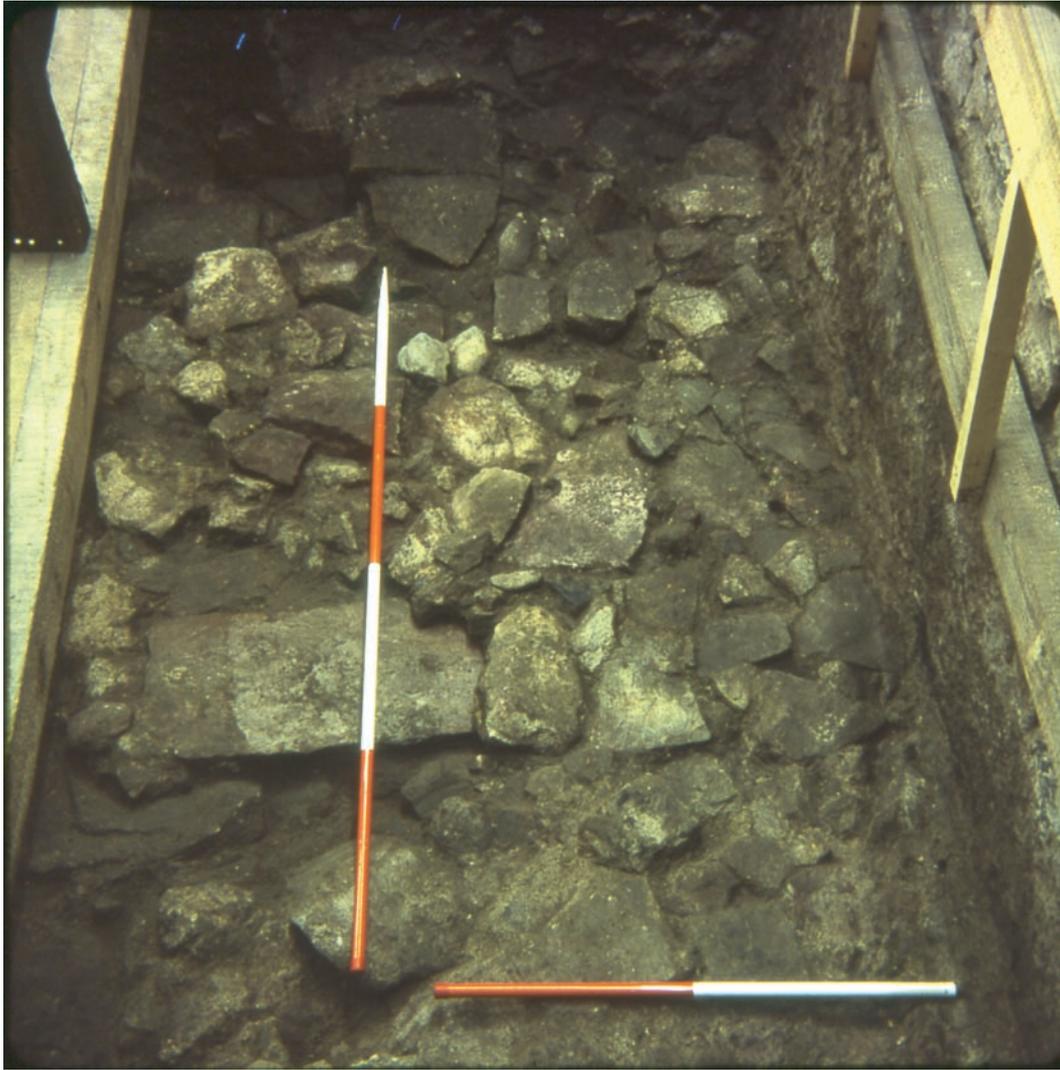
Illus 20 Footings of east wall of original presbytery (C246) in base of robber trench (C251)

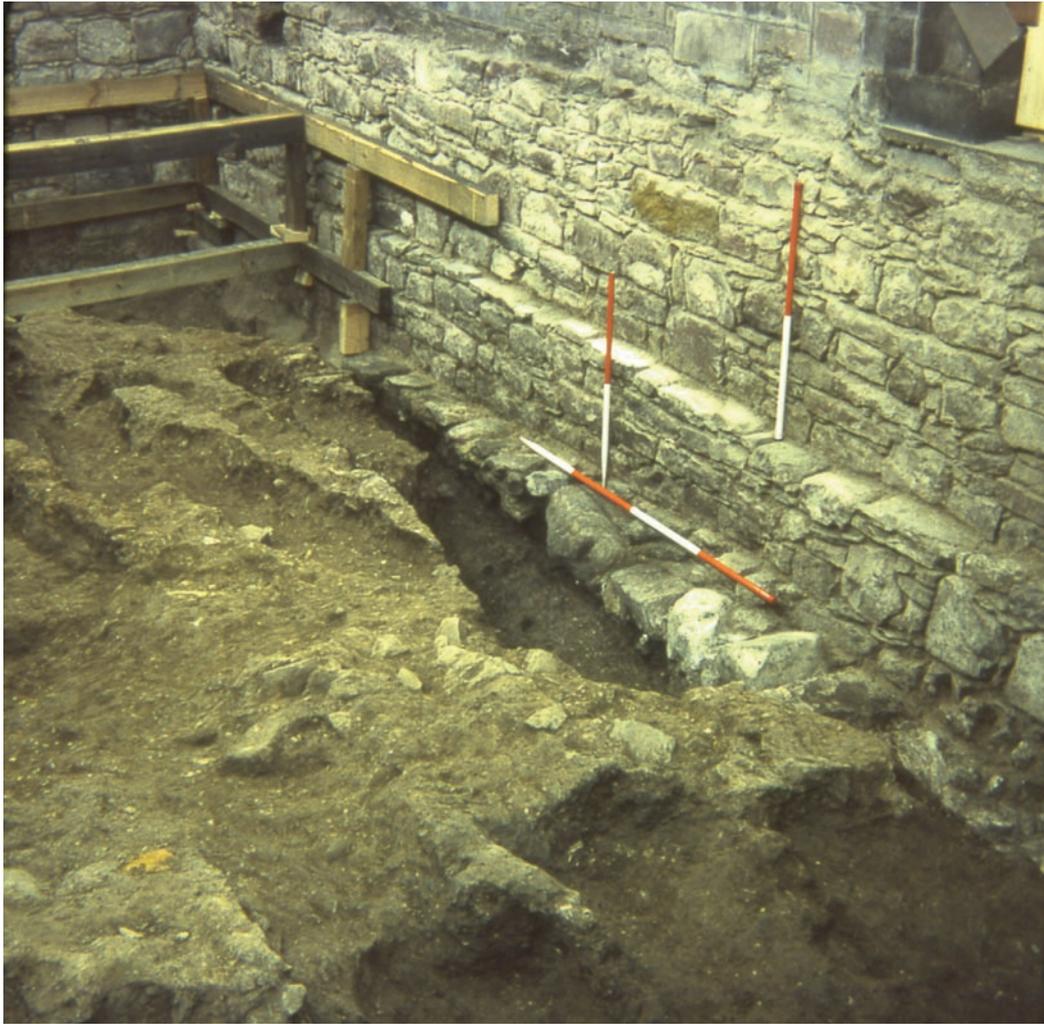
Illus 23 Underpinning of south wall in Period 3b

Subsequently, part of the south wall of the church appeared to have been underpinned at some stage (*illus 23*). A large pit (C40) had been dug adjacent to the wall beside the wall across the junction of the fourth and fifth bays, and within this pit an extra course of masonry had been inserted below the lowest foundation course of the wall, and a buttress of mortared stone (C127/C163) had been built at an angle against the foundations (*illus 22*; *illus 23*). There were also a number of flagstones at the bottom of the pit, which may have served simply as a solid floor for those employed in the underpinning. Evidence for the necessity of this underpinning could be seen in the form of cracks both in the wall above and in the roof of the aisle in this area. No burials had subsequently been inserted into the infill of the pit.
