THE ANCIENT ROOF OF GLASGOW CATHEDRAL: ITS CONDITION AND RESTORATION. BY W. T. OLDRIEVE, F.R.I.B.A., F.S.A. Scot.

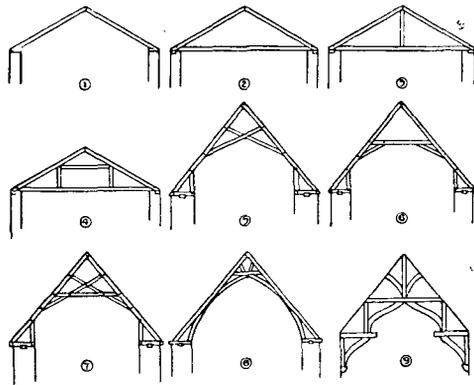
Fig. 4. Diagram to show development of the Timber Roof.

Gothic church roof design developed under four main types, *i.e.*:- (A) tie-beam, (B) trussed-rafter, (C) arch-braced, and (D) hammer-beam. Fig. 4 shows by a simple outline diagram the development of the timber roof. The tie-beam type (A) is indicated by (2), (3), and (4); the trussed-rafter type (B) by (5), (6), and (7); the arch-braced type (C) by (8); and the hammer-beam type (D) by (9). There were, however, no hard-and-fast divisions between the different types. Gothic builders had no compunction in mixing tie-beam and trussed-rafter types, tie-beam and arch-braced, tie-beam and hammer-beam, or hammer-beam and arch-braced.
