FURTHER NOTES ON HUNTLY CASTLE. BY W. DOUGLAS SIMPSON,
M.A., D.LITT., F.S.A. SCOT.

The works of repair, begun in 1923 after Huntly Castle had been handed over by the late Duke of Richmond and Gordon to the custody of the Ancient Monuments Department of His Majesty's Office of Works, have now been completed, and the entire castle area has been

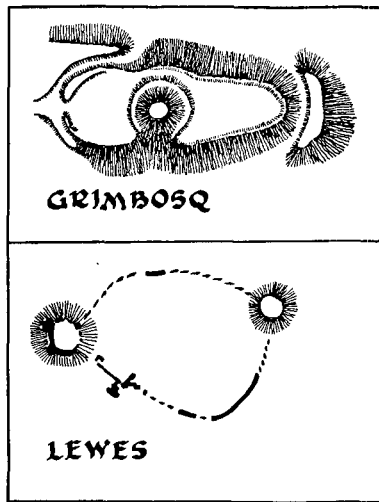
Fig. 2. Plans of *Mottes* at Grimbosq and Lewes (not to uniform scale).

The question of the relationship of this eastern mount with the bailey is an interesting one. A barbican exists at the *motte* castle of Grimbosq, in Normandy,¹ but it is much more crescentic in shape (see plan, fig. 2). Quite possibly the eastern mount at Huntly may be the remains of a second *motte*. Norman castles with double *mottes* are very uncommon, but two well-known examples exist at Lincoln and Lewes. The significance of the two *mottes* at Lewes (Plan, fig. 2) has been well explained by Dr Hamilton Thompson.² "The natural tendency," he writes, "would be to throw up the mount at first on the

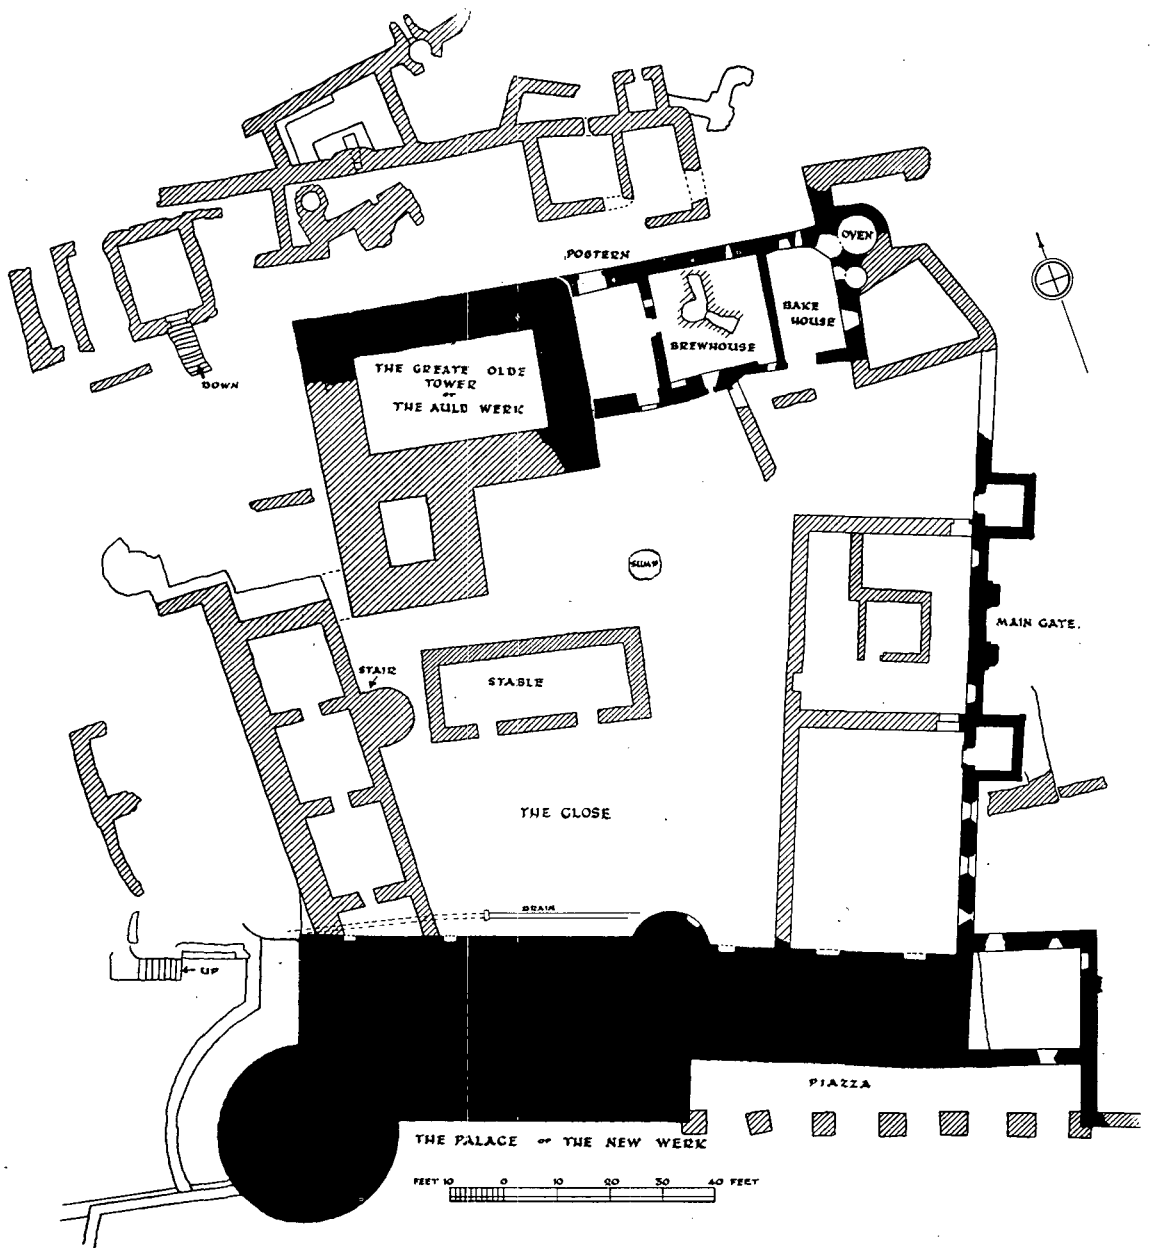
Fig. 3. Huntly Castle: Plan. (Those parts of the buildings which are hatched are now reduced to absolute foundations.)

The tower-house measures 58 feet by 52 feet 6 inches over its two long sides, with walls 9 feet 6 inches thick. Its north-eastern angle is rounded. The main portion contains a single long cellar, of which the north wall remains partly to the haunch of the vault. In the "jam" or limb of the tower-house is a chamber measuring 11 feet 9 inches by 9 feet 10 inches; it does not communicate with the long cellar, and was perhaps the "pit" or prison. The masonry of the tower-house is extremely massive, with an outer facing of boulders, and the interiors grouted.

By far the most interesting feature discovered in the excavations has been the foundations of a large and very massive tower-house of the L-plan, on the north-western side of the courtyard (see Plan, fig. 3). The unearthing of this tower restores a lost chapter in the architectural history of Strathbogie Castle, and clarifies certain statements hitherto obscure in our literary evidence. Thus Robert Gordon of Straloch, in his Latin tract on the "Origin and Progress of the Illustrious Family of Gordon," written about 1655, says of George, fourth Earl of Huntly (1524-62), that he had "magnificently extended his castle of Strathbogie, adding new structures to the ancient fortalice, and sparing no expense."² Clearly the "ancient fortalice" refers to the tower-house, while the "new structures" would include the great building on the south side. Straloch, however, was wrong in giving the fourth Earl exclusive credit for this latter building. He merely reconstructed it, for we know from other sources that the work was begun by the first Earl, *post* 1455, and completed by the second Earl (1470-1501);³ moreover, its basement, as it survives to-day intact beneath the later reconstruction, is evidently a work of the fifteenth century. This new building was of the type known technically in Scotland as a "palace" (*palatium* = hall)—*i.e.* a house designed on the plan of an elongated hall, raised above a tier or tiers of cellarge, as distinct from the tower-house plan.⁴ The word "palace" first emerges in connexion with Huntly Castle, so far as I am aware, in 1544, when the fourth Earl "caused the palace of Strathbogie to be called Huntlie, by act of Parliament."⁵ These two buildings, the ancient tower-house and the later "palace," are distinguished as the "auld werk" and the "new werk" in connexion with the events of October 1594.⁶ And the tower-house is undoubtedly the structure referred to in Randolph's account

THE COURTYARD BUILDINGS (see Plan, fig. 3).

uncovered, extending as far as the scarp of the Norman bailey. These foundations, which are shown on the plan (fig. 3), are evidently of various dates, and do not admit of any intelligible description, with the exception of a rectangular vaulted cell, measuring about 15 feet 3 inches by 12 feet 4 inches, lying to the north-west of the "greate olde tower." This cell is sunk about 4 feet 6 inches below the *terreplein*, and is reached by a flight of thirteen rough steps, with a lower door strongly secured. It may have been a strong room, possibly a prison, or perhaps a well-house, although no trace of a well-head or cistern has been discovered. Some of the walls of these outbuildings were laid in clay instead of lime: in all, the floors consisted of rammed clay above the native gravel. All over this area extensive traces of fire were noted.

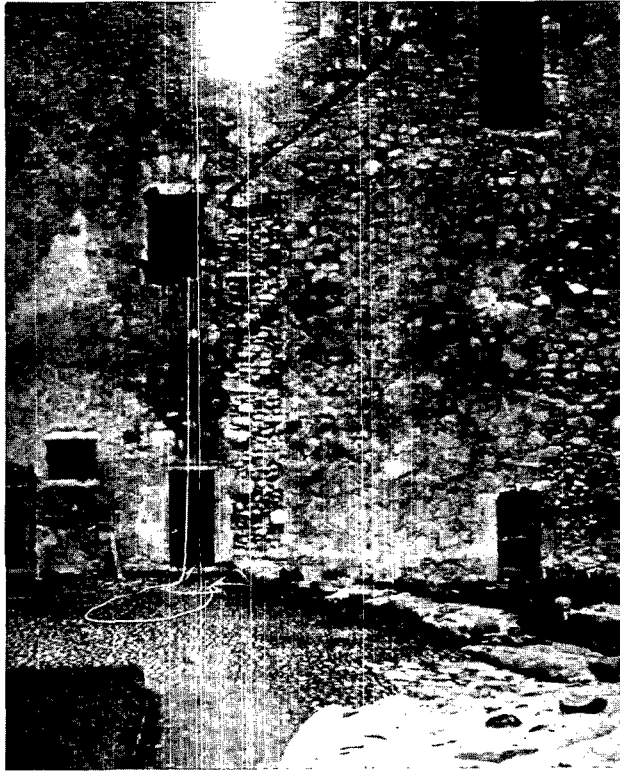
Fig. 4. Huntly Castle: Abutment of west range on north wall of the "Palace."

Two successive roof raggles of the west range, the upper one later, may be seen upon the "palace" wall (fig. 4). Midway in the range was a door from the courtyard, the worn threshold of which remains. Beside this door to the north was a half-round stair tower, the splayed freestone base-course of which is still *in situ*: it is seen in the foreground of fig. 4.
