SOME CRUCK-FRAMED BUILDINGS IN THE ABERFELDY  
DISTRICT OF PERTHSHIRE.

BY JOHN DUNBAR, B.A., F.S.A.ScOT.

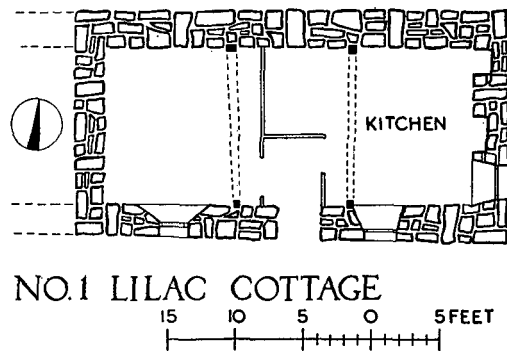
Fig. 1.

This building (fig. 1) stands about 65 yds. SE. of the parish church of Dull, which is just over 3 miles W. of Aberfeldy. It runs roughly W. and E. and measures 31 ft. 6 ins. by about 16 ft. 6 ins. over all. The structure is well preserved and is in use as a dwelling house; the thatched roof remains beneath the present covering of iron. After the erection of the house a small building, probably a byre, was added to the west gable; this addition no longer stands. The entrance doorway of the cottage is centrally placed in the south wall and on either side of it there is a window; there is a third window in the east gable. Within the entrance doorway there is a small

lobby from which access is gained to two rooms, one of which occupies the east end of the house and the other the west end. In the east room, which probably served as a kitchen in the original arrangement, there is a stone-built fireplace, with a sweep, in the gable wall. The apartment on the west, which is separated from the kitchen by a wooden partition, has no fireplace. This room was probably used as a parlour and bedroom<sup>1</sup> and was no doubt provided with a hanging chimney of lath and plaster of which no trace now remains. A loft runs the full length of the building. There are two pairs of crucks. Each pair rises from a point about 2 ft. above floor level, but the couples do not meet at the apex, being joined by a "yoke" a little below the ridge. The ridge itself is supported by additional cross-pieces which are wedged in above the yoke. Below the yoke one pair of crucks seems to have had a collar-beam, now represented by a short horizontal spar which is pegged to each of the principals.<sup>2</sup>

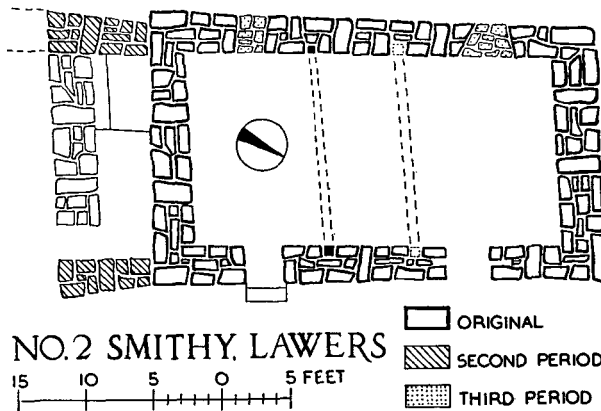
Fig. 2.

This building (fig. 2) stands about 200 yds. W. of the bridge by which the main Aberfeldy-Killin road (A 827) crosses the Lawers Burn, and about 25 yds. SW. of the house described under No. 4. It runs roughly NW. and SE. and measures about 33 ft. by about 19 ft. over all. The structure is now roofless and is falling into decay but it is said locally to have been used at first as a smithy and later as a barn. Subsequent to the erection of the smithy a byre was added to its south-east gable, but this is now reduced almost to its foundations although a small sheepfold has been

contrived at its north-west end. In the smithy itself there are two doorways in the north-east wall and a doorway and a window, both blocked up, in the south-west wall; there is another smaller window high up in the north-west gable. It is uncertain whether or not all these openings are original and in the absence of any indications of internal partitions the original plan of the building is uncertain. When the structure was used as a smithy, however, there were probably two main internal divisions, the one to the NW. comprising a living room and the one to the SE. being the workshop. There is now no trace of a fireplace. The roof was carried on two pairs of crucks, somewhat unequally spaced, of which the south-east pair alone survives. In the remaining couple (fig. 9) the principals rise from a point between 2 ft. and 3 ft. above floor level and cross at the apex to carry the ridge. A little below the apex there are pegs for a collar-beam, now missing.

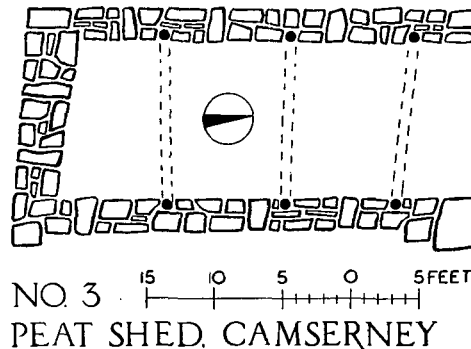
Fig. 3.

This structure (fig. 3) now forms one of a number of outbuildings on Camserney Farm,  $2\frac{1}{2}$  miles W. of Aberfeldy. It stands a few yards to the SW. of the old house described under No. 6. The building runs roughly

N. and S. and measures about 33 ft. by about 15 ft. over all. It is said locally to have been a peat-shed and it is now used for storing tools; the structure is in good condition but the thatch has been replaced by a corrugated iron roof. There are no doors or windows, access being obtained from the north side, which stands open. Within, there are three pairs of crucks (fig. 9), which spring from a height about 3 ft. above floor level; the couples cross at the apex to carry the roof and have collar-beams. The crucks have a pronounced elbow shape.

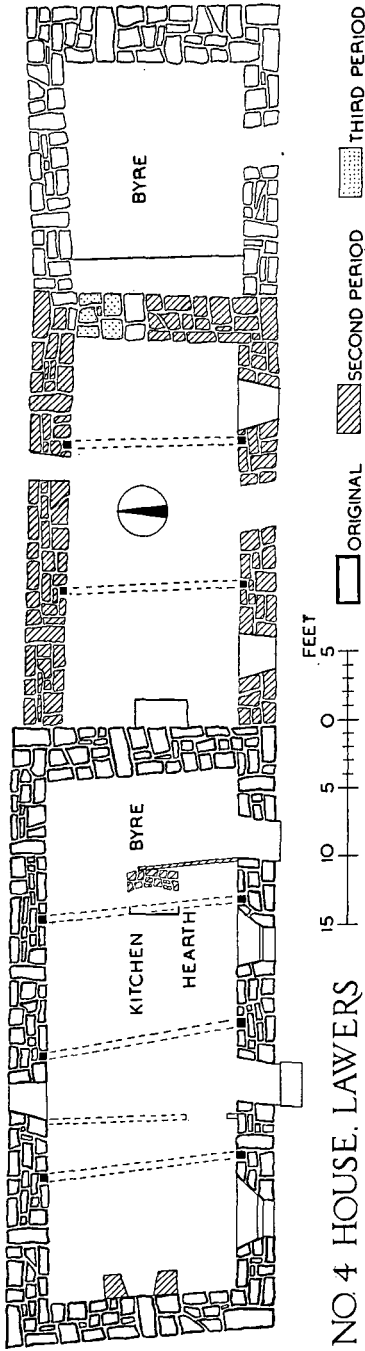
Fig. 4.

This building (fig. 4) stands about 25 yds. NE. of No. 2.<sup>1</sup> The structure, which is not all of the same period, runs roughly W. and E. and comprises an original house, to the east gable of which there has been added a second house, to the east gable of which there was added subsequently a third building, probably a byre. The byre is now ruinous; the remainder of the building retains its roof, but is unoccupied and is now falling into decay. The original house measures about 44 ft. 6 ins. by about 19 ft. 6 ins. over all. There is a doorway a little to the W. of centre in the south wall and on either side of it a window; there is a second doorway at the east end of the south wall. A single window is set a little to the W. of centre in the north wall. The disposition of the openings, together with what remains of the internal arrangements suggests that the building contained both living space and byre under the same roof. The west portion of the structure seems to have formed a dwelling of very much the same size as Lilac Cottage (No. 1) the internal arrangements of which it may have repeated; the eastern end of the building, which was partitioned off, no doubt contained the byre. This had its own entrance doorway but would communicate with

the dwelling. The stone fireplace in the west gable is an addition and may replace an older hanging chimney; the roughly formed fireplace with a wooden box-flue in the east room of the house seems comparatively modern, but may replace an older fireplace. The west portion of the building, at least, had a loft. There are three pairs of crucks (fig. 9); they spring from a height of about 3 ft. above floor level and cross at the apex to support the ridge. Each pair has a collar-beam a little below the apex.

The house that has been added to the east gable of the earlier building measures about 31 ft. 6 ins. by about 18 ft. over all and corresponds both in dimensions and in plan to the west portion, or dwelling space, of the older house. The internal arrangements probably resembled those of Lilac Cottage (No. 1). Some traces remain of a hanging chimney against the west gable; there was originally a loft. There are two pairs of crucks, similar in form to the ones in the older house; they have no collar-beams, however, but the joists supporting the loft acted as ties, being checked into the couples at wall-head level. When a byre was added to the E. a door was broken through the east gable of this house to give access to it.

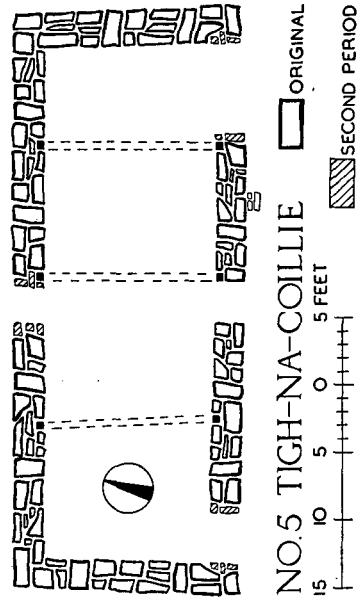
Fig. 5.

This building (fig. 5) stands at the west end of the hamlet of Boltachan,  $\frac{3}{4}$  mile NW. of Aberfeldy; it runs roughly W. and E. and measures about 42 ft. 6 ins. by 16 ft. 4 ins. over all. The structure has been somewhat altered and is now used as a hen-house, but it is said locally to have been originally a dwelling house. An entrance doorway is centrally placed in the south wall but this appears to be the only original opening, the doorways at the west and east ends of the south wall being recent insertions and the one in the centre of the north wall an enlarged window. The south wall is now buttressed towards its east end. As the position of the original doors and windows is to a large extent uncertain and as no trace of the former internal arrangements remains, it is impossible to say anything of the original plan of the building. It is perhaps worth noting, however, that the structure corresponds in its overall dimensions to the oldest portion of the house at Lawers (No. 4), which contained both living accommodation and byre under the same roof. There are three pairs of crucks (fig. 9), the couples of which spring from a height of about 3 ft. 6 ins. above floor-level and cross at the apex to carry the ridge; below the apex there is a collar-beam.

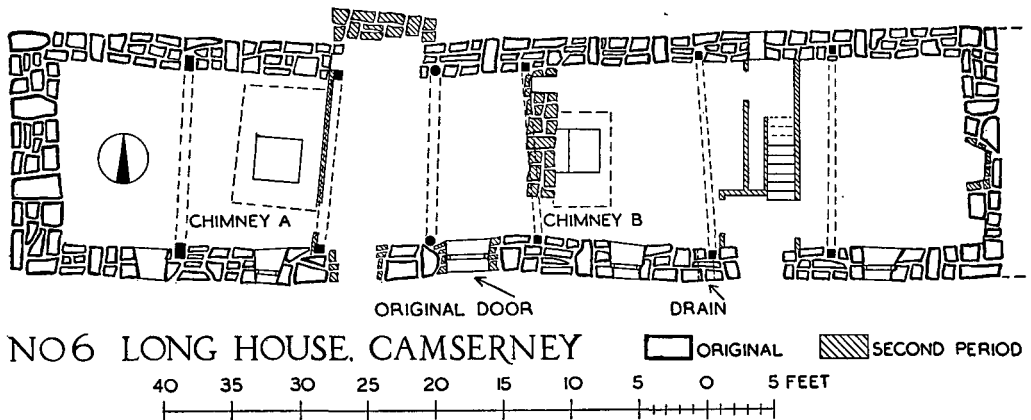
Fig. 6.

The principal features of the structure may be deduced from a study of the plan (fig. 6), and it is clear that latterly, at least, the building contained two dwelling houses of approximately the same size and with similar internal arrangements. The houses are separated by a stone partition in which there was a communicating door. The west house contains two apartments, which are separated by a thin wooden partition. The west room, presumably the kitchen, contains a stone hearth above which there is a hanging chimney (fig. 7); on the north side of the east room the wall has been extruded to form a bed recess, but this is not an original feature. Above the east room there was a loft. The front door of the east house opens into a lobby from which access can be gained to the kitchen on the W. and to a room on the E. which served as a parlour and bedroom. The kitchen has a hanging chimney (fig. 8) which is built against the stone partition that separates the two houses. To the N. of the fireplace a wooden salt-box is built into the partition. The parlour has a stone fireplace in the east gable; it is said that box beds formerly occupied the north part of the room. From the lobby a wooden stair ascends to a loft, which runs the full length of the

house; behind the stair there is a small apartment, lit by a window to the N. and reached from the kitchen.

It has been assumed that the building always comprised two dwelling houses,<sup>1</sup> but although this was undoubtedly the case during the latest period of occupation, it seems more likely that the structure was at first a "long house,"<sup>2</sup> containing both house and byre under the same roof. In this arrangement the building appears to have contained two main divisions, as at present. The west division, which formed the house, was entered by a door at the east end, a little to the E. of the present doorway; the old doorway is now blocked and has been turned into a window, but the outline of the jambs is visible in the masonry. A front door in this position would provide ready access both to the house and to the byre, which no doubt occupied the east division of the building. The internal arrangements of

the house are uncertain but the central position of the fireplace suggests that it may have contained a single large apartment only, with the fire in the middle of the floor. The house was separated from the byre by a partition of wood or stone,<sup>1</sup> but there was through communication between the two divisions, as at present, although the byre also possessed its own entrance doorway. The identification of the east division as a byre is supported by the presence of a drain at the base of the south wall, a little to the W. of the doorway. Further, the fireplace in the east gable of the byre appears to be an insertion, while the hanging chimney against the stone partition is certainly later in date than the canopy above the hearth in the west division, being made of lath and plaster as opposed to wattle and daub. From all this it would appear probable that the internal arrangements of the east division are secondary, being the result of the conversion of the byre of an original "long house" into a separate dwelling. To this period too may be ascribed the blocking up of the old front door of the west division and the insertion of the present doorway to the W. of it.

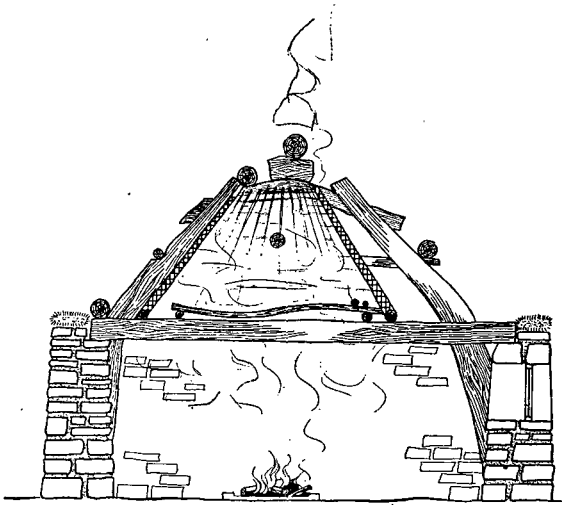
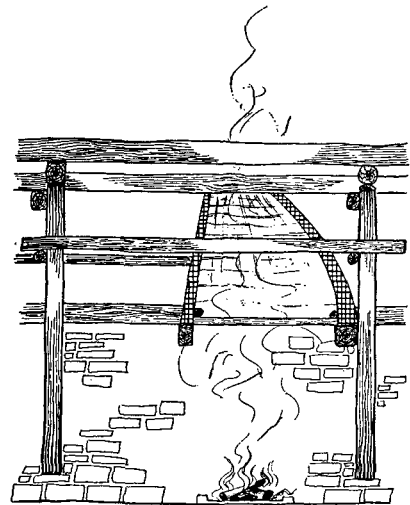
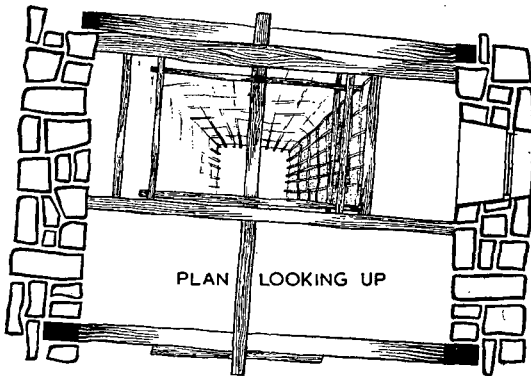
Fig. 7.

SECTION LOOKING EAST

SECTION LOOKING NORTH

PLAN LOOKING UP

CHIMNEY "A"  
LONG HOUSE,  
CAMSERNEY

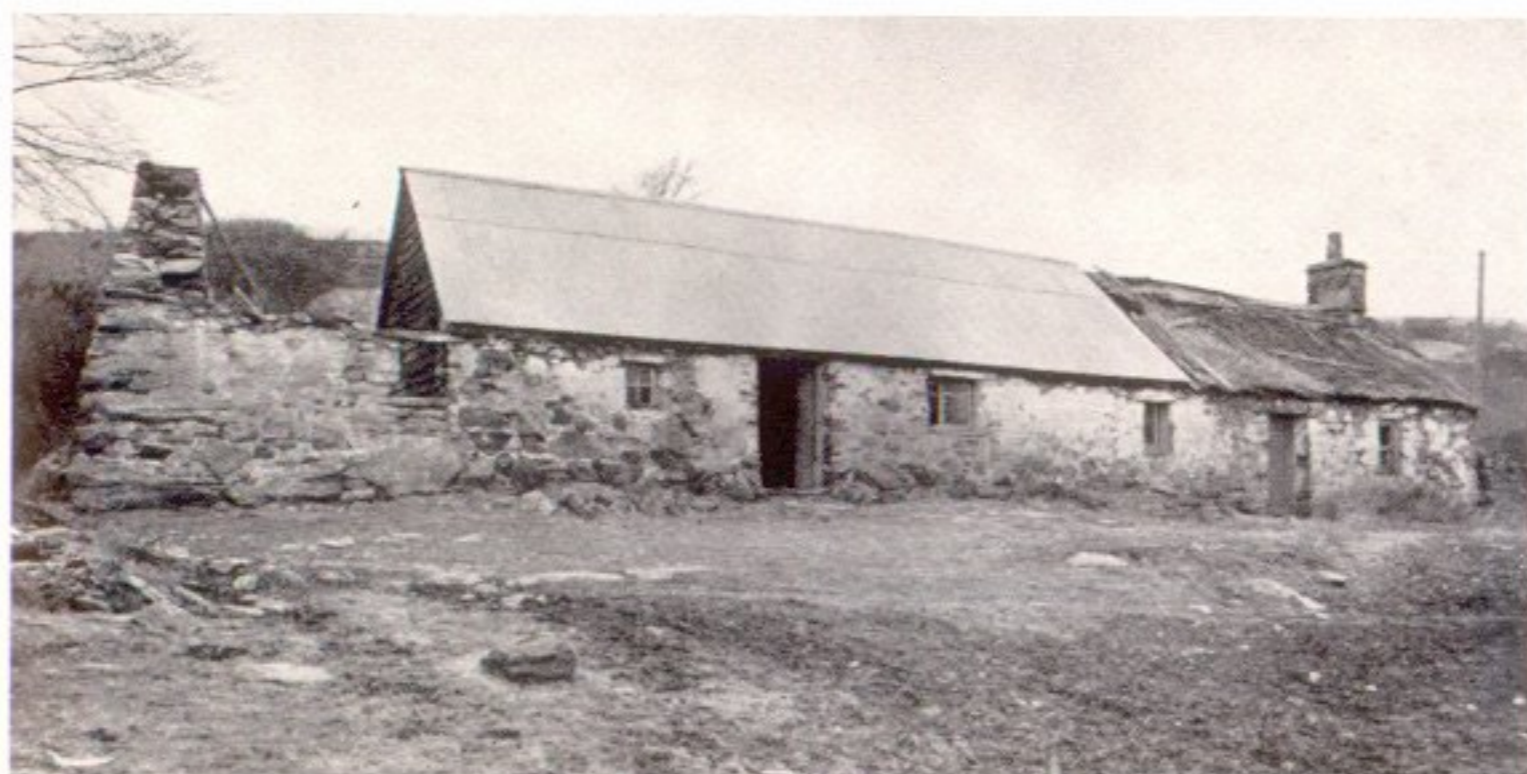
(a) Long House, Camserney Farm.

This building stands a few yards to the NW. of the peat shed described under No. 3. As it is undoubtedly the most interesting structure discovered during the course of the survey and as it differs in many respects from the buildings already noted, it is described in some detail here. The building runs roughly W. and E. and measures about 72 ft. 6 ins. by about

17 ft. 9 ins. over all; a small outshot has at some time be added to the east gable, but this is now ruinous. When first visited in August 1955, the building retained its thatched roof, but this had ceased to be waterproof and damage was being done to the interior, some of the features of which are of considerable interest. Thanks to grants from the Russell Trust and from the Trustees for the Highland Folk Museum (Am Fasgadh), however, a temporary but waterproof covering was placed over the west portion of the building early in 1957, and the more interesting items of furniture were moved to this end of the house.

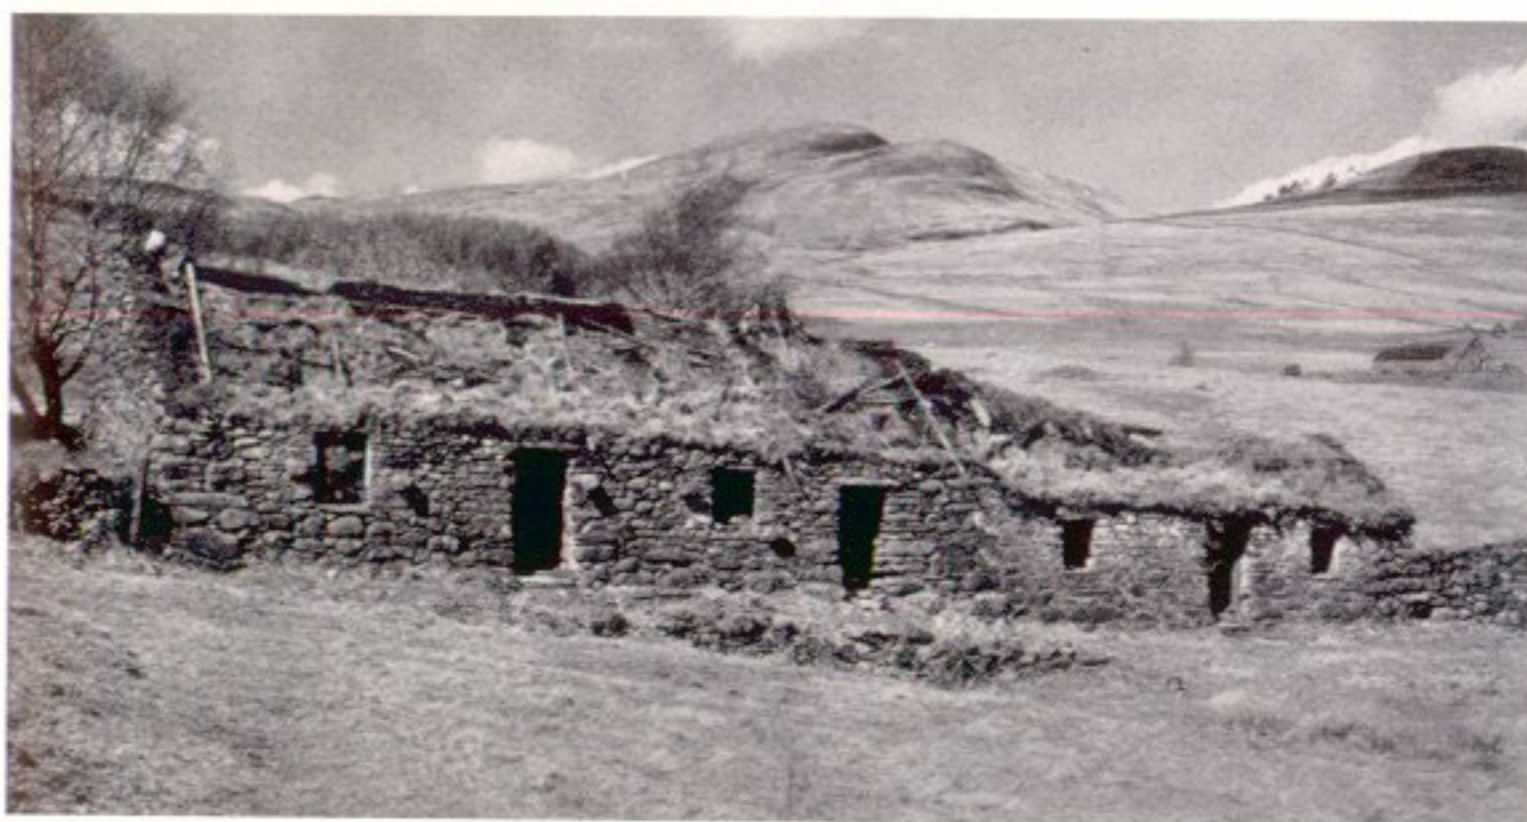
(b) House, Lawers.

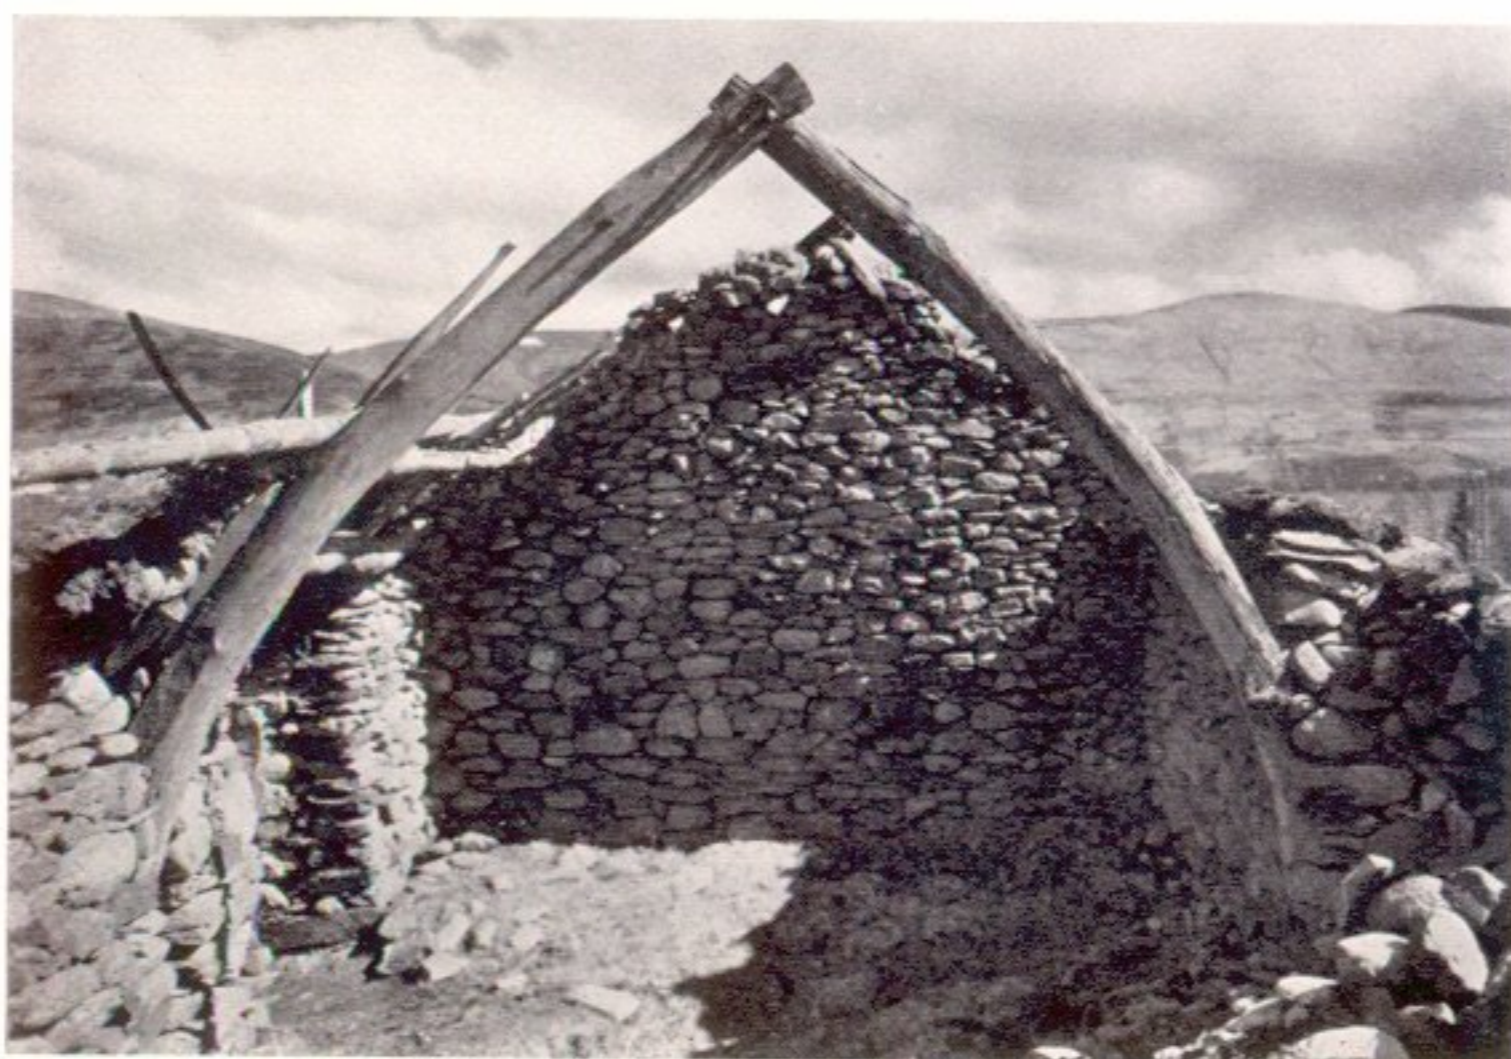
(c) Smithy, Lawers.

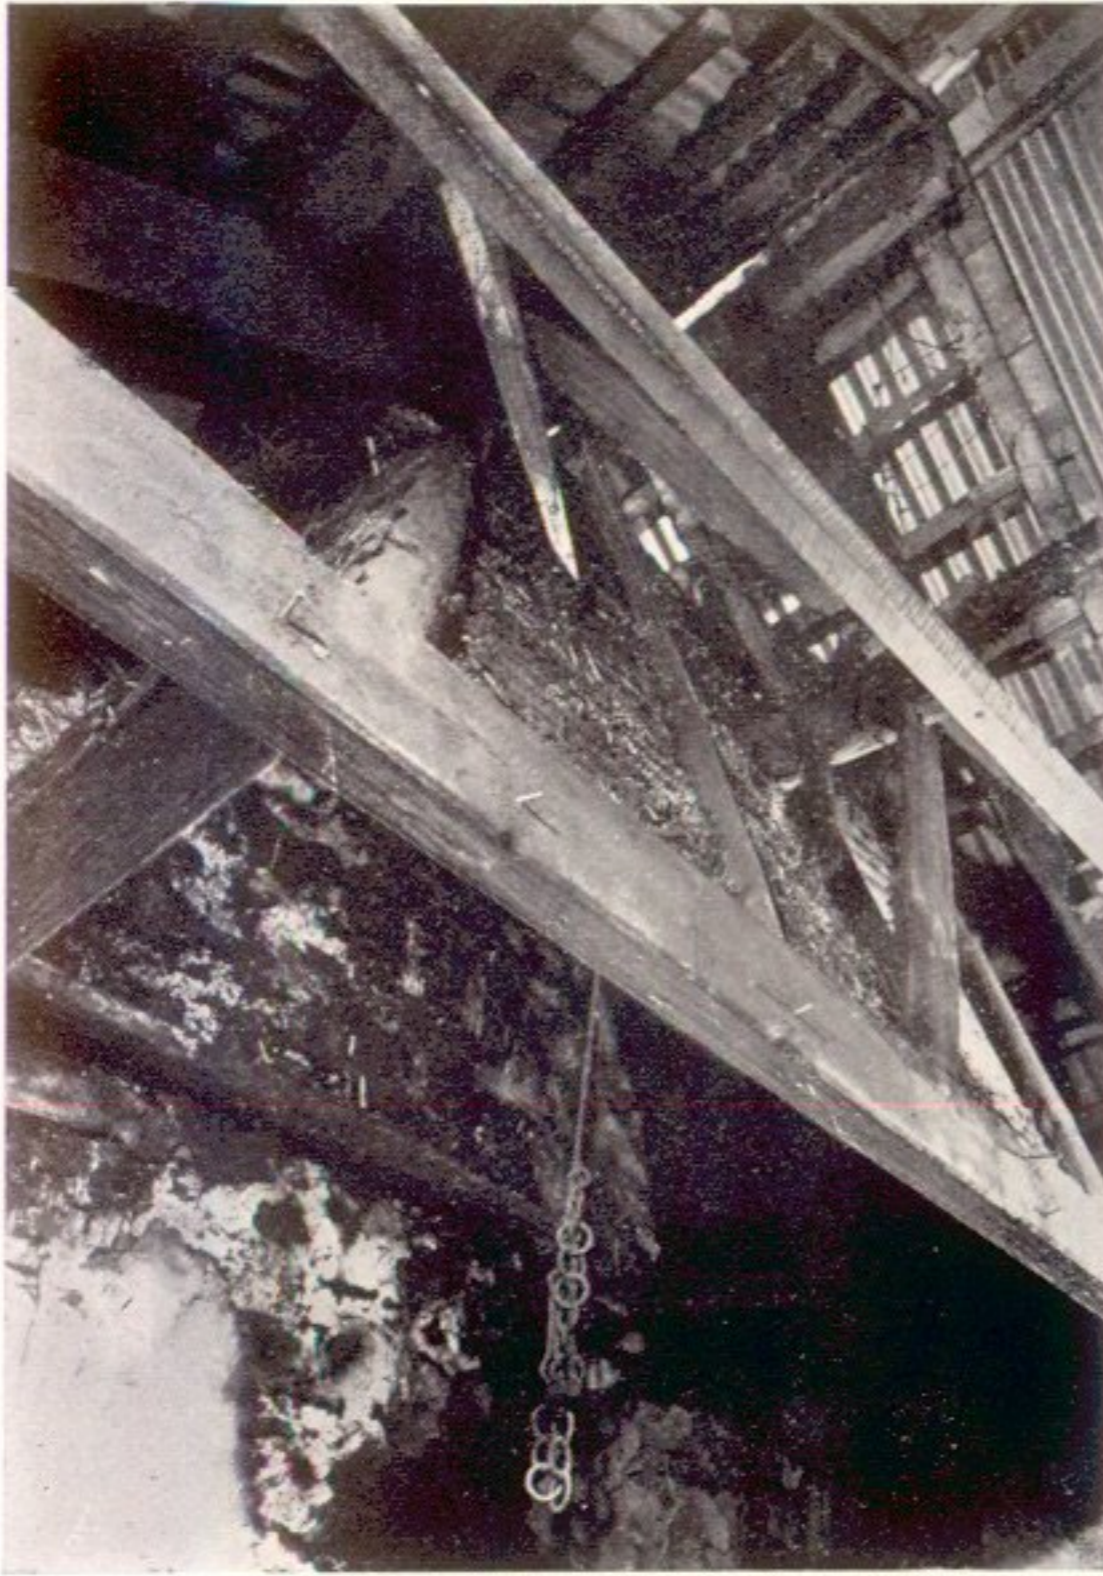
(a) Long House, Camserney, Chimney "B".

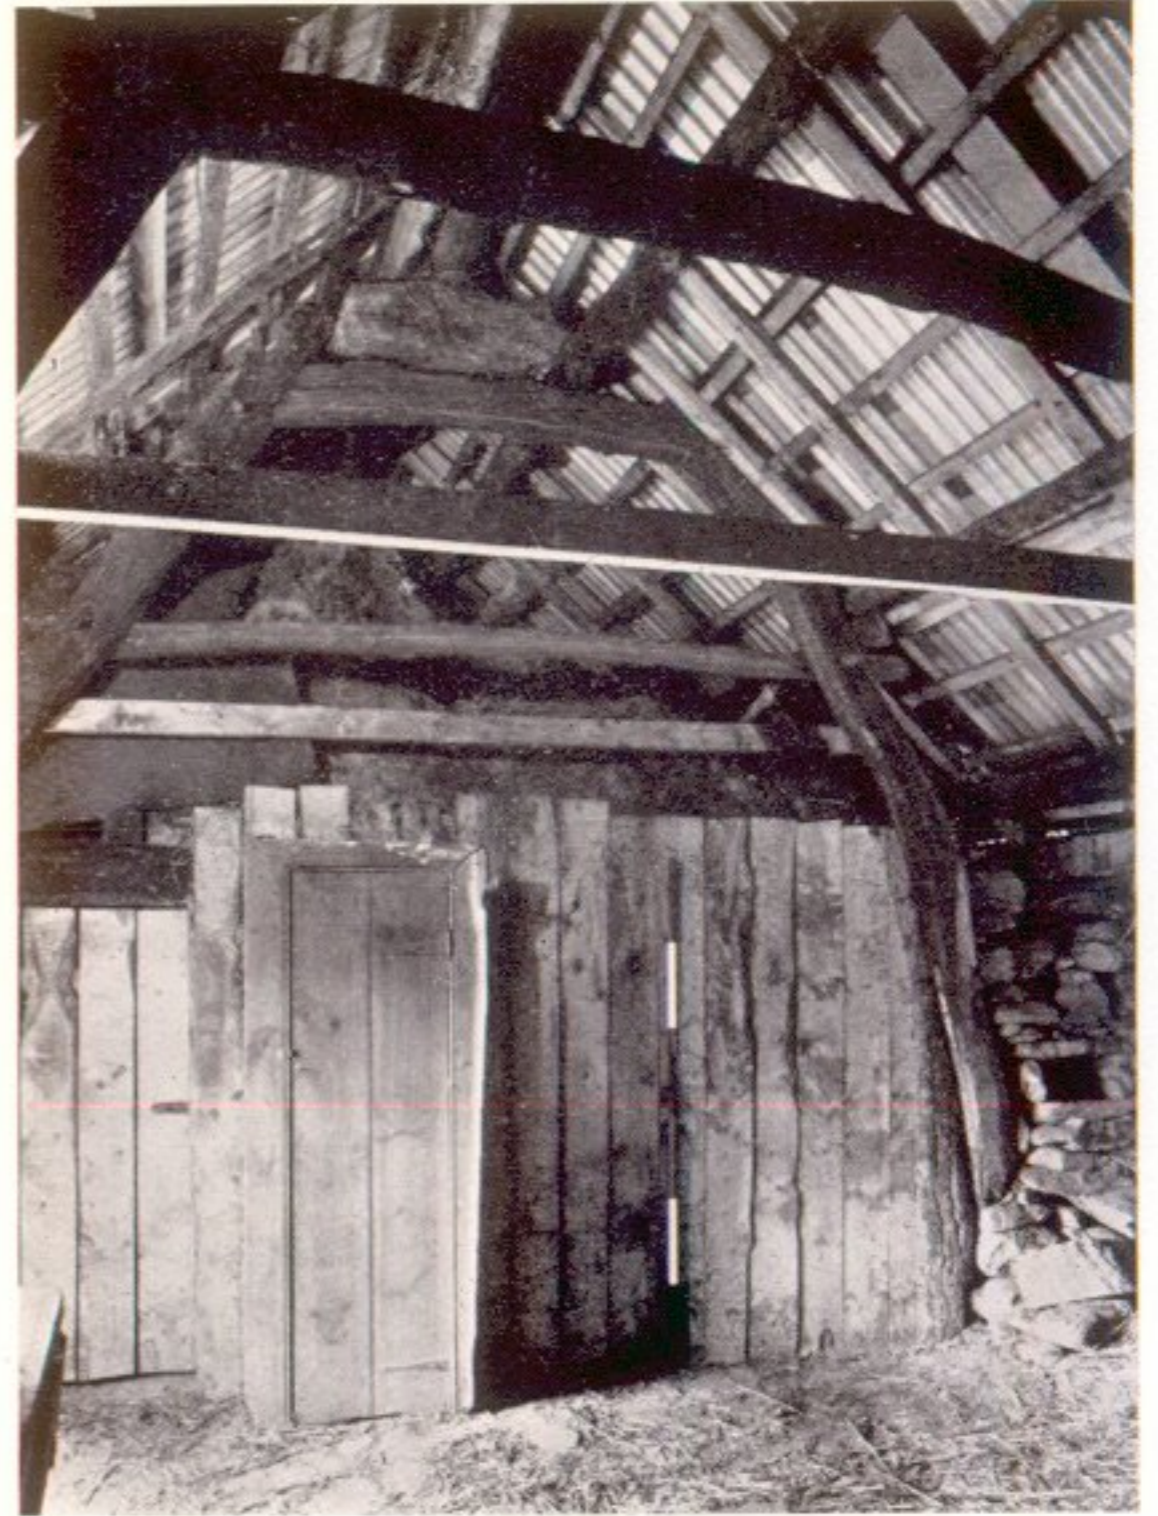
(b) Long House, Camserney, Interior.

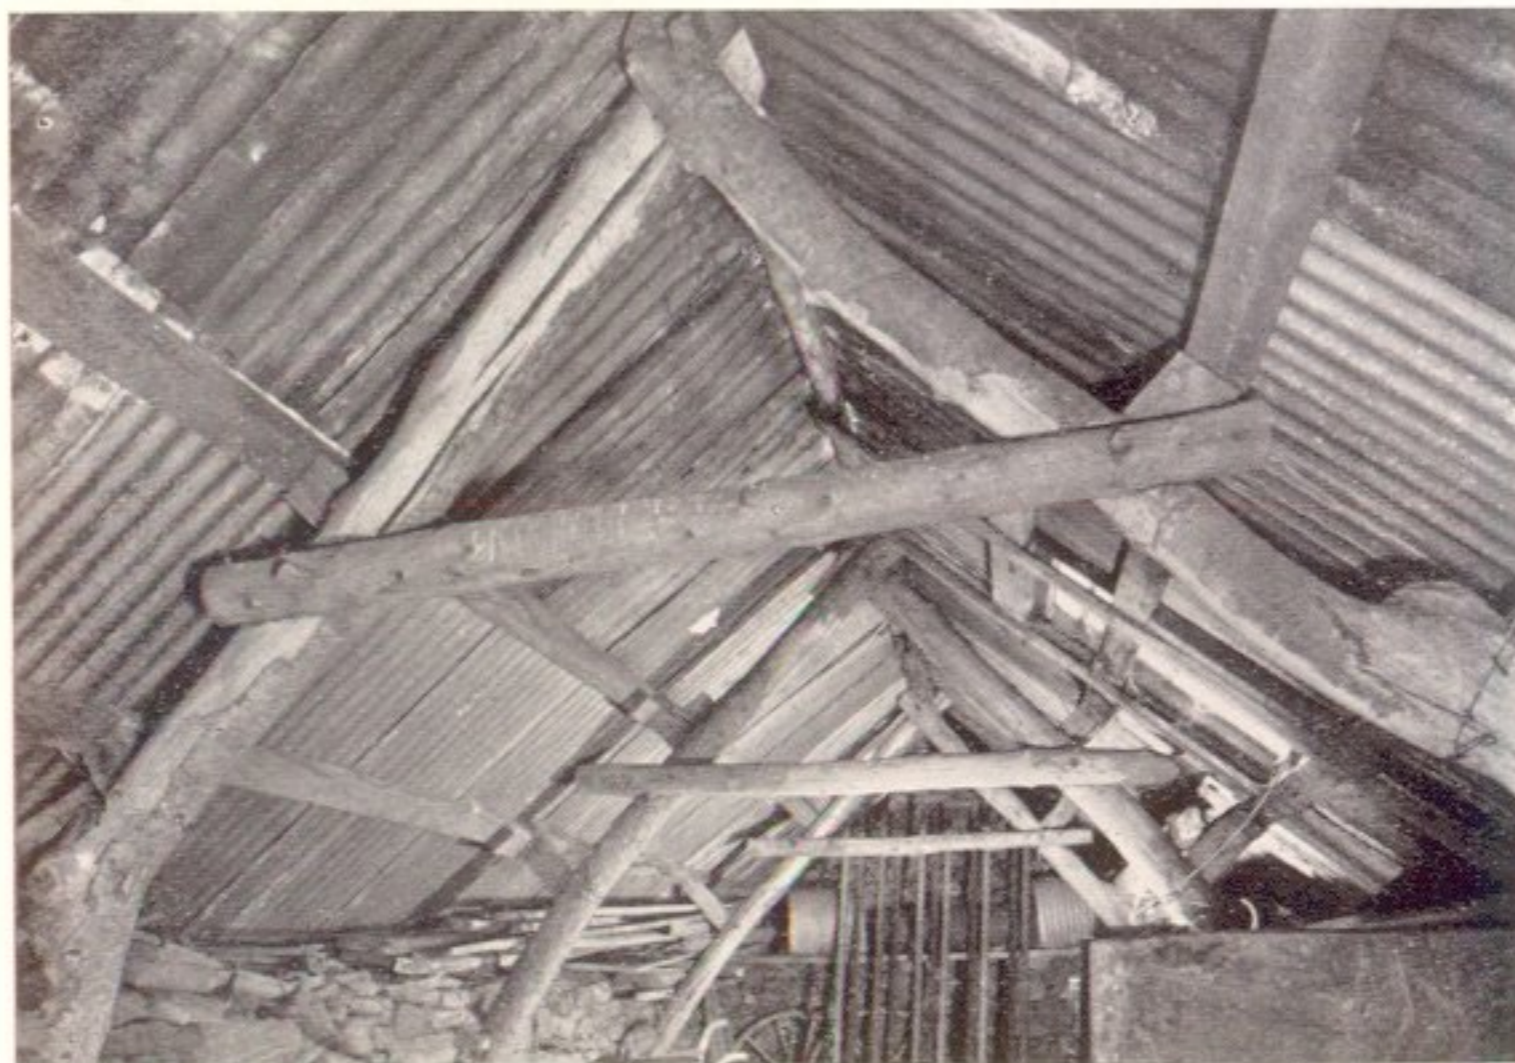
(c) Peat-shed, Camserney Farm, Interior.
